# Foundation & Geotechnical Engineering, LLC

FGE Project No.: G08-L-293

Subject: **Shaft Integrity Testing Results**  
XXXXXXXXXXXXXXXXXXXXXXXXXXXX

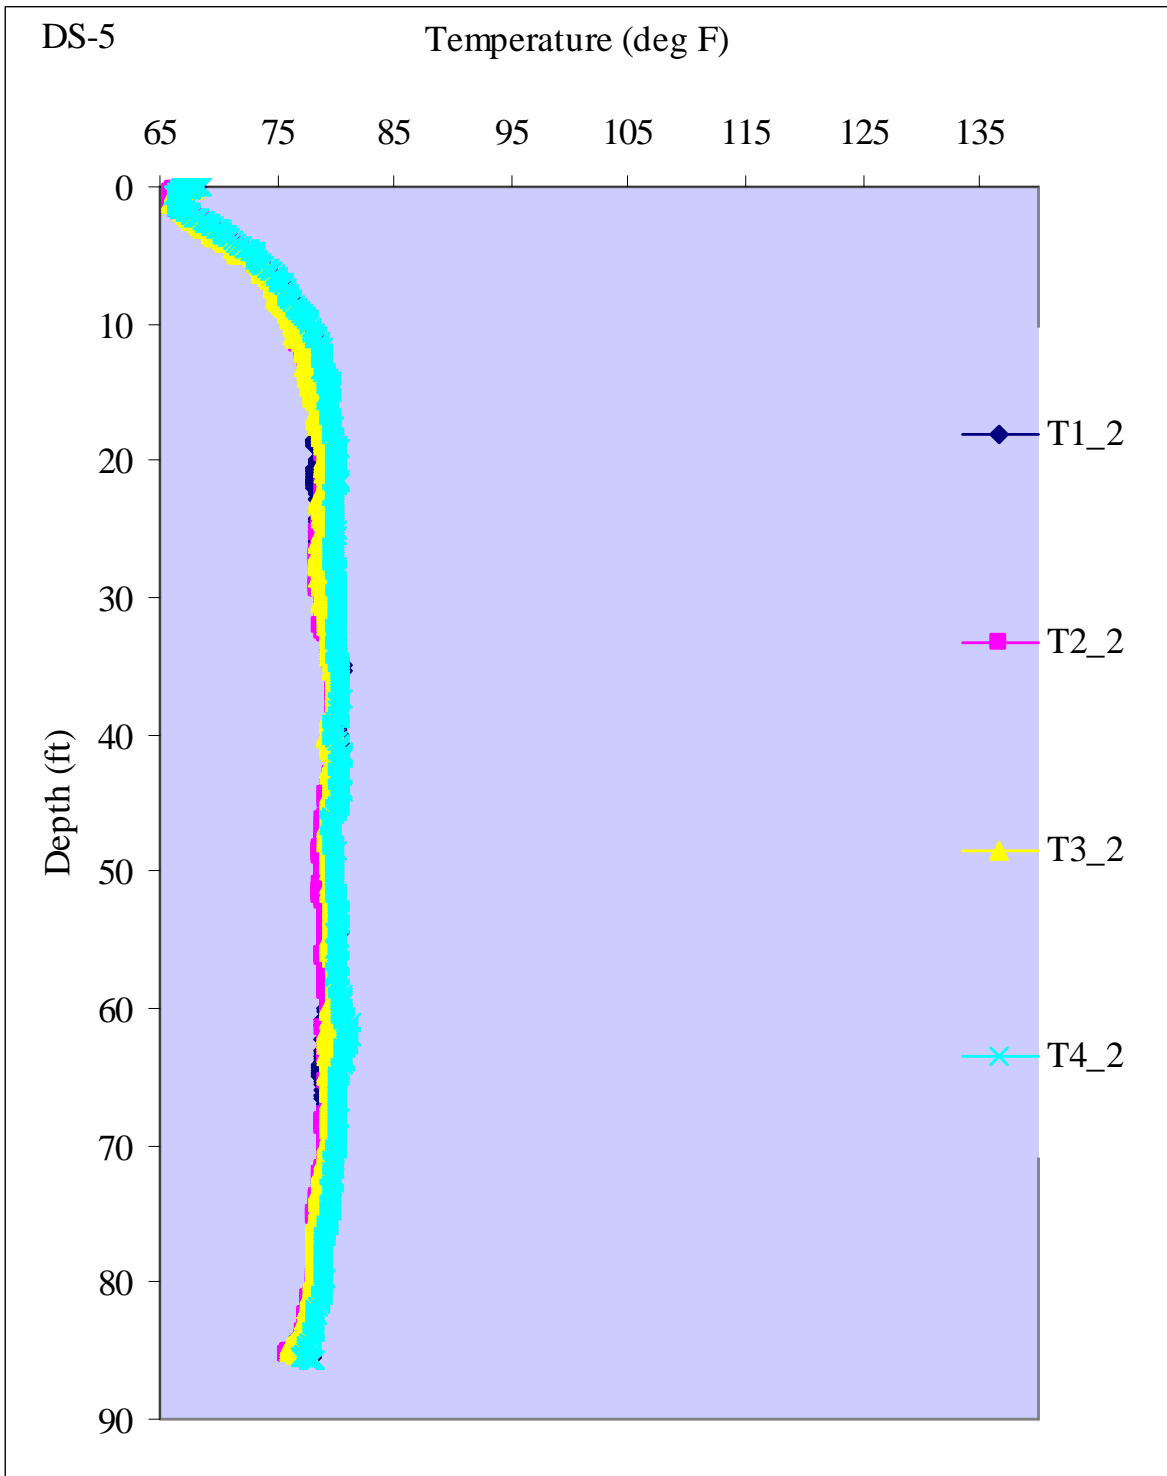
Figure DS-5 Measured temperature traces for Tubes 1 through 4.

DS-5. Although elevated temperatures were still present, this shaft was tested long after the recommended 24 to 48 hours and is thermally inconclusive. An outward thermal gradient is required to clearly delineate inclusions. Full modeling would not be productive. CSL testing and report produced separate to this document.

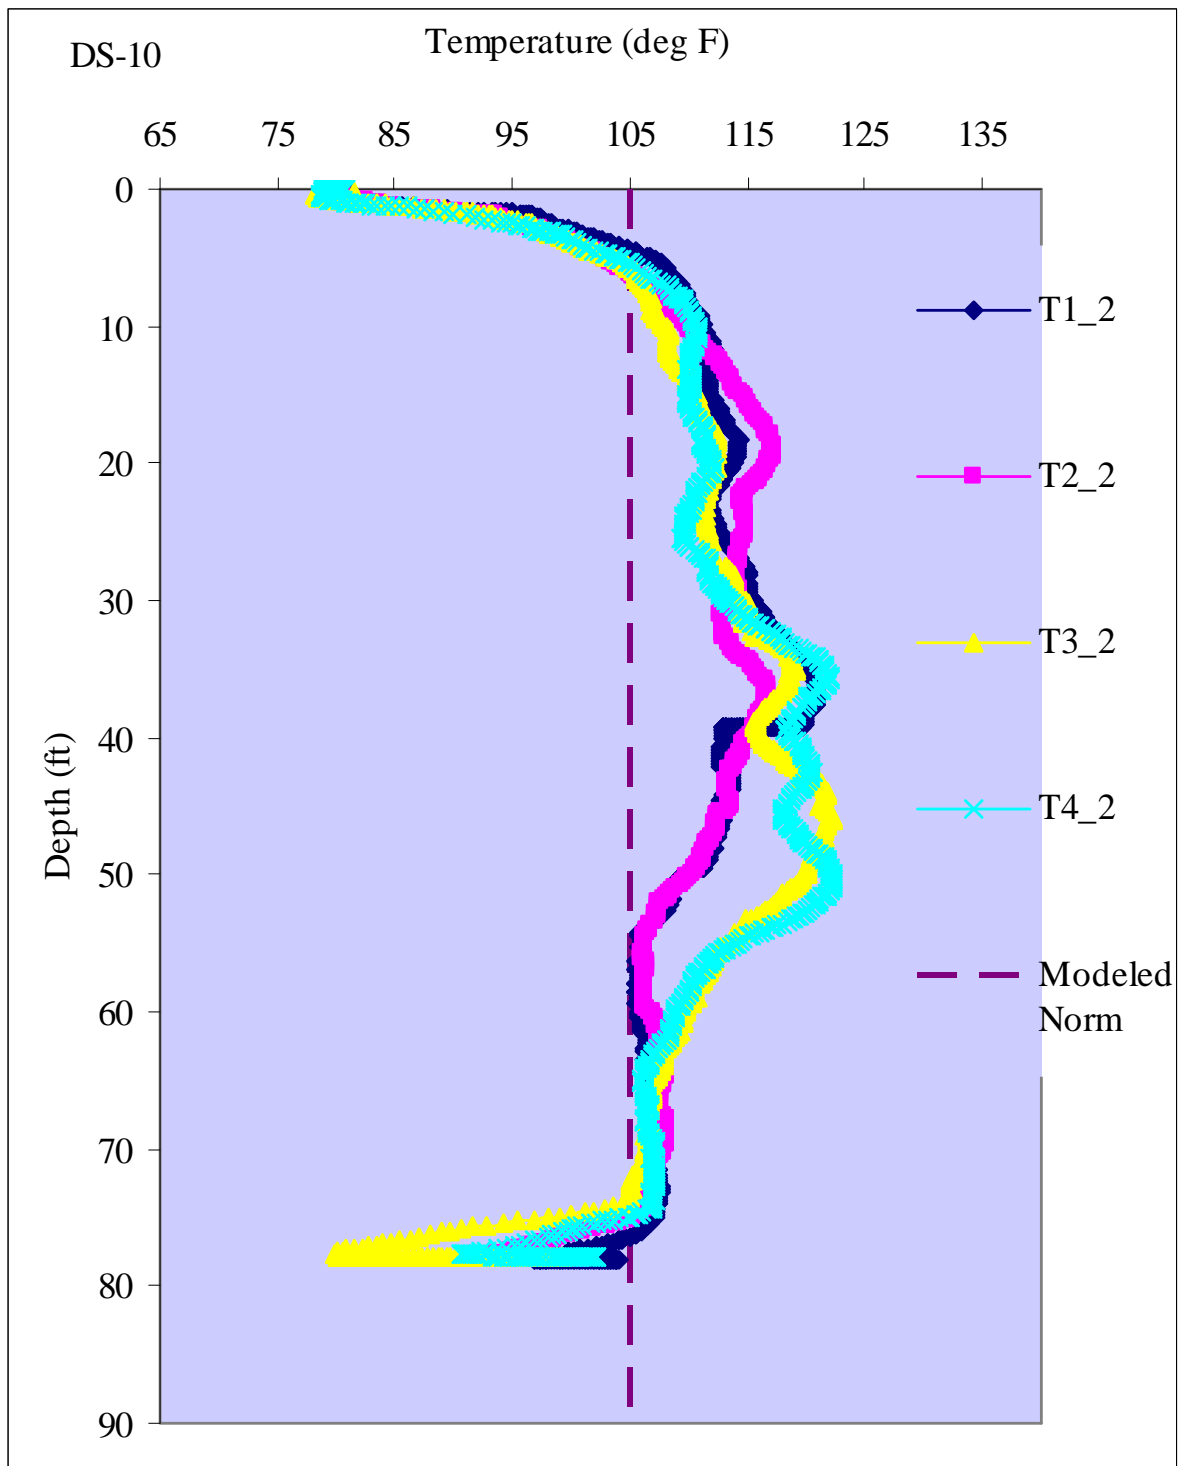
Figure DS-10 Measured temperature traces for Tubes 1 through 4 compared to the model norm.

DS-10. No structural or durability concerns. Shaft shows over-pour bulging in all areas above the rock socket which is in keeping with field logs indicating 147% concrete usage when compared to theoretical. Full modeling is not necessary.

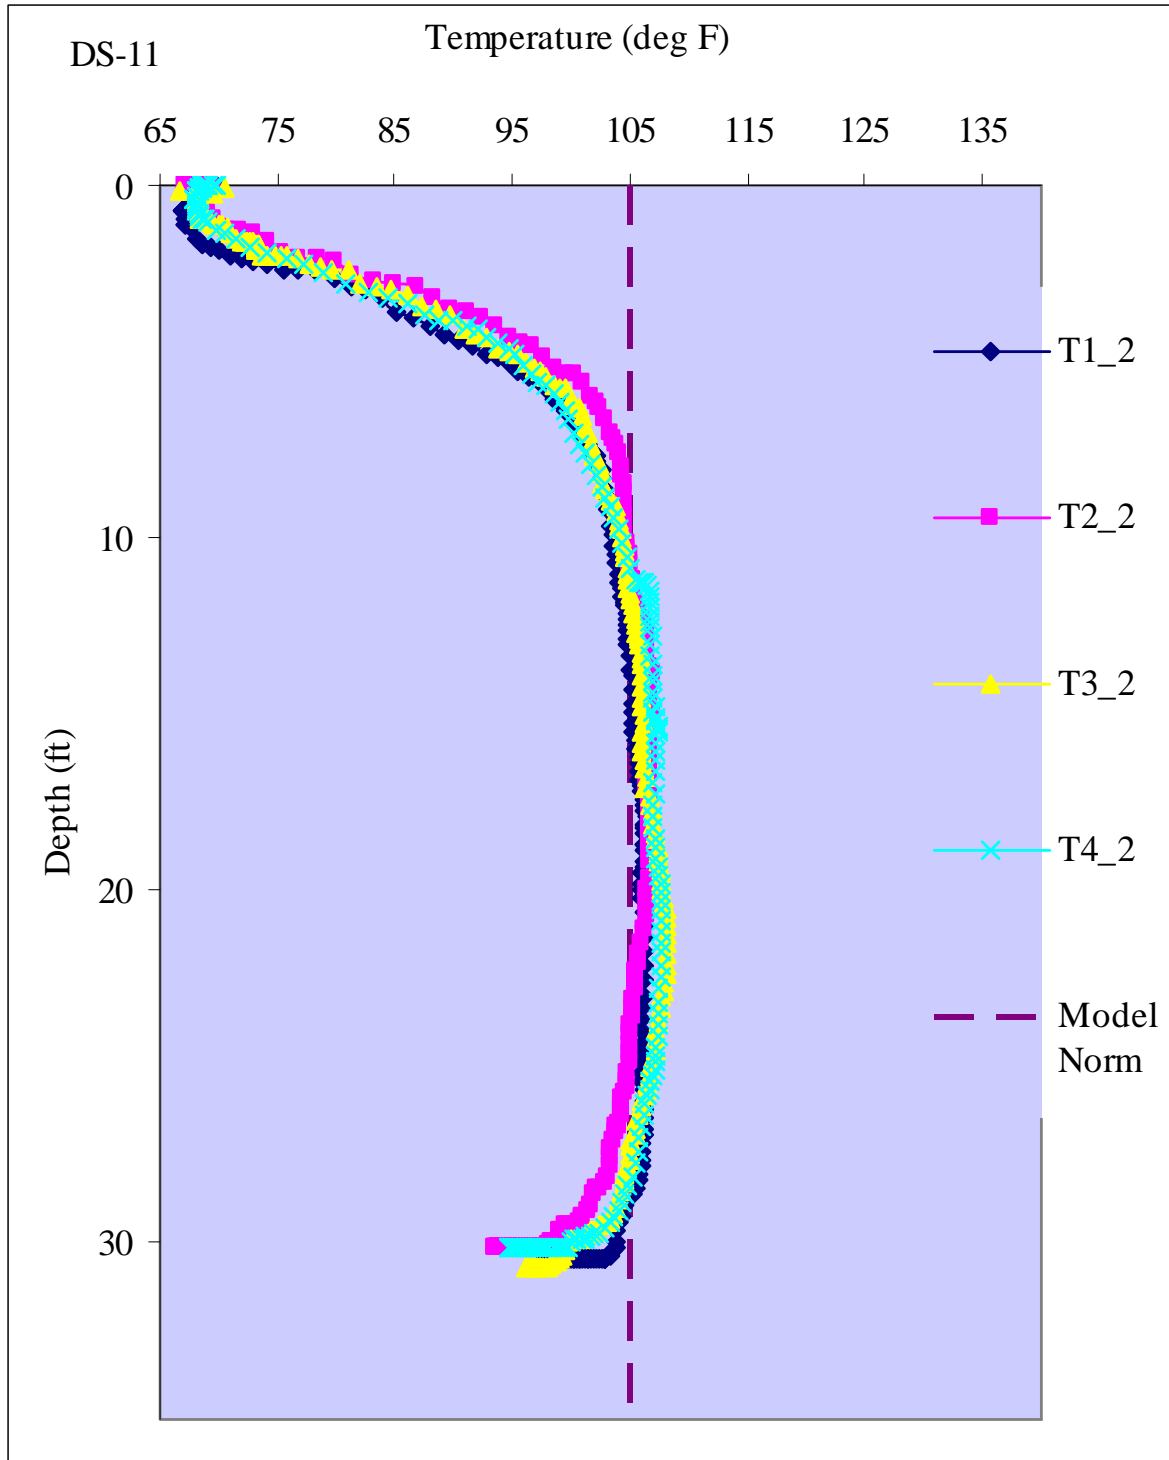
Figure DS-11 Measured temperature traces for Tubes 1 through 4 compared to the model norm.

DS-11. No concerns. Shaft shows temperature signature of a normal shaft.

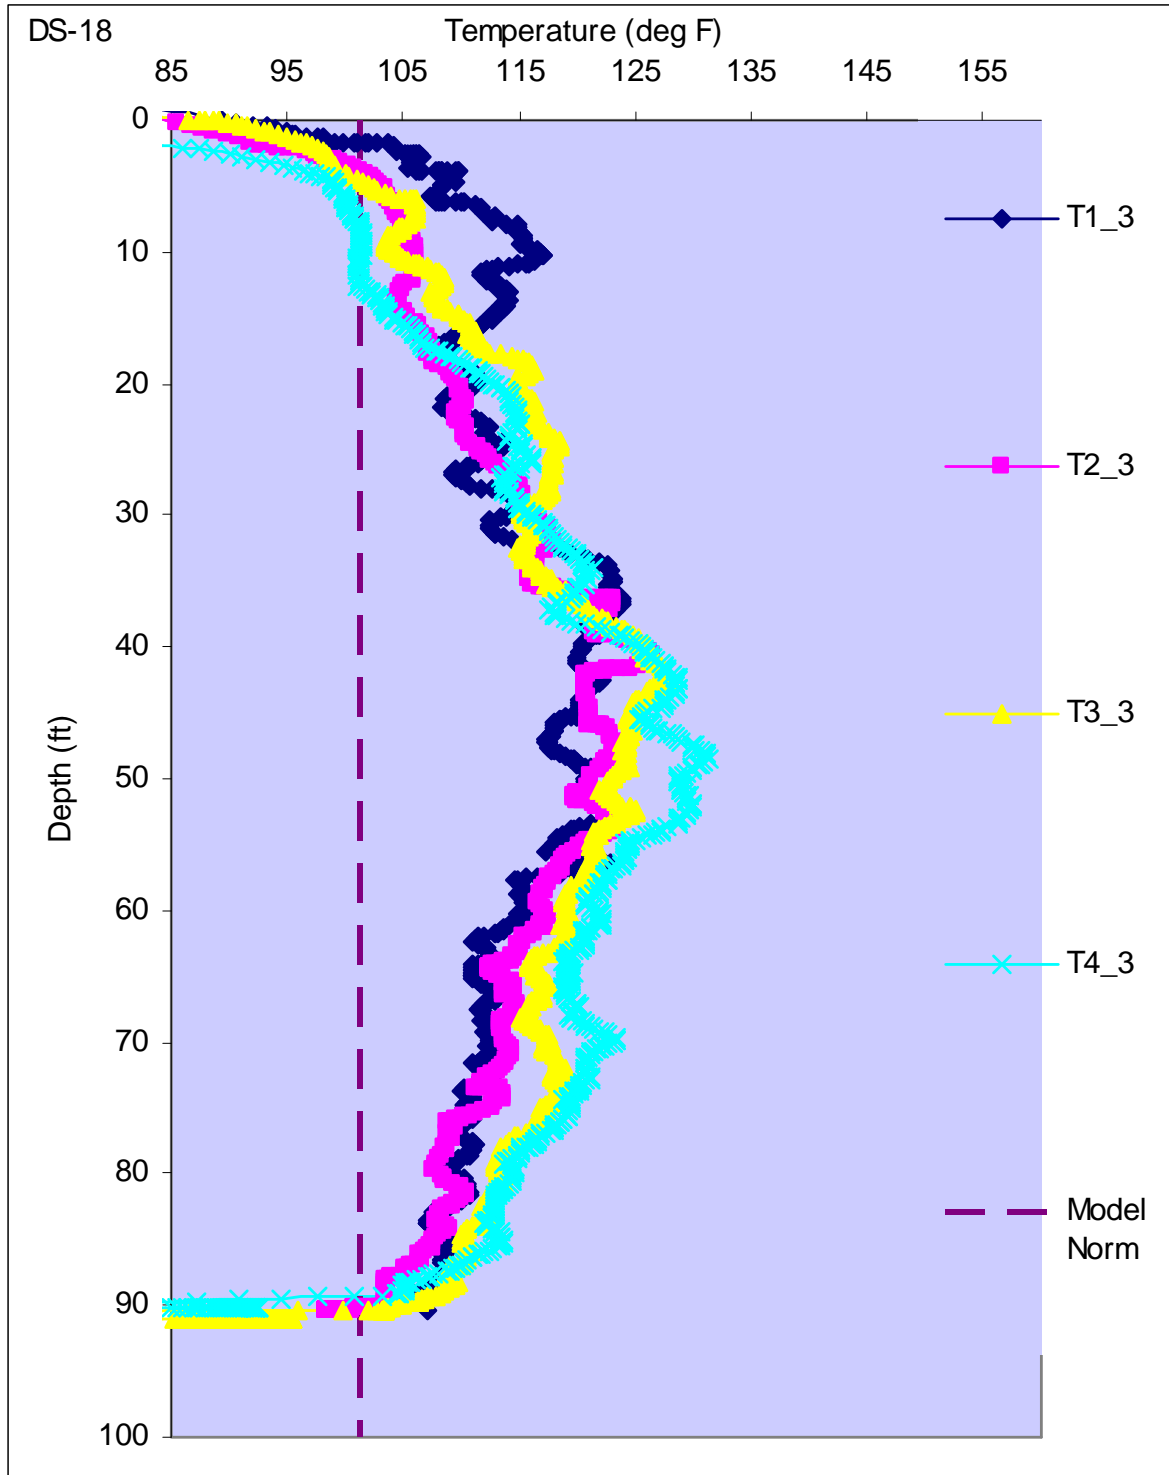
Figure DS-18 Measured temperature traces for Tubes 1 through 4 compared to the model norm.

DS-18. No concerns. Shaft shows temperature signature consistent with over-pour bulging at all depths which is in agreement to the 54" temporary casing used to a depth of 74 ft. Figure DS-18 shows this region (near 74') as a temperature transition zone to the rock socket.

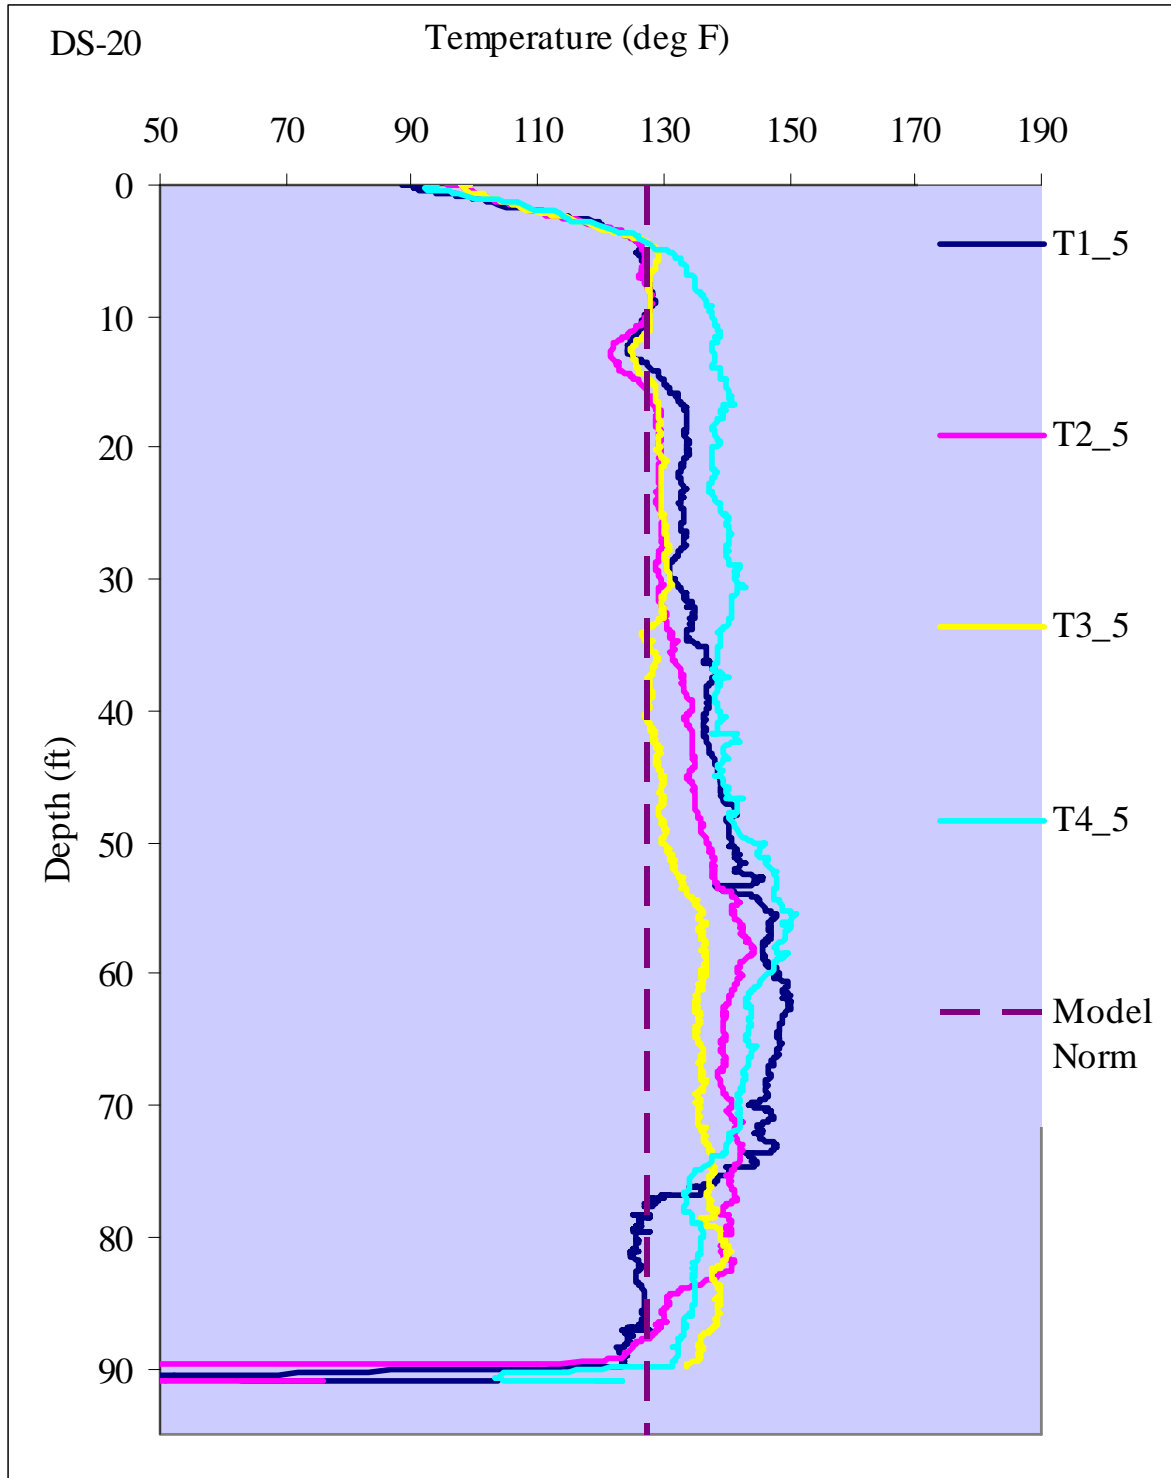
Figure DS-20 Measured temperature traces for Tubes 1 through 4 compared to the model norm.

DS-20. No major concerns. Slight neck from 11 – 14 ft; no more than 2 inches of cover loss. Higher than normal temperatures down to the depth of temporary casing (76') is consistent with over-sized casing (54") used to that depth.

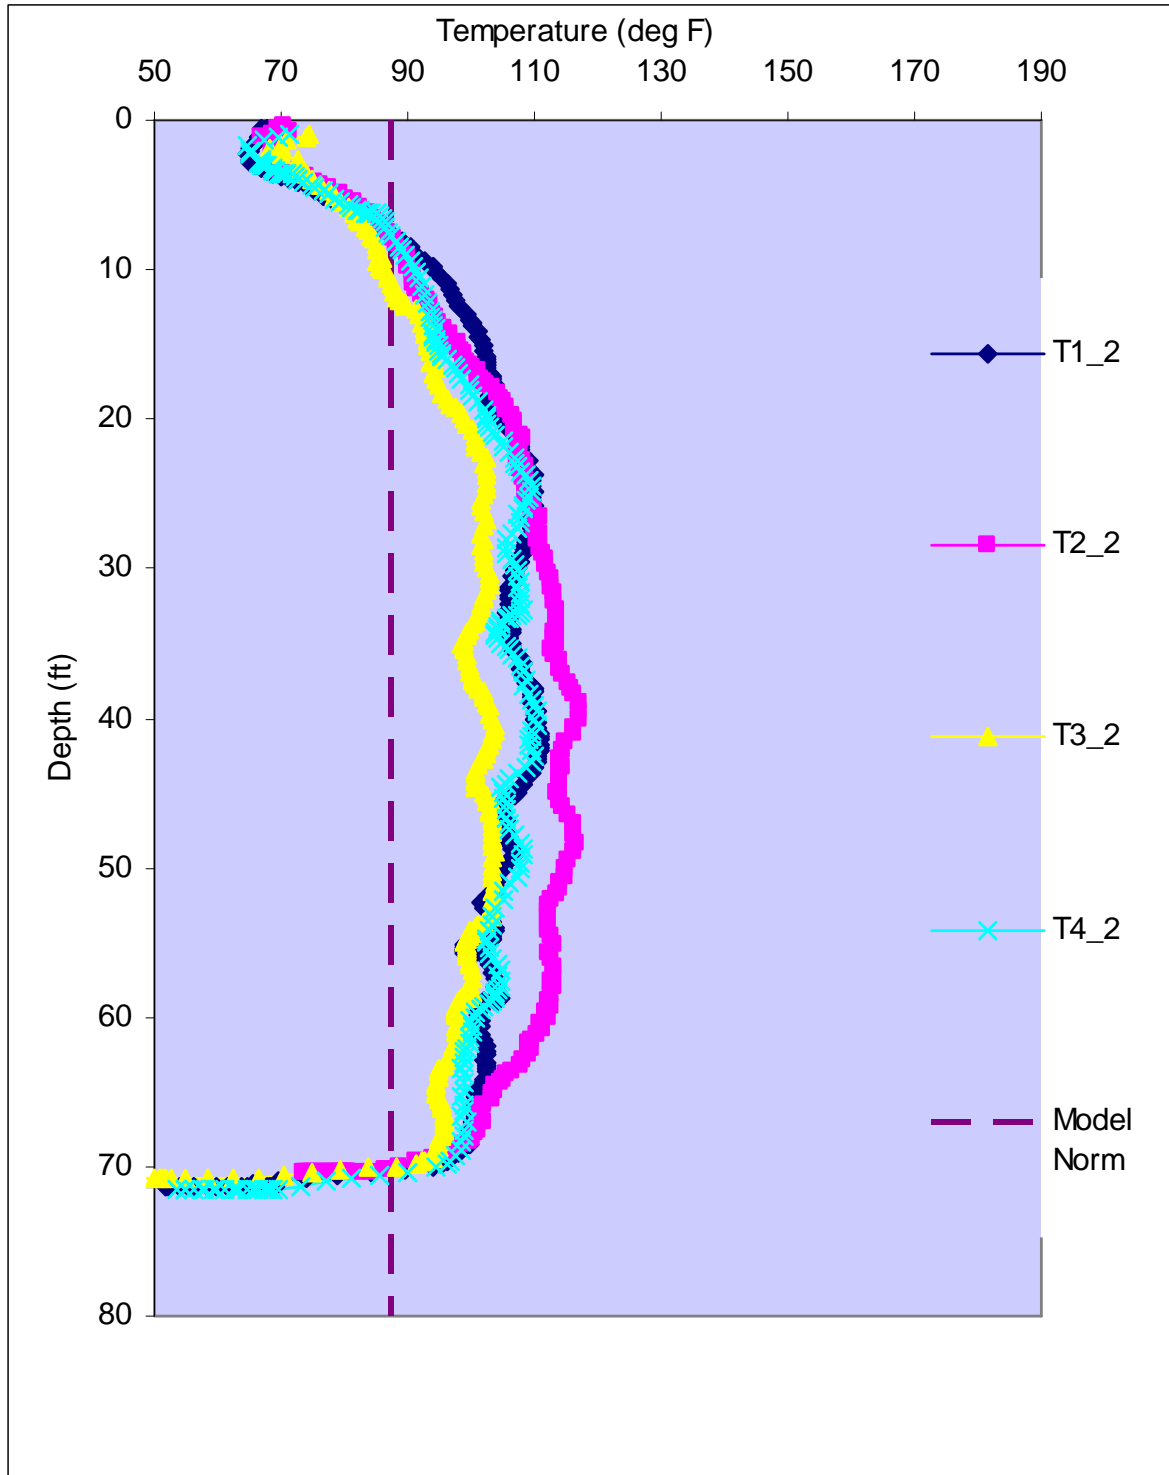
Figure DS-23 Measured temperature traces for Tubes 1 through 4 compared to the model norm.

DS-23. No concerns. Slightly higher than normal shaft temperature signature (typical of the site); testing performed at 72 hrs but produced usable data.

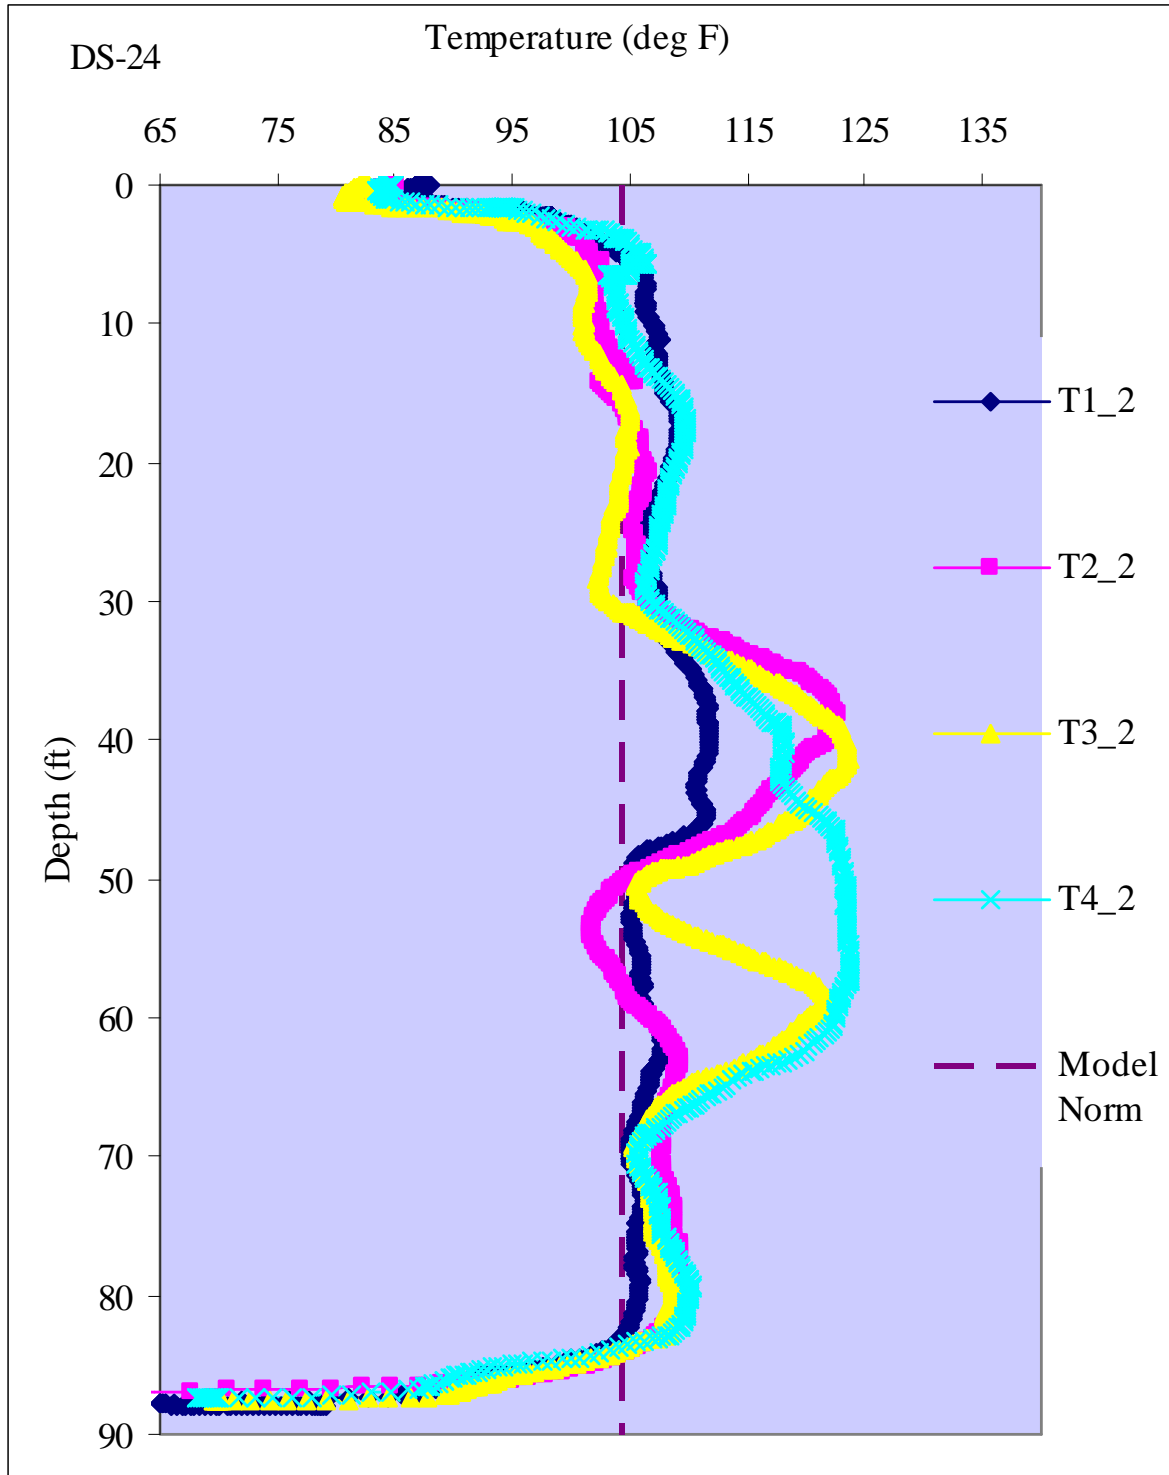
Figure DS-24 Measured temperature traces for Tubes 1 through 4 compared to the model norm.

DS-24. No concerns. Shaft shows extensive over-pour and bulging between 30 and 65 ft in depth. Concreting logs indicate 250% of the theoretical concrete volume.

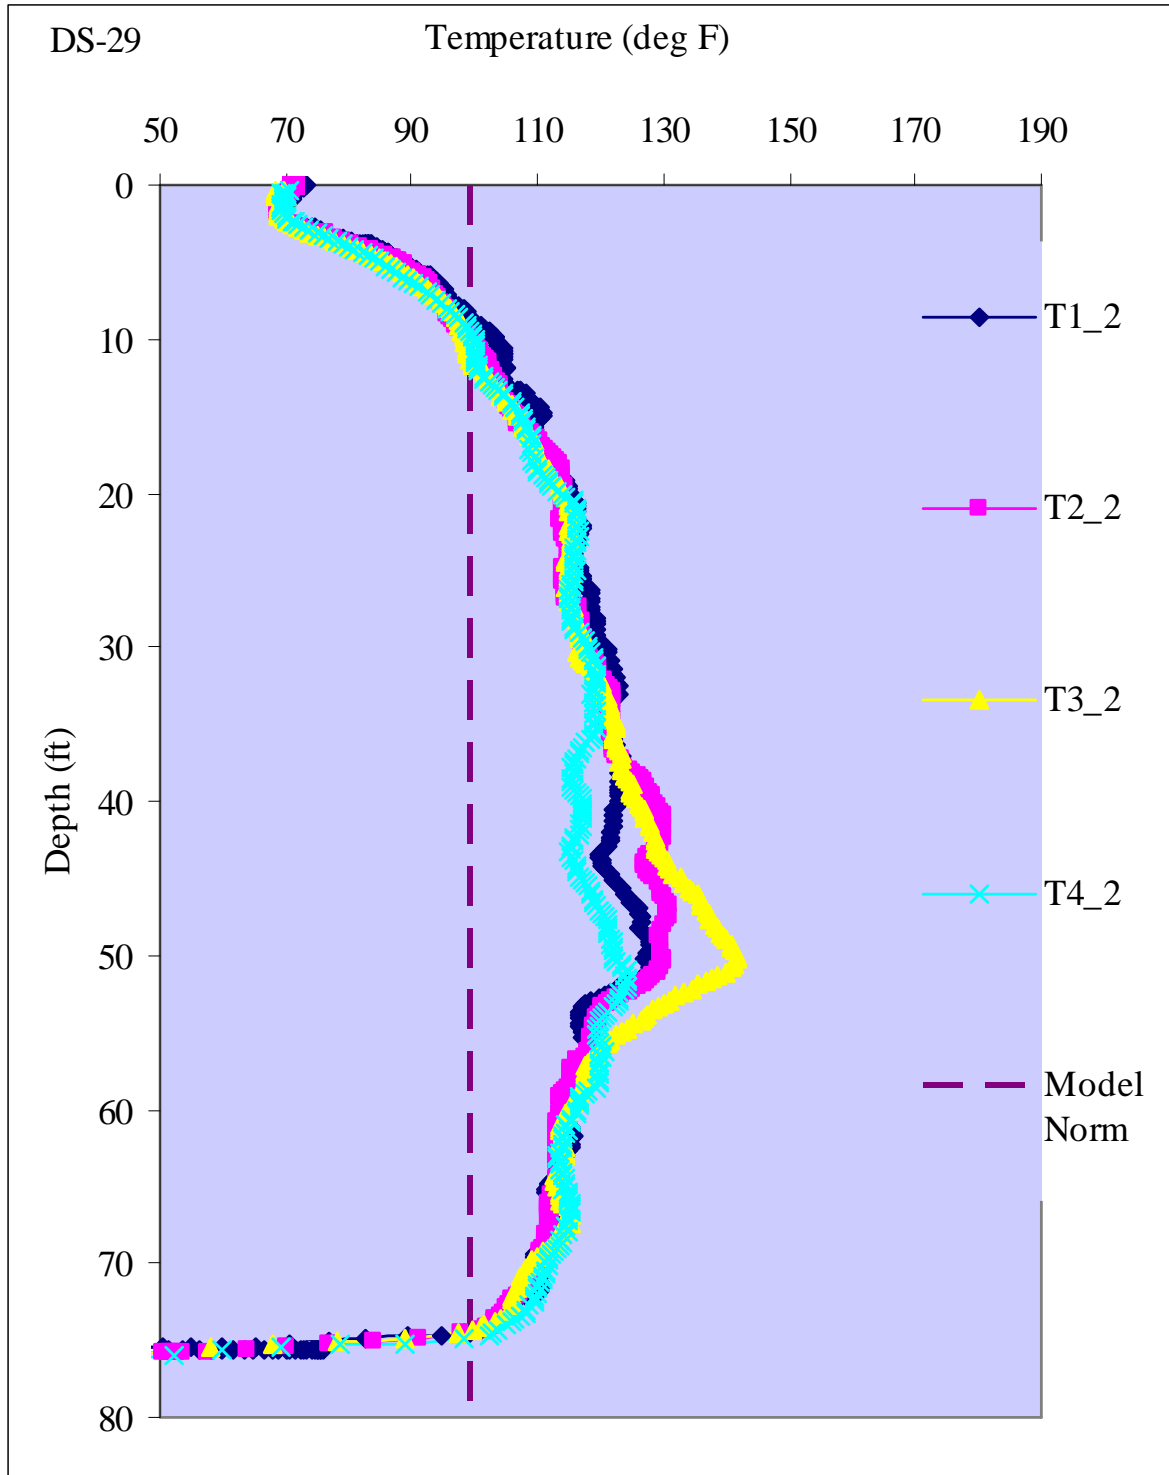
Figure DS-29 Measured temperature traces for Tubes 1 through 4 compared to the model norm.

DS-29. No concerns. Typical over pour bulging above the rock socket.

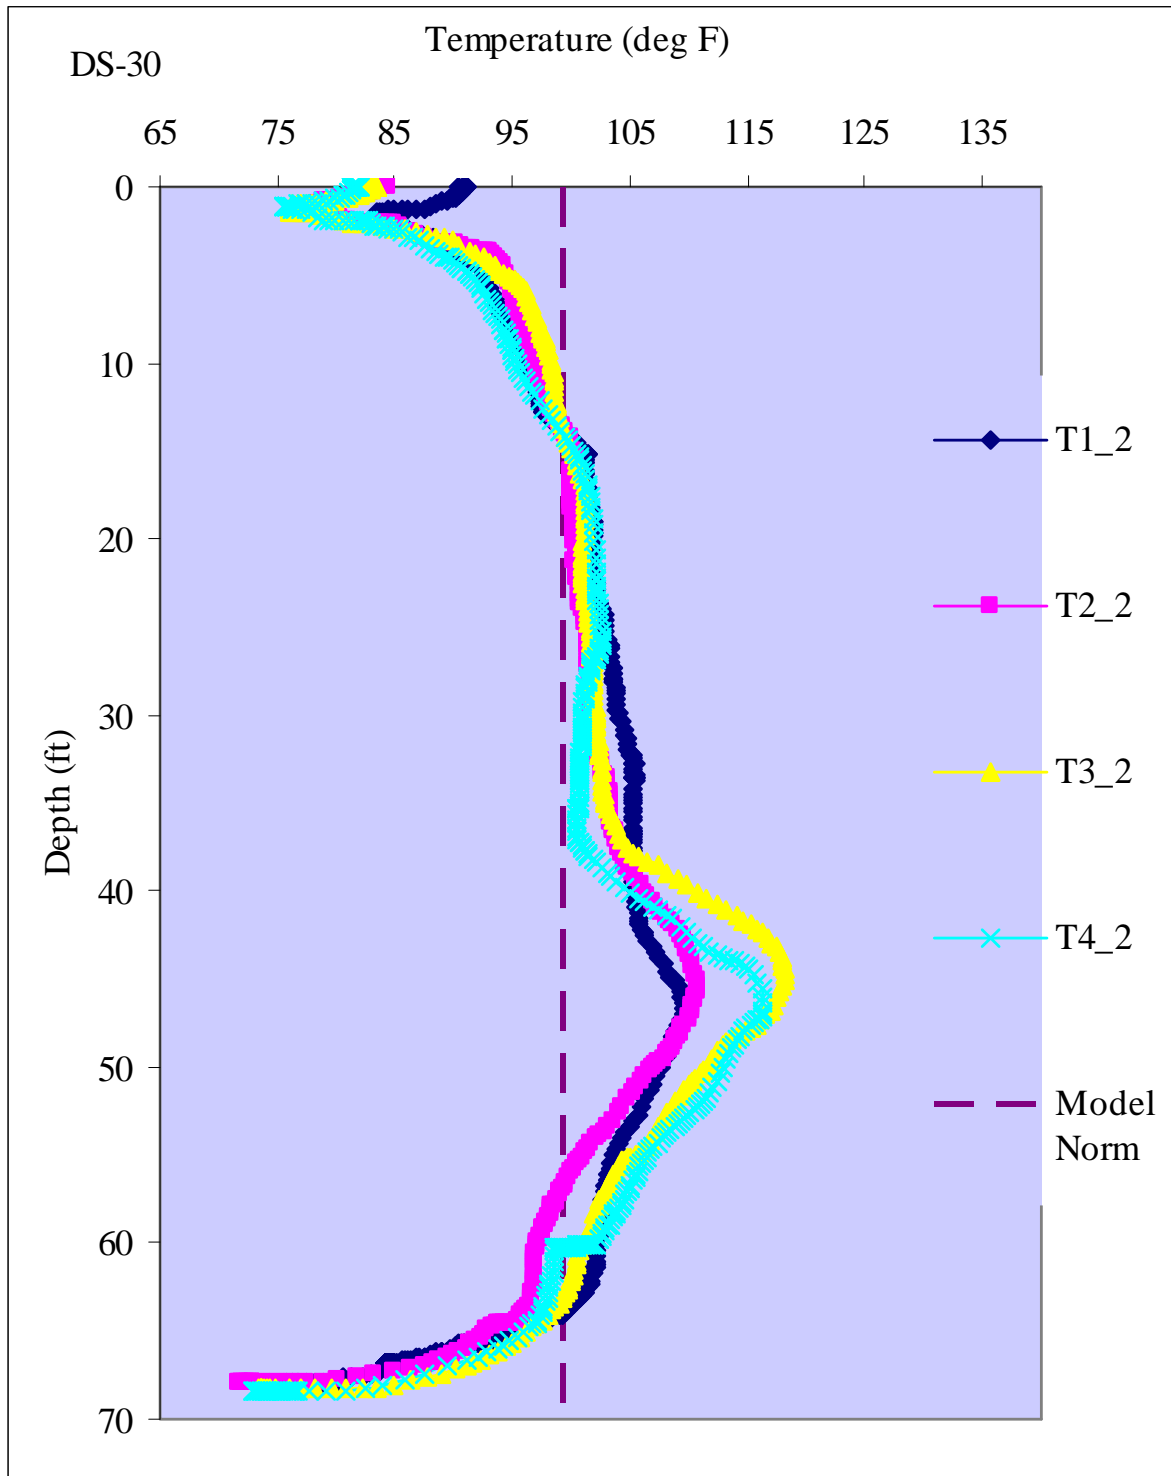
Figure DS-30 Measured temperature traces for Tubes 1 through 4 compared to the model norm.

DS-30. No major concerns. Mild cross-sectional reduction between 0 and 10 ft (no more than 2 inches). Over-pour bulging indicated at depths between 45 and 55 ft. Concrete usage is 280% of theoretical.

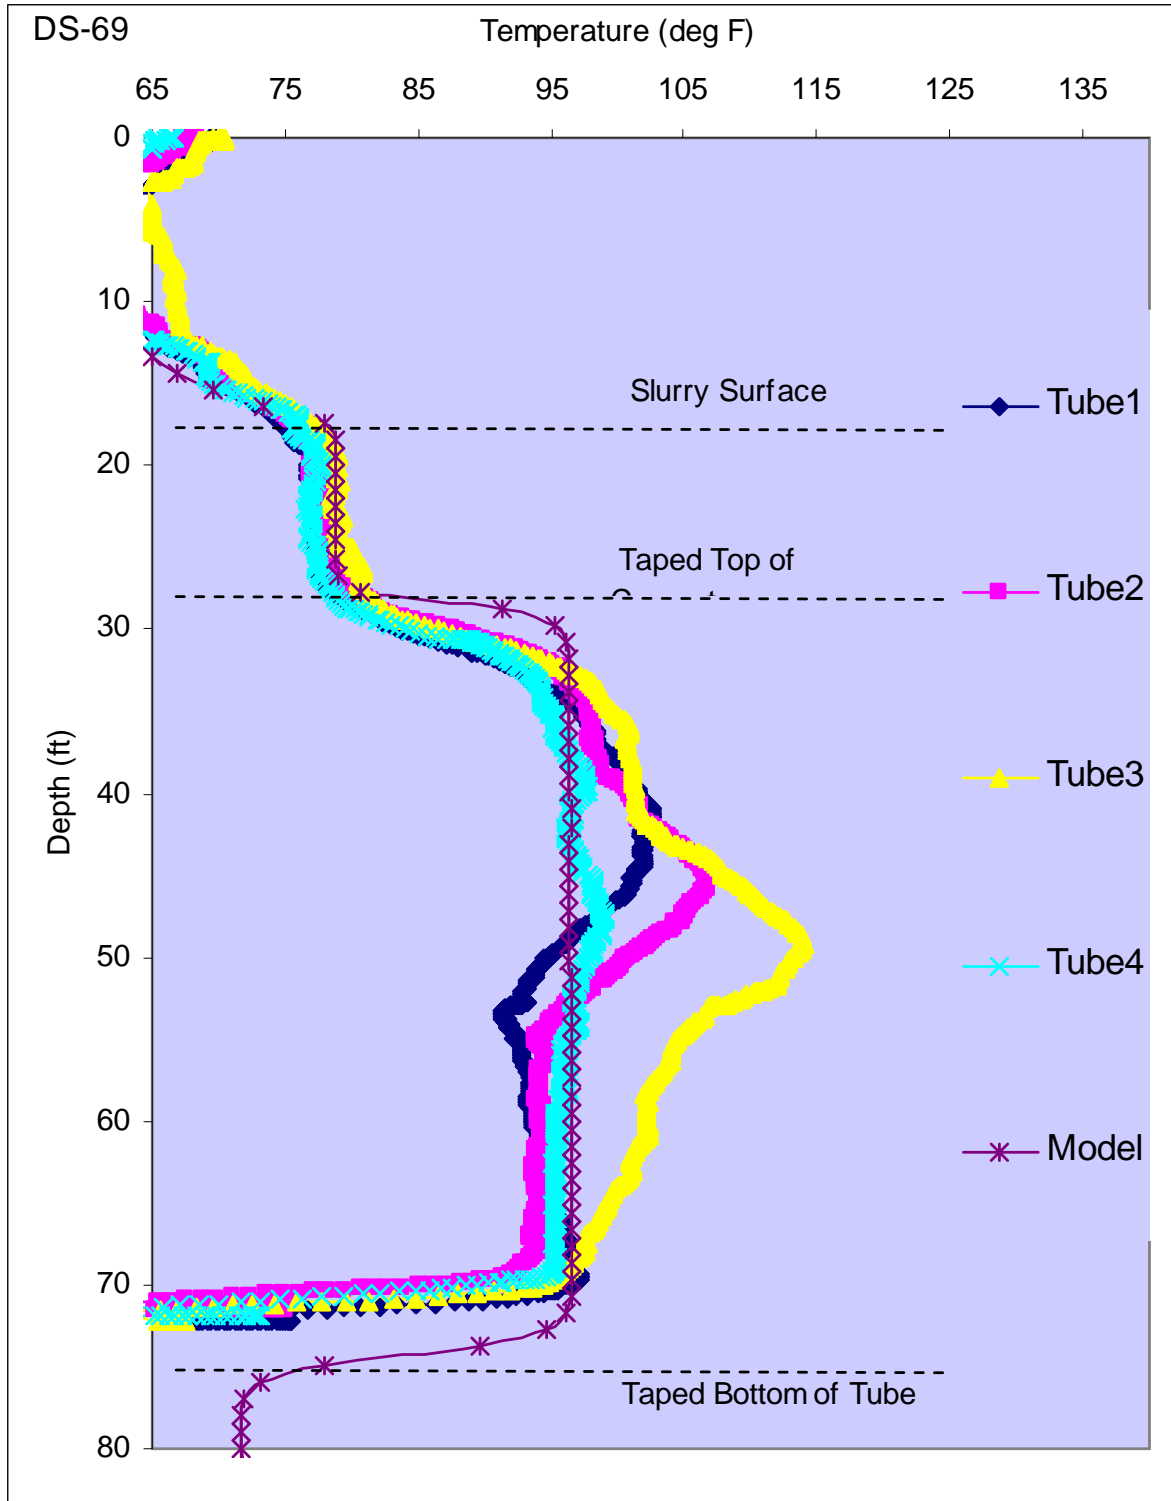
Figure DS-69 Measured temperature traces for Tubes 1 through 4 compared to full model norm.

DS-69. Shaft construction experience difficulties removing tremie and only partially poured shaft from the bottom depth of 75' to 28'. At approximate depths between 28 and 32 is a more dramatic change in temperature than expected. As it is shown in all tubes, it is likely a partially cemented material which under normal concreting processes would have been expelled as debris. As with many of the other shafts, a sizeable bulge in the shaft between 30 and 54 ft is present that caused the higher than normal temperature in that zone which is of no concern to the integrity. Also apparent is that the cage is out of alignment near the rock socket interface pushing tube No. 1 closer to the wall (cooler) and the opposite tube (No. 3) farther away from the wall (warmer); this 1.5 – 2" offset in the cage at depth 50' decreases with depth. Finally, the bottom of the shaft shows a large reduction in temperature signal before reaching the bottom of the tube. Note the modeled response show a drastic decrease to be normal, but in this case it occurs prematurely. *This shaft was fully reported under separate cover February 27, 2008.*

Thermal Integrity testing and evaluation was performed on fourteen (14) of the XXXXXXXXXXXXXXXXXXXXXXX foundation shafts. Of the shafts thermally scanned and evaluated, only shaft DS-69 showed defects of concern the least of which (near the toe) can be mitigated by post grouting. The upper-most defect may not be so quick resolved. With the exception of shaft DS-5, the remaining shafts showed characteristics consistent with the strata and the construction methods used producing higher than normal temperature signatures due to over-pour bulging. In a few instances, slight necking was detected at a depth consistent with the base of the temporary casing, but reduced section showed no more than 2 inch reduction leaving 4 inches of cover. In the case of shaft DS-5, too much time had elapsed between time of concreting and thermal scanning to perform a satisfactory integrity evaluation. Thermal scans are ideally conducted between 24 and 48 hours after concreting.

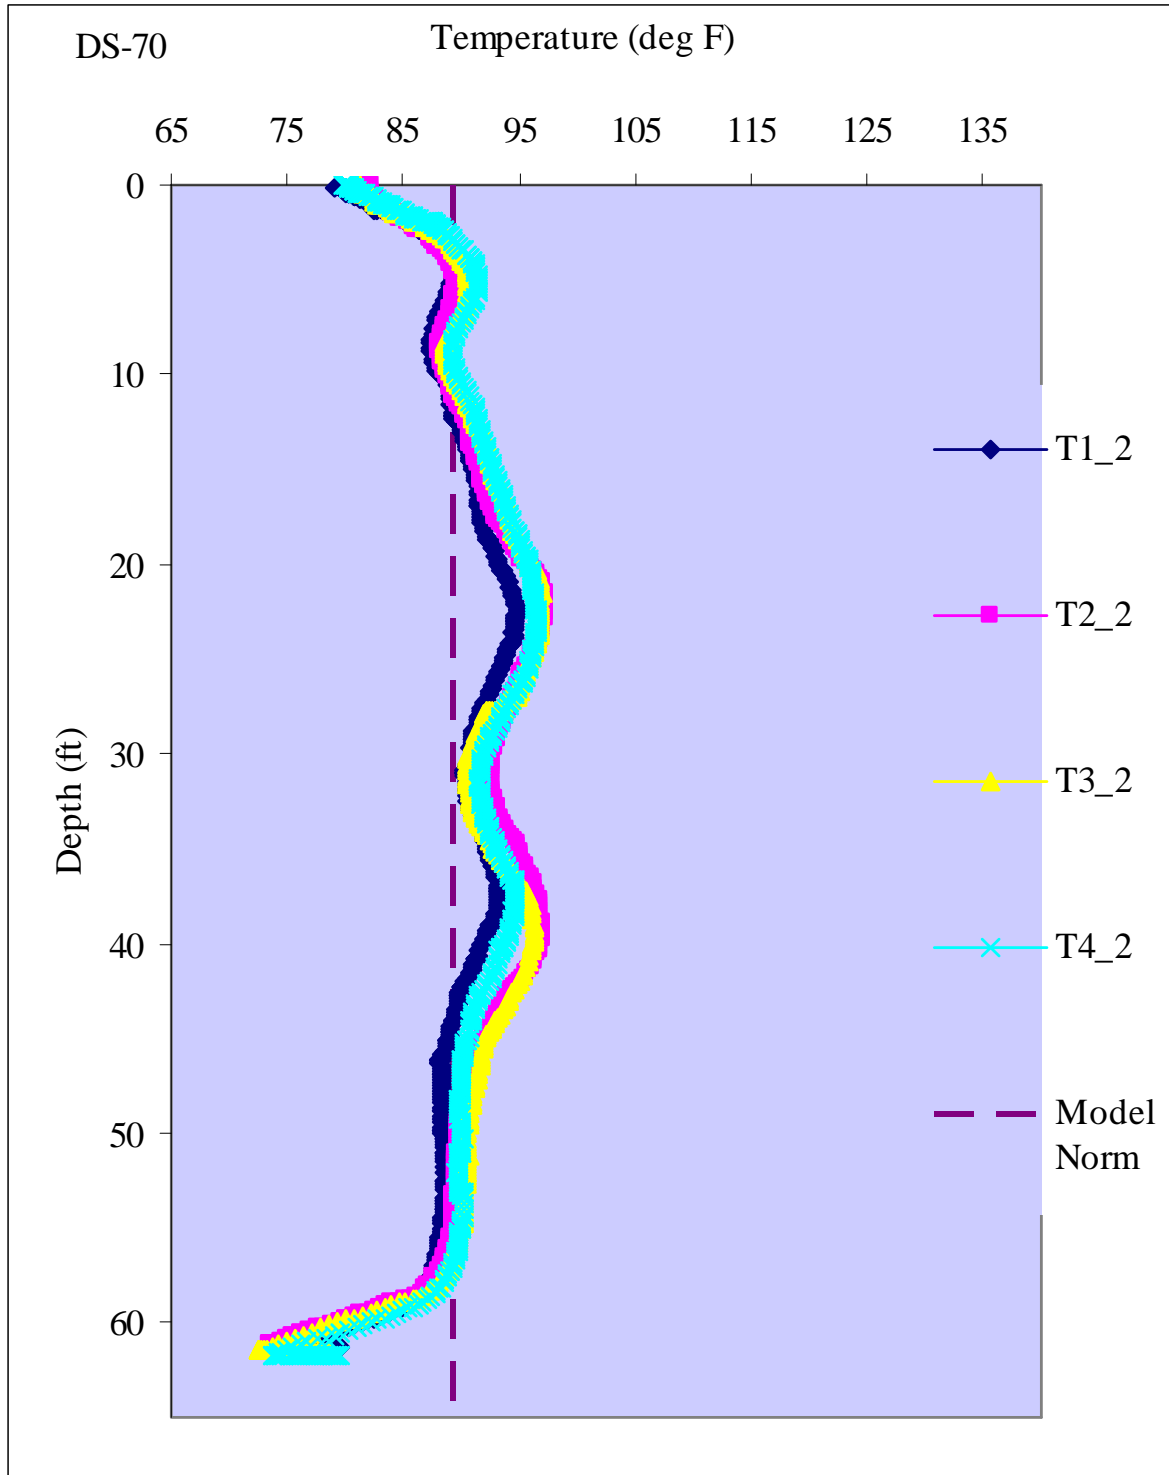
Figure DS-70 Measured temperature traces for Tubes 1 through 4 compared to the model norm.

DS-70. No concerns. Although not as drastic as some, this shaft shows common site characteristic of over-pour bulging in almost all regions above the rock socket. Inspector notes indicate 190% of theoretical concrete usage.

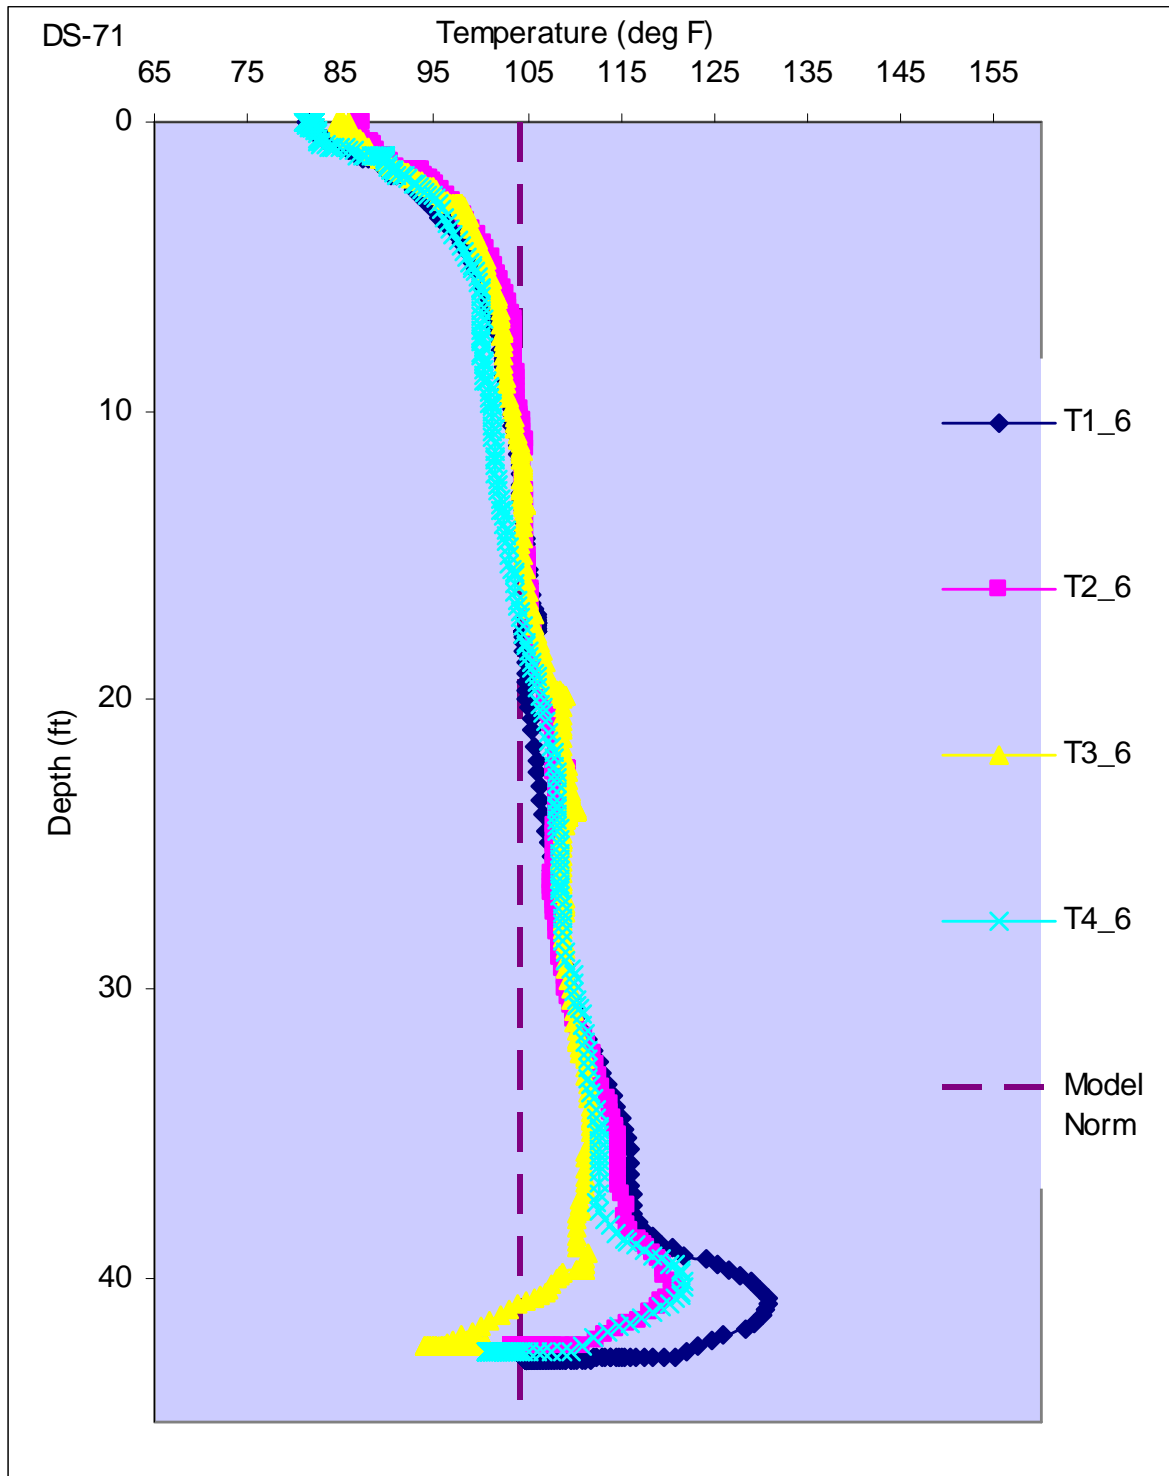
Figure DS-71 Measured temperature traces for Tubes 1 through 4 compared to the model norm.

DS-71. No concerns. Concrete logs were unavailable at the time of reporting; however, no extensive over-pour is indicated by the thermal scans with the exception of the toe region of the shaft where a bell-shape is prominent on all sides except T3.
