# Foundation & Geotechnical Engineering, LLC

FGE Project No.: G08-L-293

Subject: **Shaft Integrity Testing Results**  
XXXXXXXXXXXXXXXXXXXXXXXXXXXX

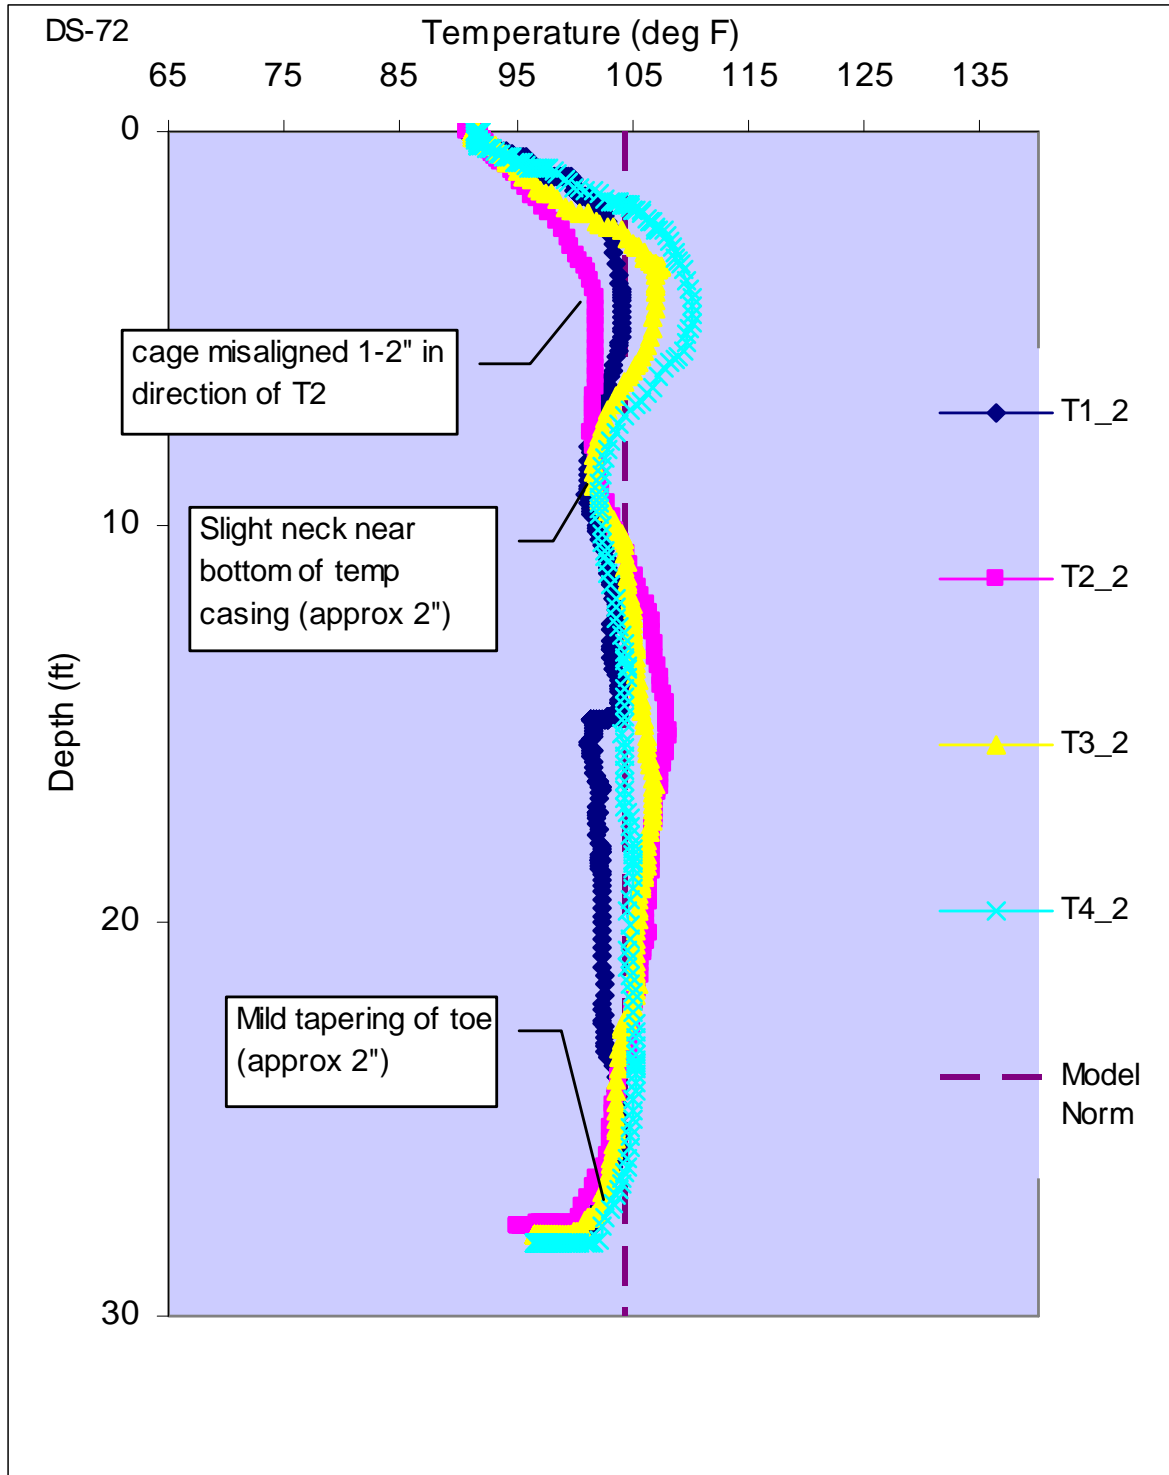
Figure DS-72 Measured temperature traces for Tubes 1 through 4 compared to the model norm.

DS-72. No major concerns. Figure DS-72 shows slight necking between 8 and 11 ft in depth which is likely due to temporary casing extraction. Modeling of a similar condition in DS-73 revealed this is no greater than a 2" reduction in radius leaving 4" of concrete cover. A similar cross-section reduction is noted at the bottom 2 ft of the shaft. Finally, the cage appears to be slightly misaligned near the top on the order of 1 to 2 inches as indicated by opposite tubes T2 and T4 get cooler and warmer, respectively. The magnitude of the cage offset was determined by modeled normal response of the tube position relative to the excavation wall.

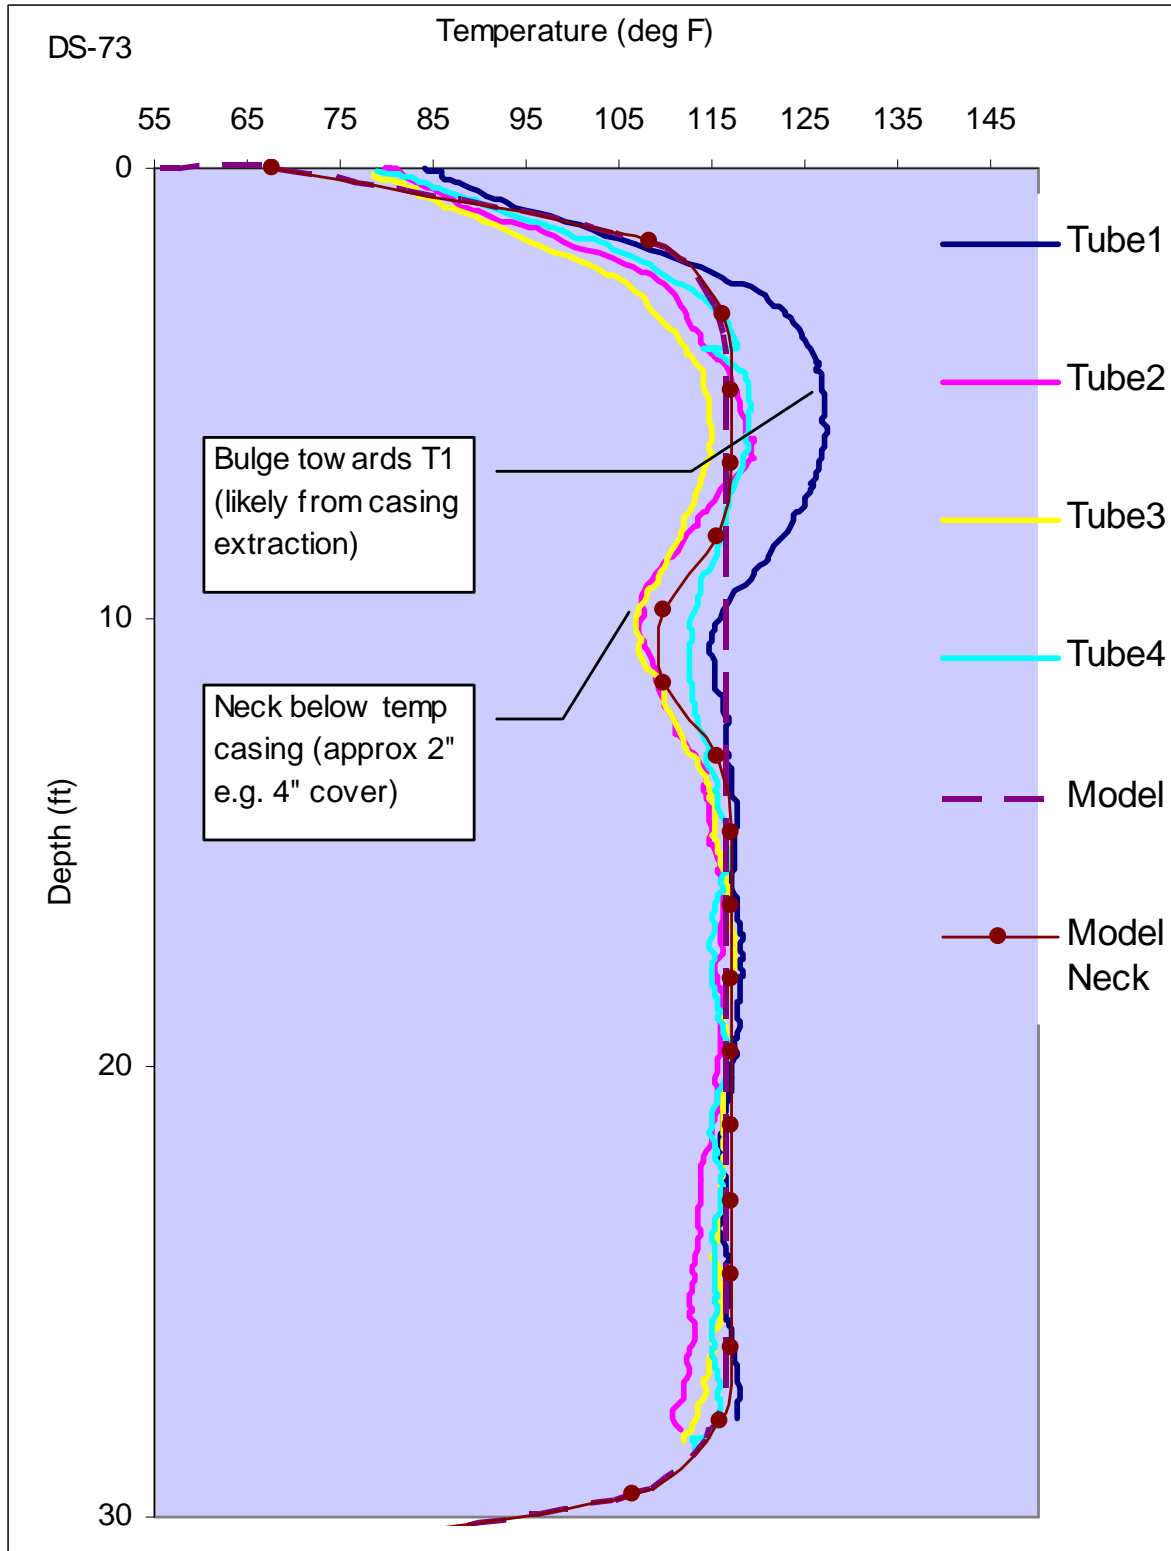
Figure DS-73 Measured temperature traces for Tubes 1 through 4 signal matched to model.

DS-73. No major concerns. Figure DS-73 shows the same slight necking between 8 and 12 ft in depth again just below the location of the temporary casing. The necking which was signal matched to be on the order of 2 inches is most prominent near tubes T2 and T3, reduces as it approaches T4, and is minimal at T1. The casing extraction process appears to have pushed against the excavation walls in the direction of T1 causing a bulge in that direction. This interpretation varies from DS-72 in that all other tubes return to a normal temperature (cover thickness) just above the neck whereas T1 experiences the higher than normal temperature.
