## Acknowledgments

## Table of Contents

## Case Study 2: St. Anthony Falls Bridge Foundation Monitoring

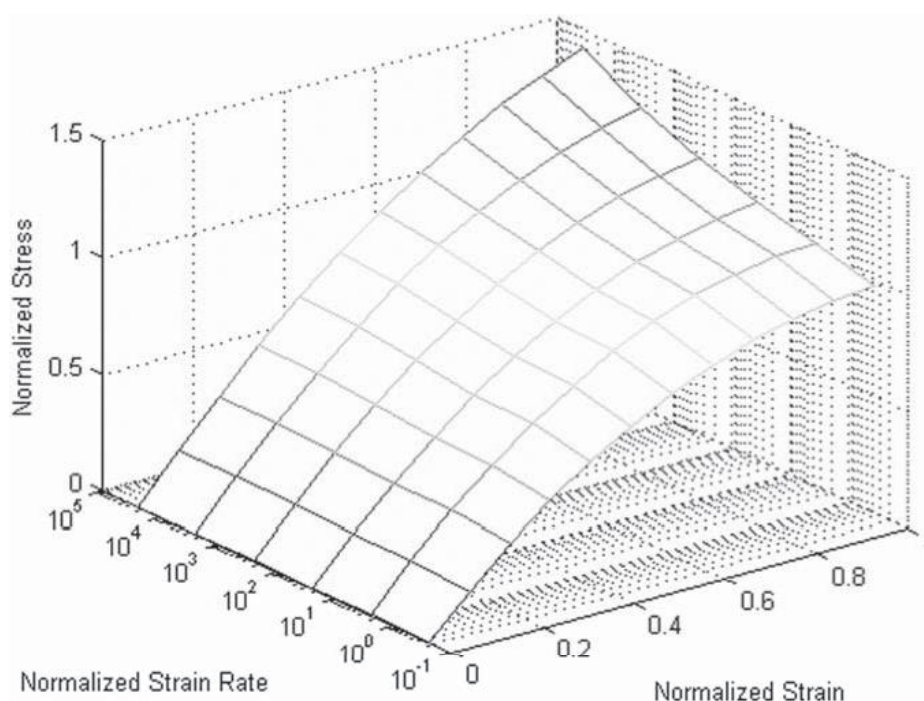
Figure 4 Normalized concrete stress-strain-strain rate relationship (adapted from Takeda and Tachikawa (1971)).

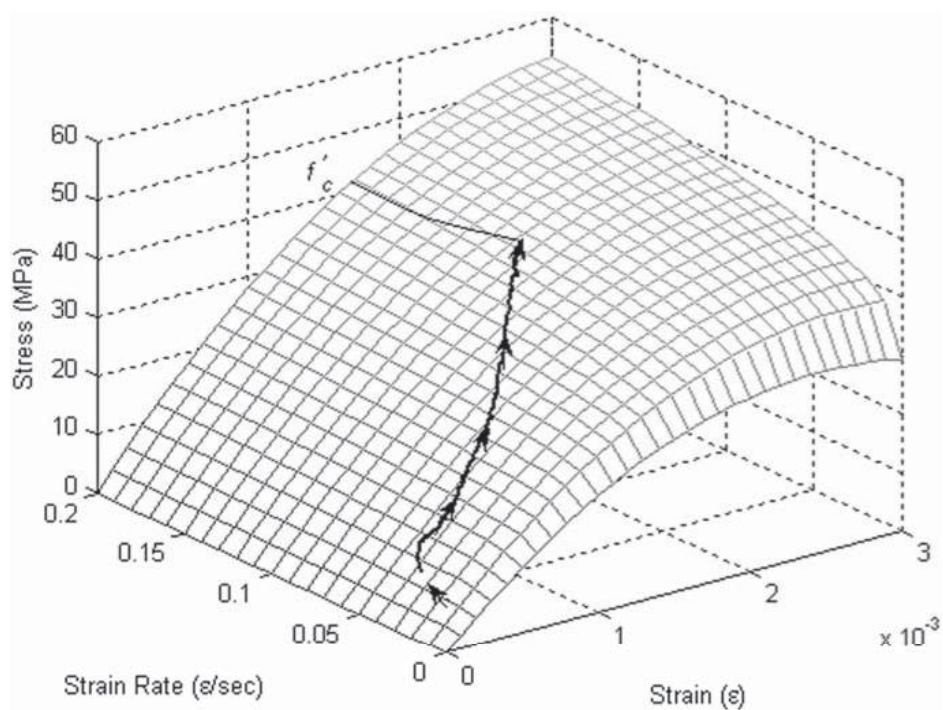
Figure 15 Stress path of a specimen taken to failure.

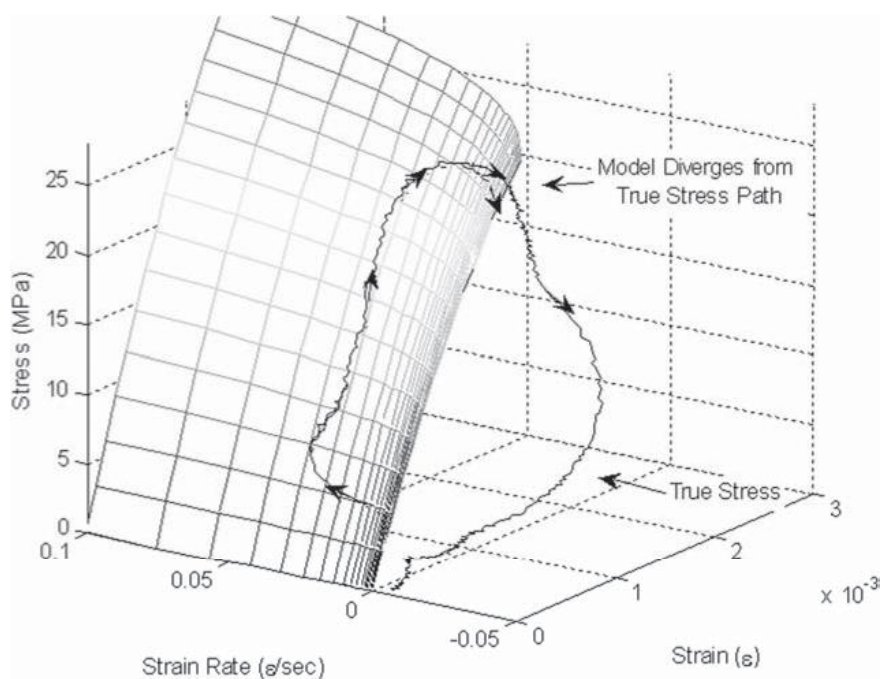
Figure 16 Stress path of a specimen that underwent a load cycle and divergence from original surface.

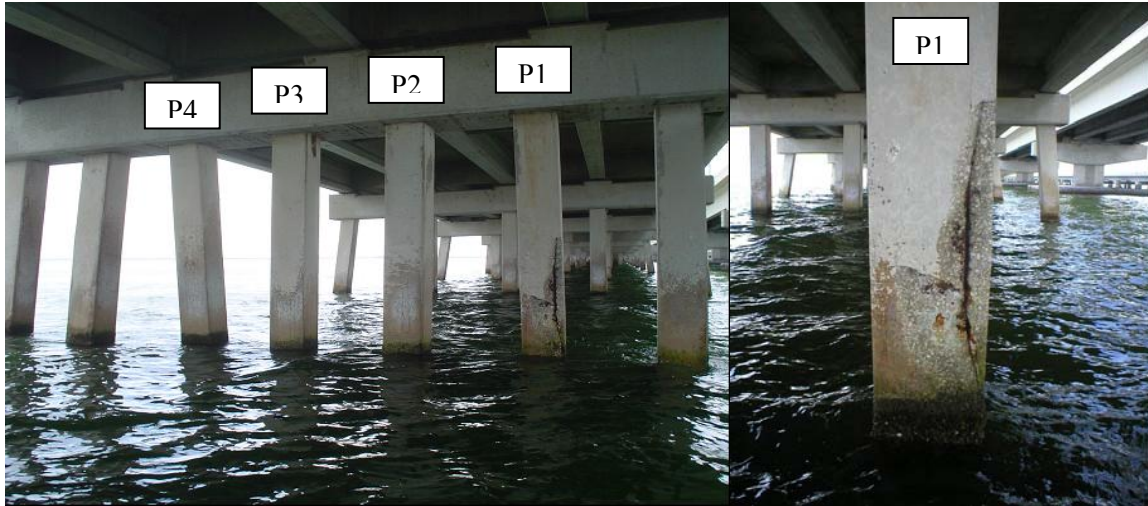
Figure 10 – Gandy bridge piles. P1 was the most corroded. P4 was the control.

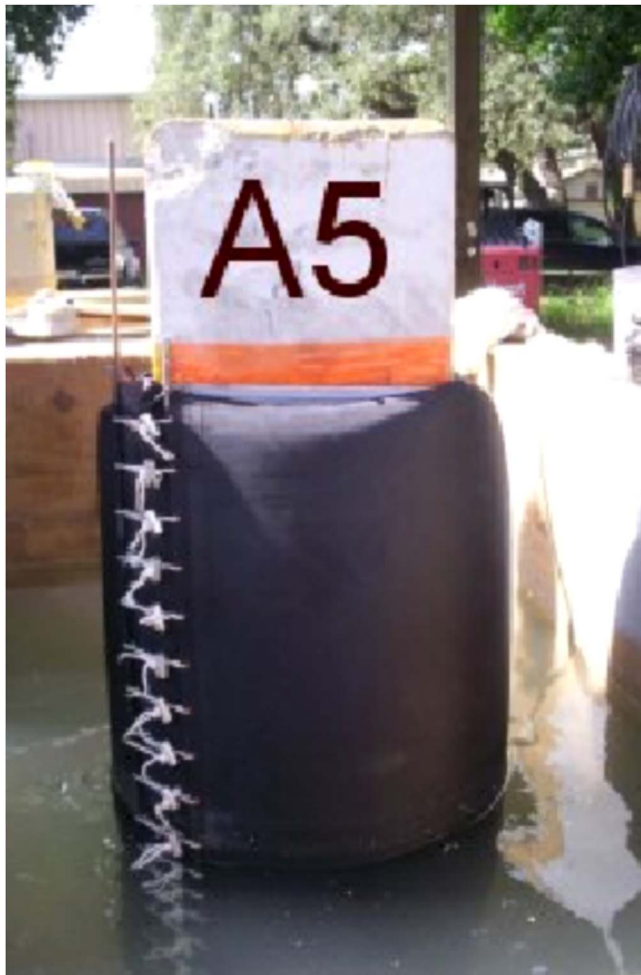
Fig. 9. Pressure bag applied to prepreg system

**Wet Layup System.** The wet layup system was only tested using the pressure bag system on piles F1 and F2 with F3 serving as a control pile. The applied pressure was 34.5 kPa (5 psi) and 14.5 kPa (2.1 psi) on test piles F1 and F2, respectively.

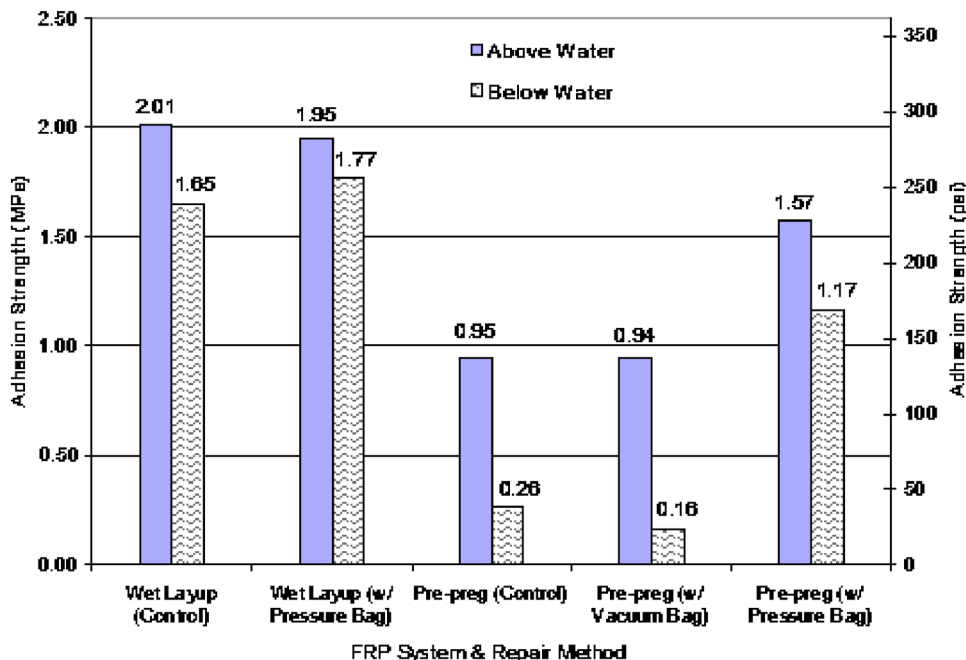
Fig. 10. Pullout test results for two systems

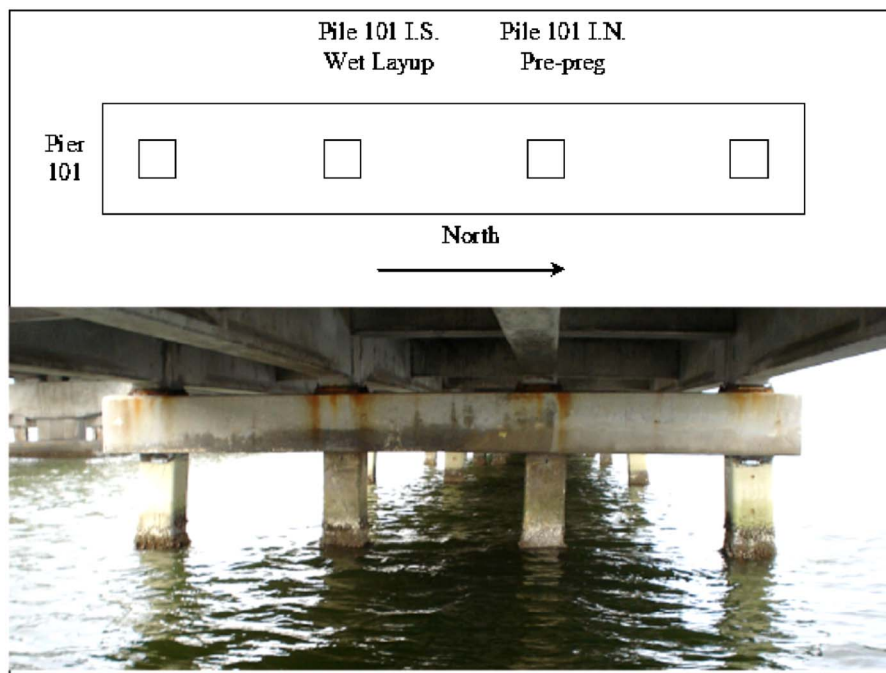
Fig. 12. Pier 101 layout

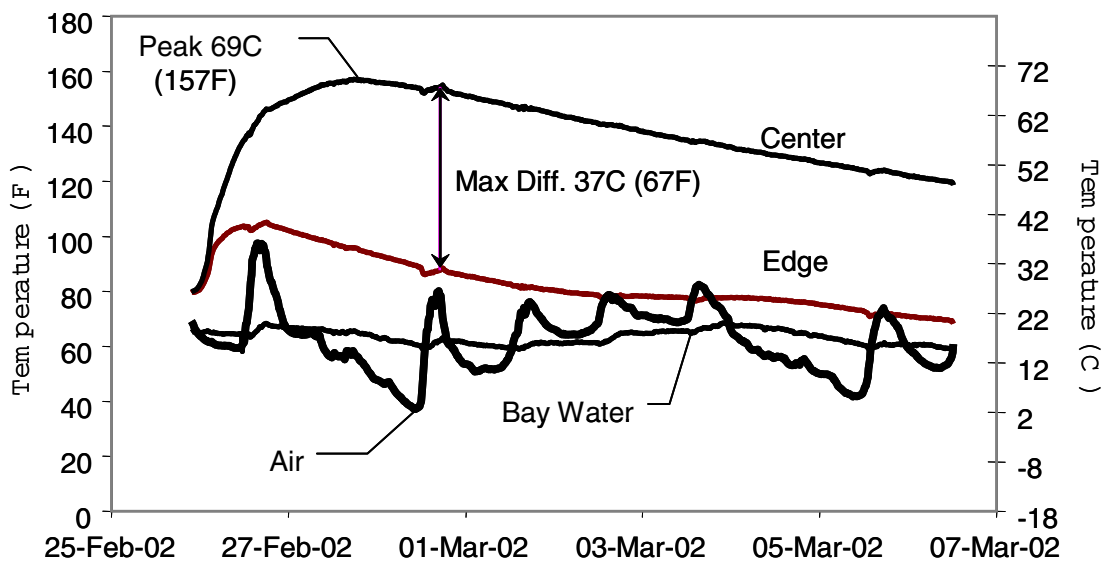
Figure 1. Temperature traces from the Ringling Causeway Bridge.

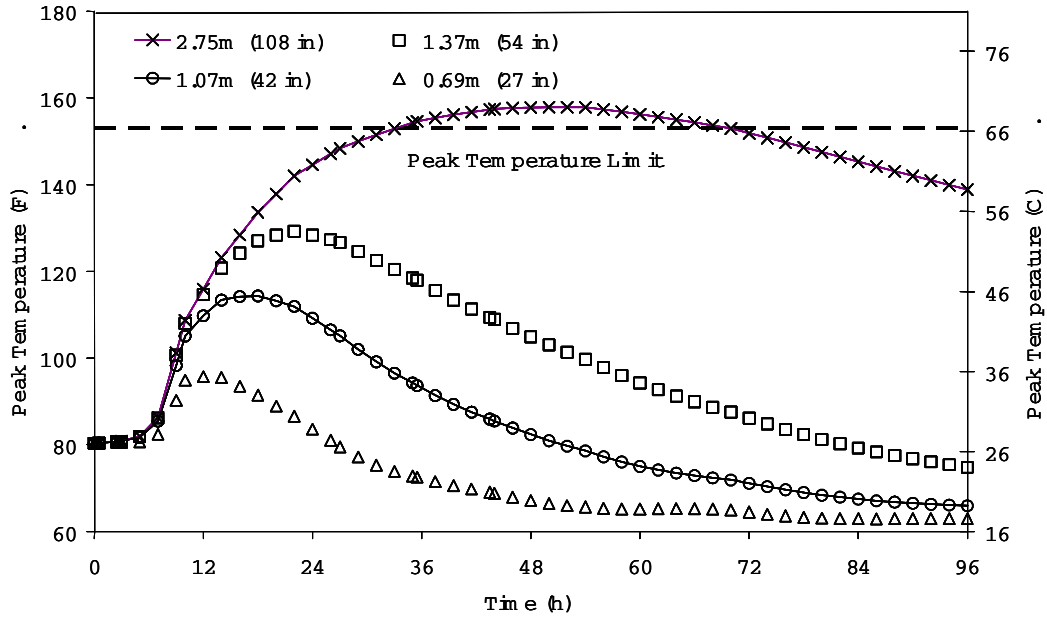
Figure 2. Modeled peak temperature traces for various shaft sizes, based on “Ringling” shaft mix design and conditions.

Figures 2 and 3 show the peak and differential temperatures, respectively, for four modeled shaft diameters; the 2.75m shaft closely matched that observed (model calibration). Under these relatively cool conditions, the differential temperature predictions show shafts as small as 1m can exceed the recommended limit; the generated peak temperatures in general did not.

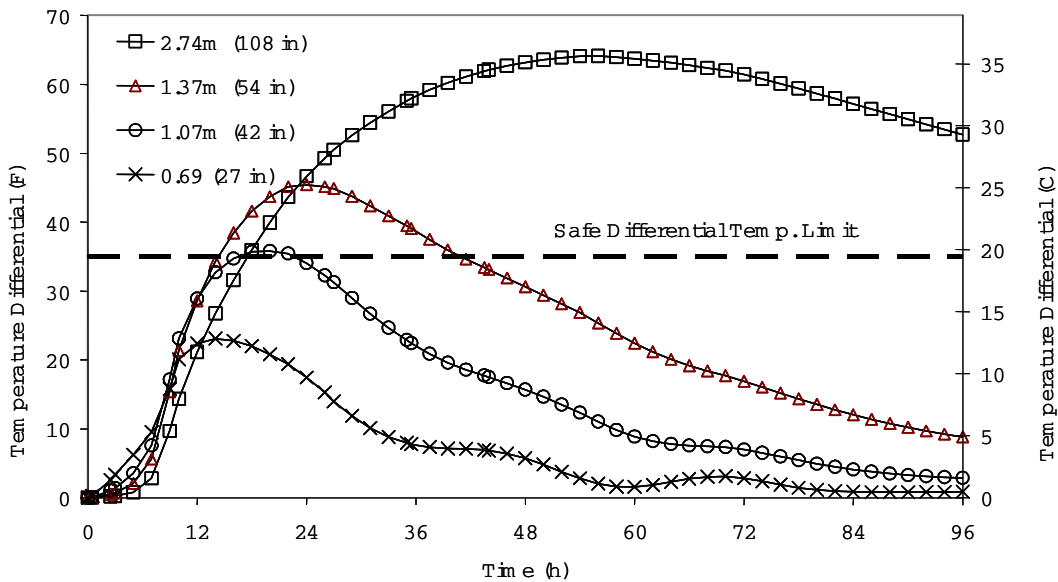
Figure 3. Modeled differential temperatures for “Ringling” shaft mix.

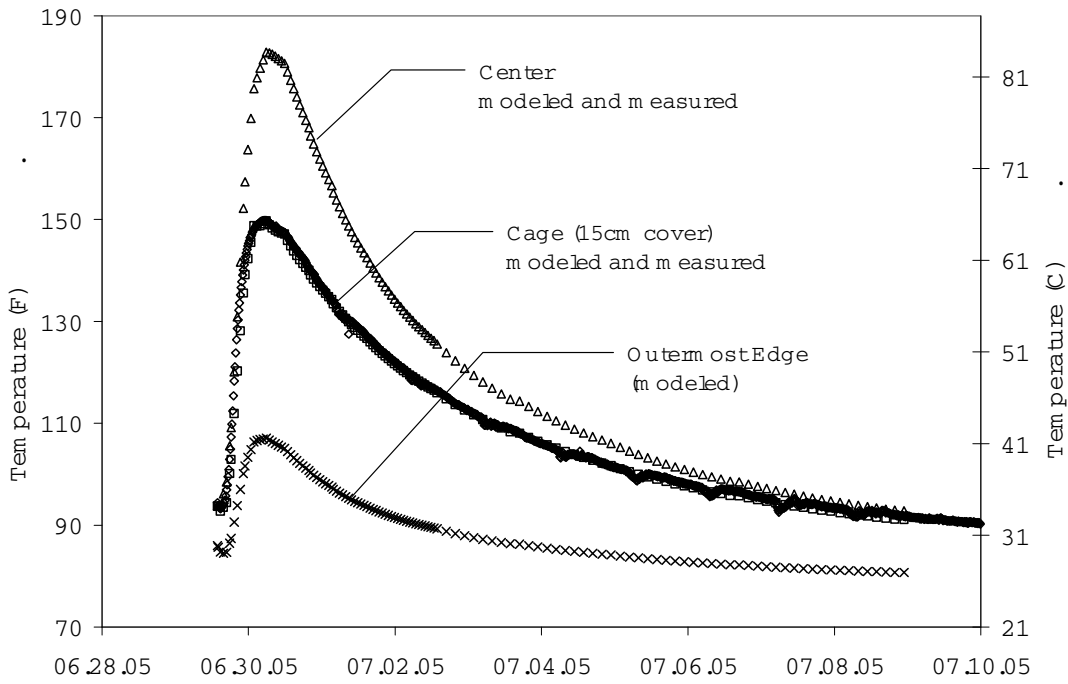
Figure 4. Temperature traces for the 1.22m Clearwater shaft (modeled and observed).

Using the measured temperature response, the same numerical model was applied to this site’s conditions which were significantly different from the Ringling site. Specifically, the ambient temperature was much higher, the surrounding heat diffusing materials were non-convective with no flowing water, and the mix design contained little to no pozzolans. Figure 4 shows the measured and modeled results superimposed with no recognizable differences aside from the diurnal temperature fluctuations on one thermocouple channel. A peak temperature of 84C (183F) was observed with a maximum differential temperature of 32C (57F).

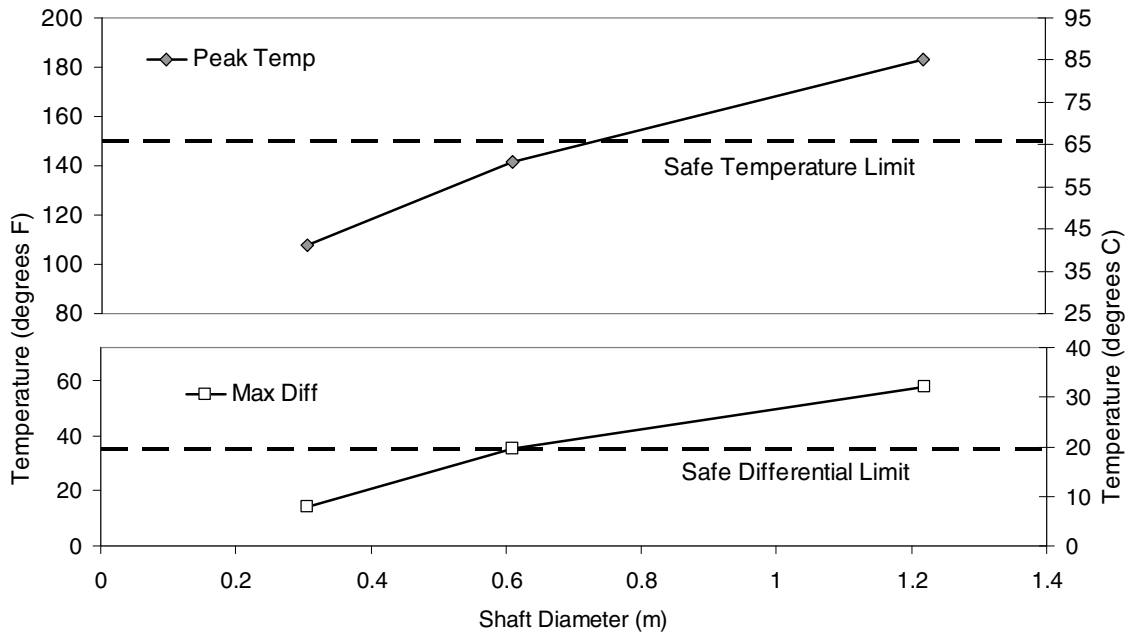
Figure 5. Modeled temperature generation versus shaft diameter.

Using the same Clearwater conditions, the numerical model was extended to simulated smaller shaft sizes (Figure 5). The results showed that even the smallest of constructible shafts (0.6m) would exhibit mass concrete under these highly adverse conditions.

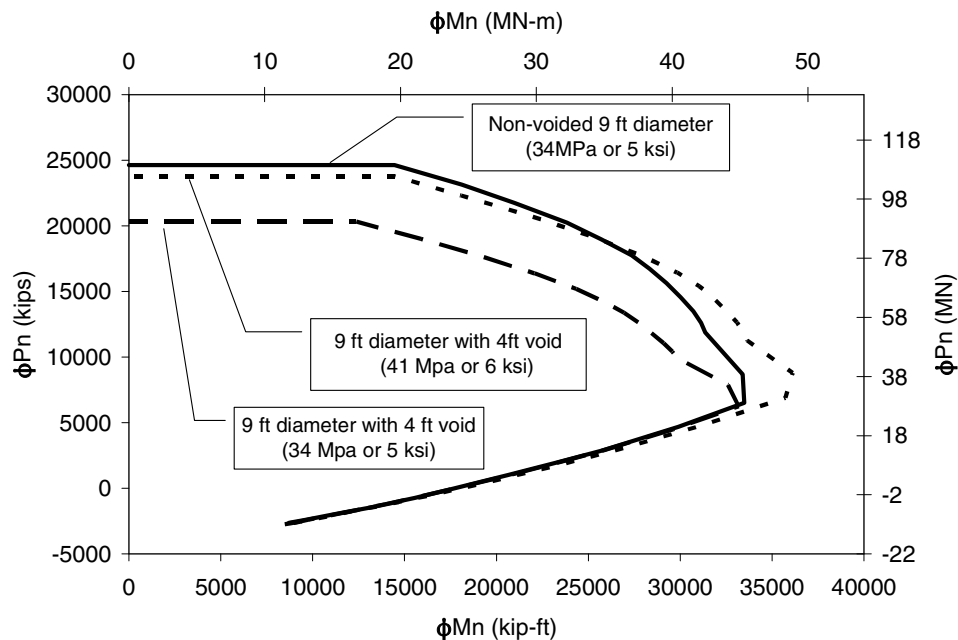
Figure 10. Interaction diagram of 2.75m diameter voided and un-voided shafts.

Structurally, a centrally voided shaft would exhibit a reduction in axial capacity roughly proportional to the loss in cross-sectional area. In general, load cases involving lateral loads and overturning moments produce far more severe stresses but would only be mildly affected by the presence of the void. For example, a 2.75m (9 ft) diameter shaft with a 1.22m (4ft) diameter void, 1% 410MPa (60ksi) steel, and  $f'_c$  of 34MPa (5ksi) would result in a axial capacity reduction in the range of 17% whereas the bending capacity would be reduced less than 1%. This is due to the minimal contribution to the moment of inertia and the associated bending strength provided by the more centrally located concrete material. Further, the 1% reduction does not consider the gain in bending capacity associated with the inner steel casing if permanent. If the axial capacity must be maintained slightly increasing  $f'_c$  to 41MPa (6ksi) would suffice. Figure 10 shows the interaction diagram for the above example shafts as well as the 41MPa voided option.

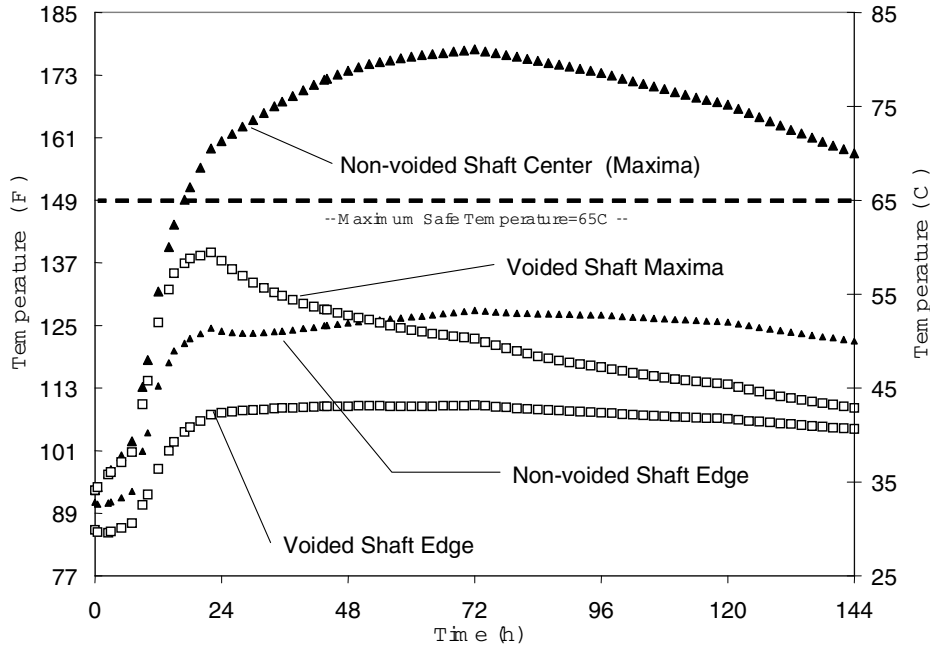
Figure 11. Calculated temperatures for 2.75m voided and non-voided drilled shafts in saturated sands, with summer installation (“Clearwater” type).

**Curing Temperature Maintenance.** The numerically modeled temperature responses of a 2.75m (9ft) diameter shaft with and without a 1.22m (4 ft) diameter void are shown in Figure 11. The model parameters simulated summer ambient conditions (changing winter to summer) but used concrete heat parameters similar to the Ringling Causeway Bridge. Note that under those conditions the peak temperature increase in the un-voided shaft (Figure 2 and 11) is related to the difference in ambient temperature and the lack of thermal convection in saturated soil.

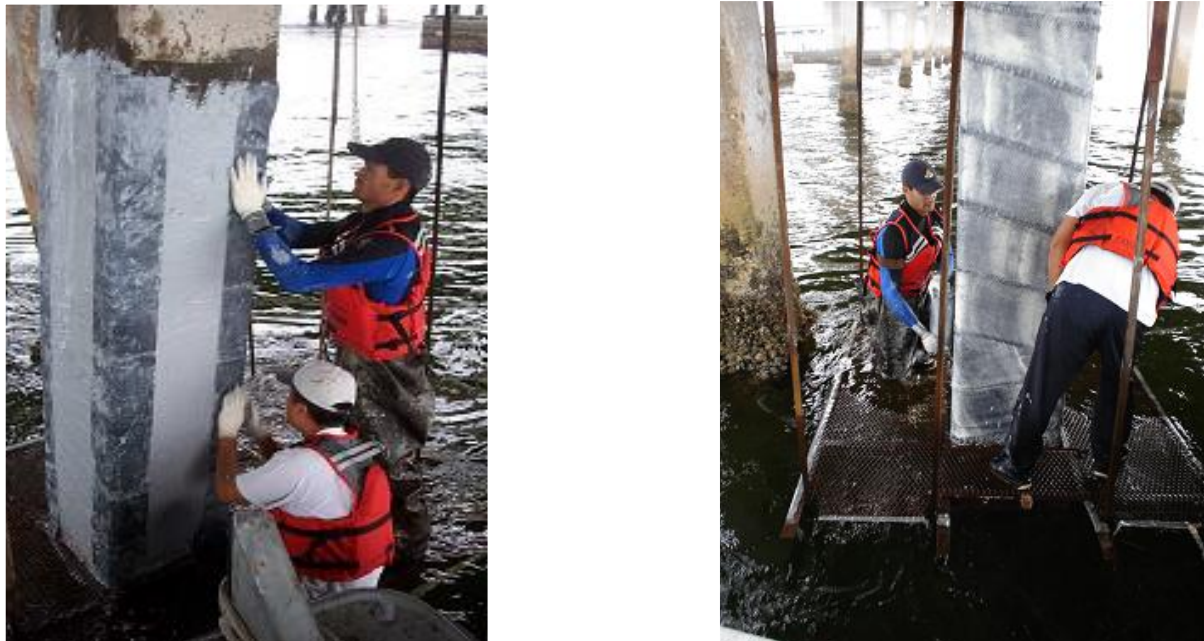
Figure 3. Installation vertical (left) transverse layer (right) typically at low tide

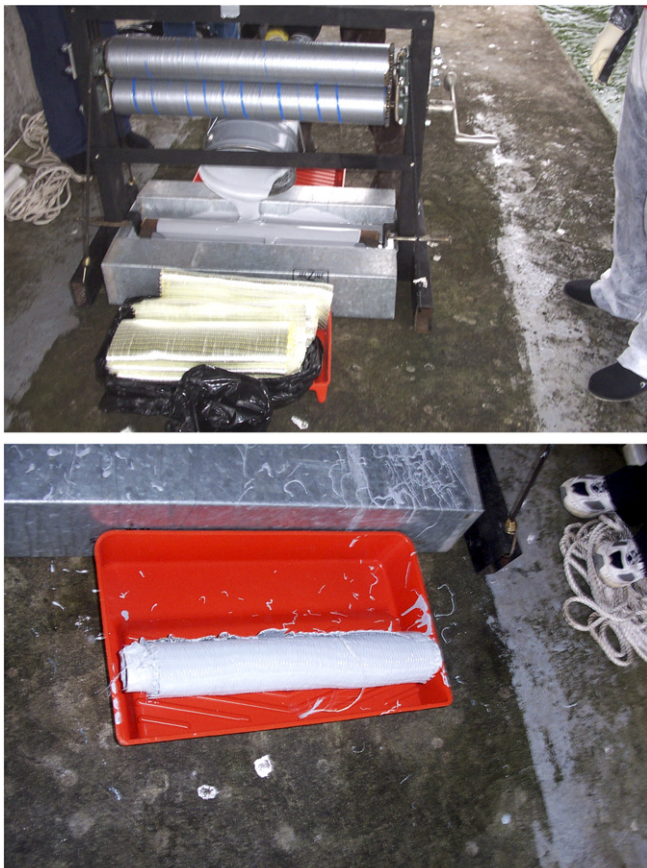
Fig. 8. On-site saturation of fiberglass fabric.

The FRP fabric for pile 101S was impregnated by hand. For pile 101N re-wrapped three months later, a resin impregnator was used (Fig. 8). Following the saturation of the FRP, the wrapping procedure was identical to that for System A. Complete details may be found in the final report [5].

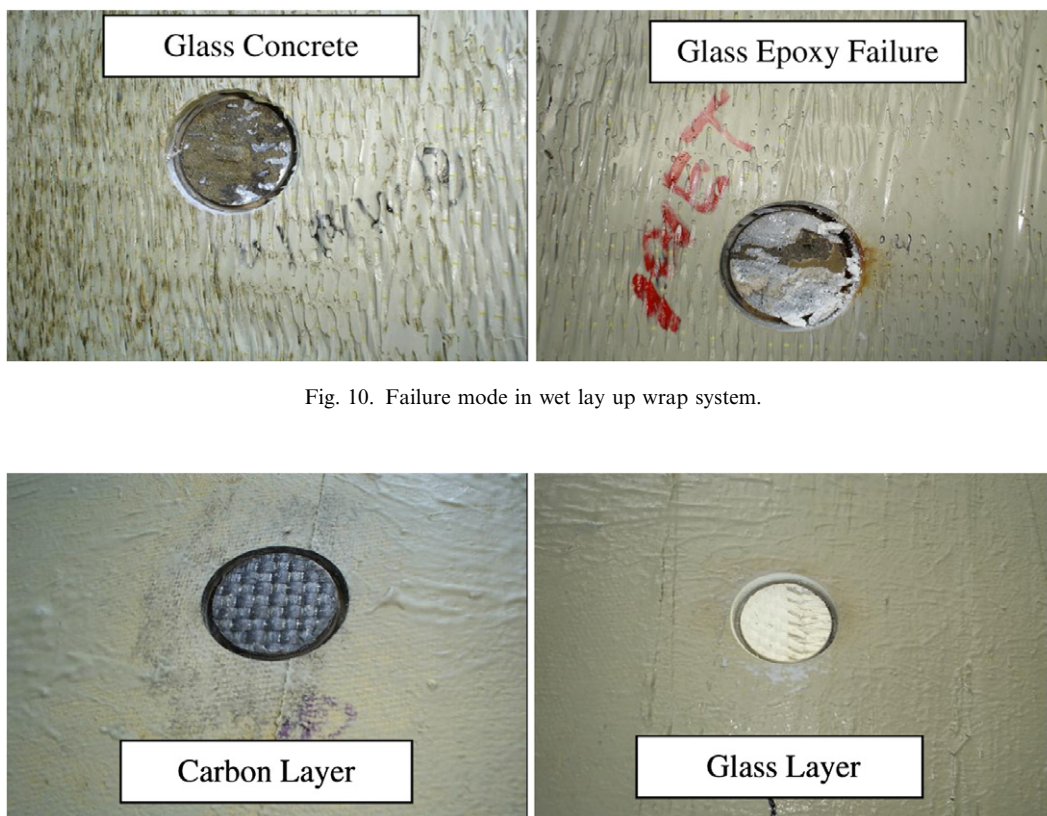
Fig. 10. Failure mode in wet lay up wrap system.

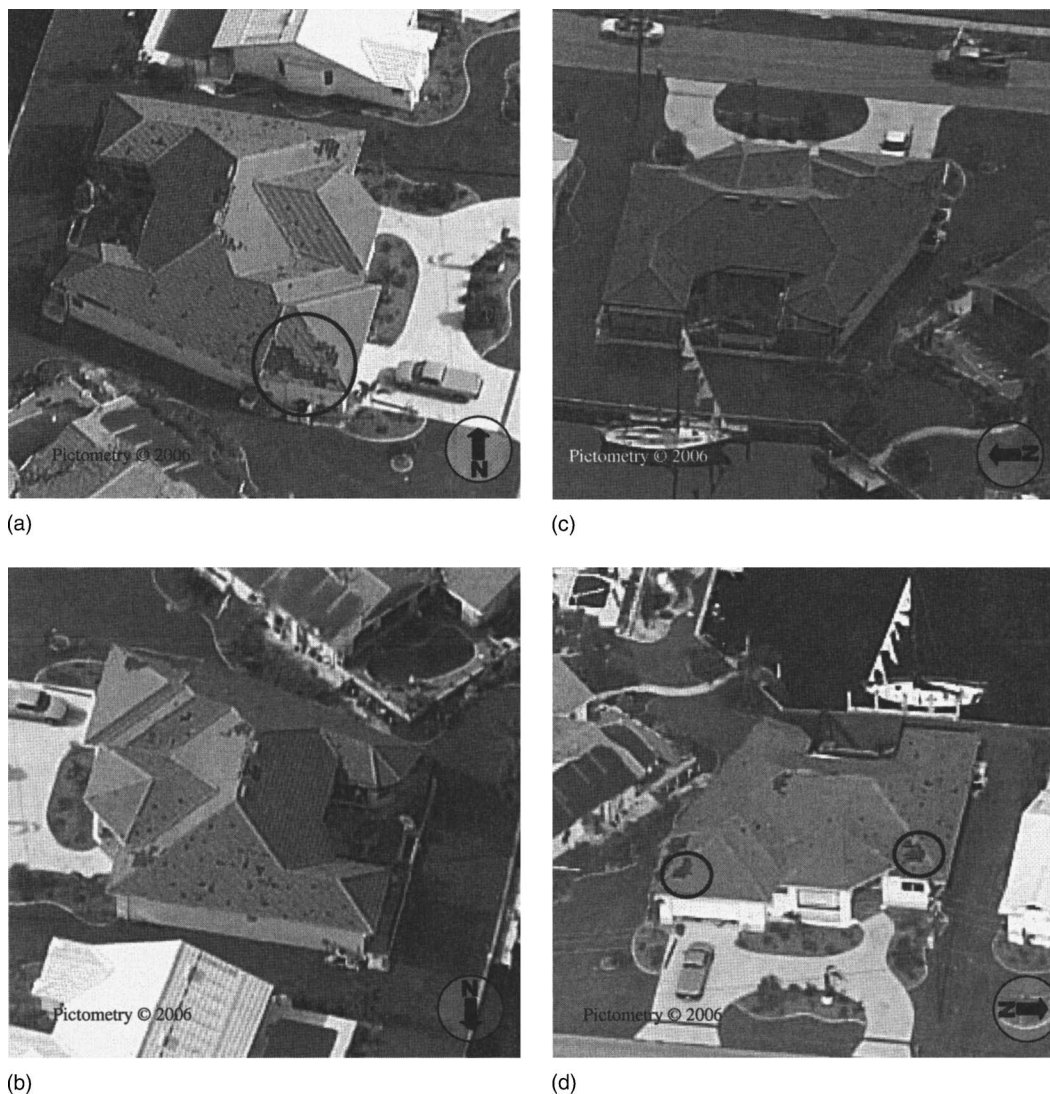
**Fig. 3.** Example neighborhood oblique image. Four views allow for damage on all sides to be clearly seen and estimated: (a) south; (b) north; (c) west; and (d) east views of a damaged house (Reprinted with permission, Pictometry International Corp. 2006).

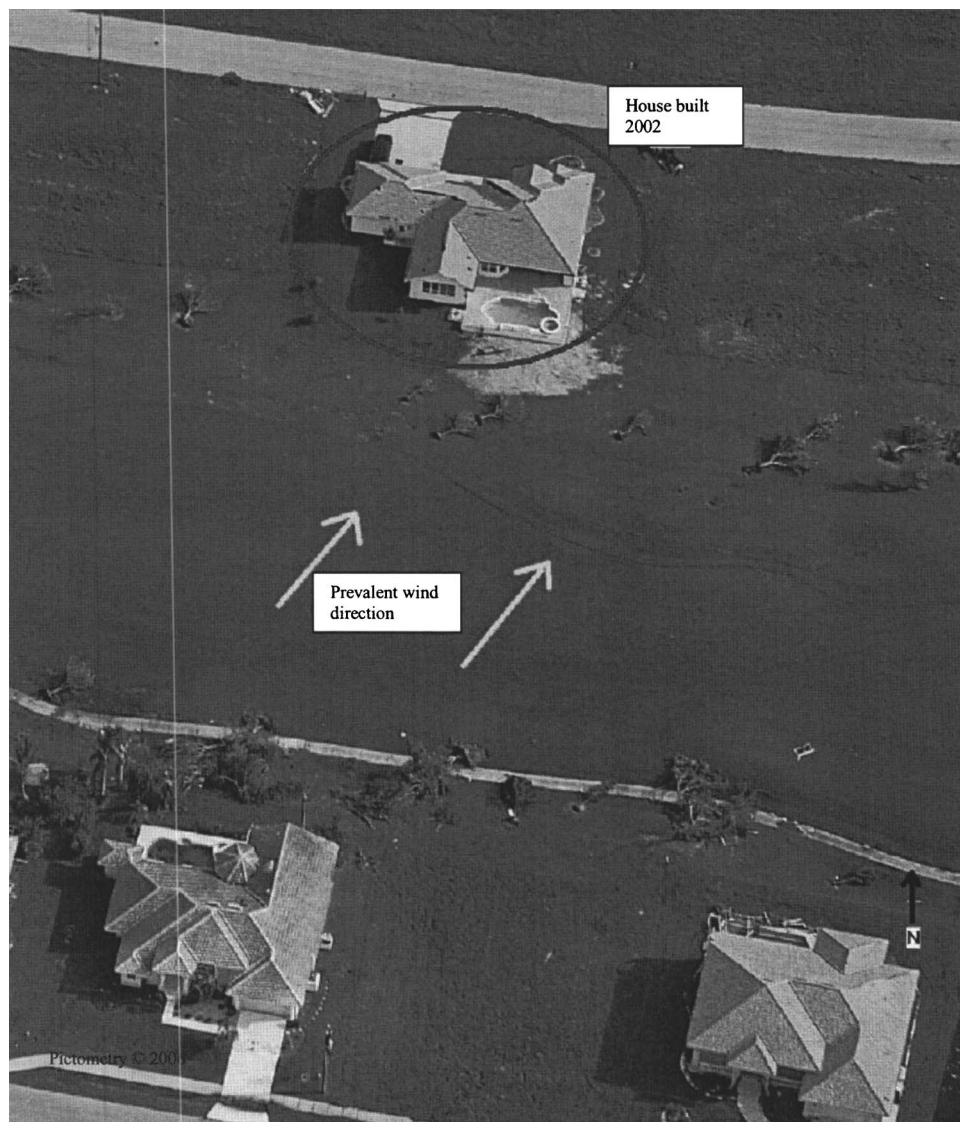
**Fig. 16.** Damage along ridges. Houses upwind show little damage (Reprinted with permission, Pictometry International Corp. 2006).

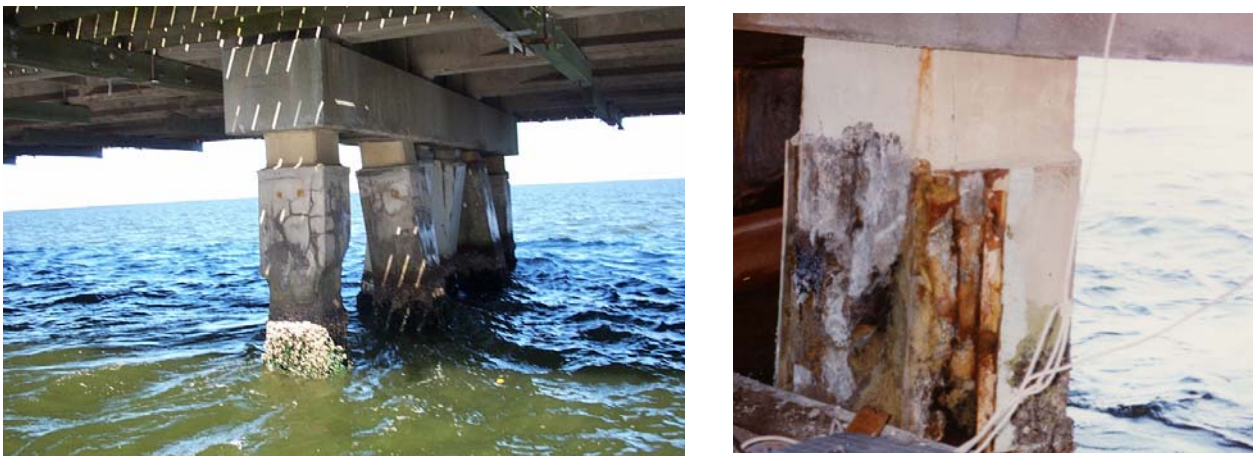
Fig. 1. View of jacketed piles (left) and view of underlying corrosion with the jacket removed (right)

Minor corrosion repairs are carried out using 'chip and patch' repair techniques. Greater damage is commonly repaired by encapsulating the corroded area in the "splash zone" (a region subjected to wet-dry tidal cycles) in a jacket (Fig. 1), usually made of fiberglass because of its light weight. The jacket does not contribute to the repair strength but merely serves as a stay-in-place form for the concrete that is poured in the annular space between the pile and the inside surface of the jacket. Since the fiberglass jacket is opaque the repaired region is hidden making it impossible for inspectors to assess its state of repair unless corrosion has progressed to the extent that external rust stains become visible.

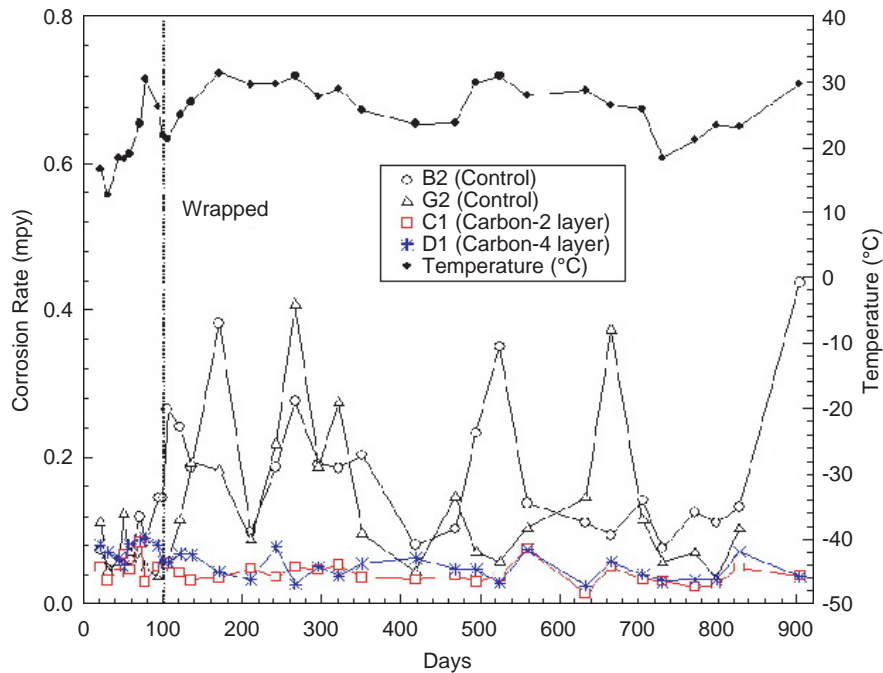
FIGURE 8 Corrosion rates in wrapped and unwrapped piles, Allen Creek Bridge, Clearwater.

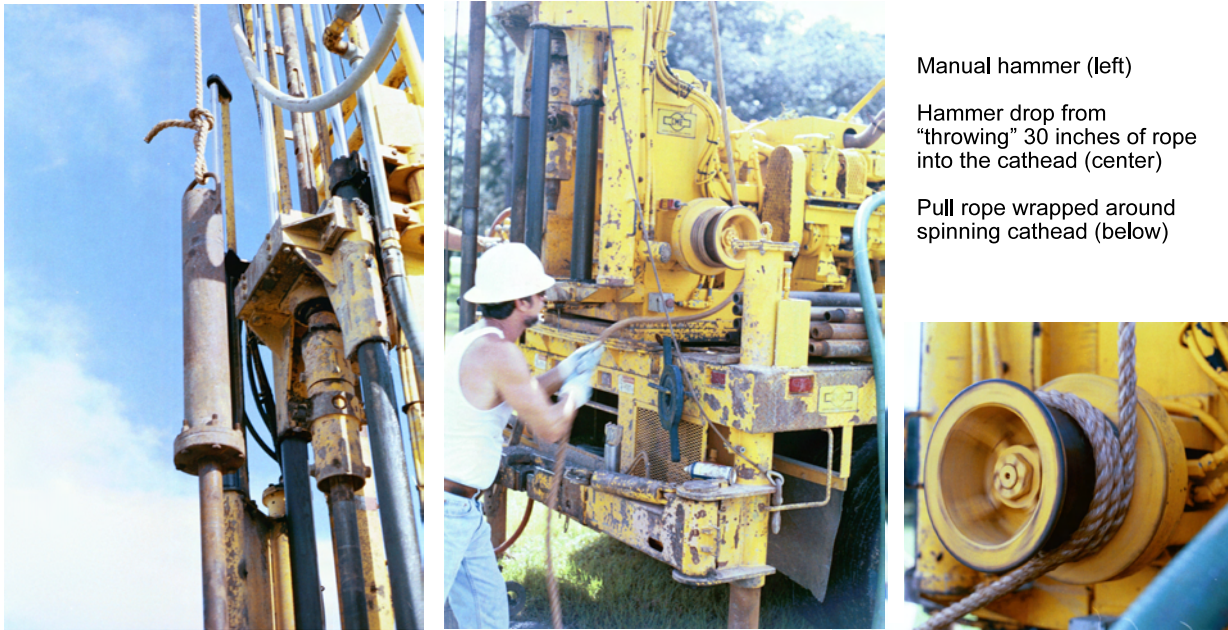
**Figure 5** Manual hammer SPT apparatus.

The hammer used to drive the sampler can either be manual or automatic. Numerous configurations of both hammer types have been manufactured. The safety type is the most common manual hammer as it is equally suited to both drive and extract the split spoon. This type of hammer is lifted by the friction developed between a rope and a spinning cathead power take-off. The number of wraps around the cathead as well as the diameter of cathead are specified as well as the condition of the rope and cathead surface (Figure 5). Due to the incomplete release of the drop weight from the cathead, the total potential energy of the drop is not available to advance the sampler. A recent study showed that manual hammers transfer anywhere between 39 and 93% of the energy (average 66%), while automatic hammers ranged between 52 and 98% (average 79%). Although the reproducibility of a automatic hammer is better than manual hammers, the variation in energy efficiency cited is dependent on the upward velocity of the hammer as controlled by the revolutions per minute of the drive chain motor (Figure 6). To this end, a given machine should be calibrated to produce an exact 30 inch drop height and the rpms required to produce that drop recorded and maintained.

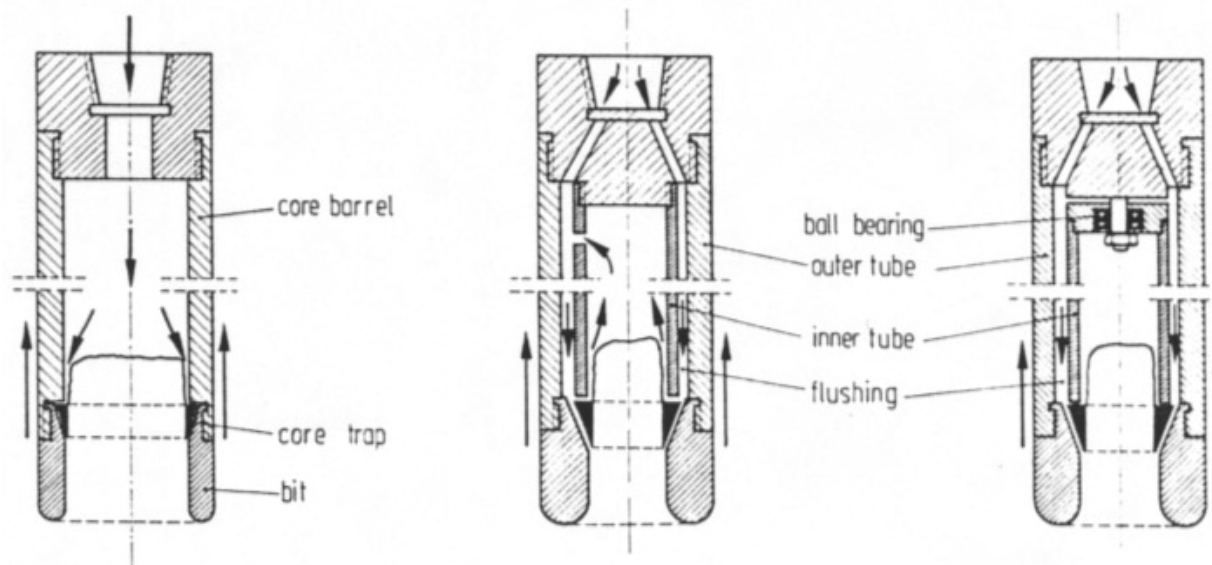
**Figure 8** Single tube (left), double tube w/rotating inner tube (center), and double tube w/fixed inner tube (right), after Wittke, 1990 .

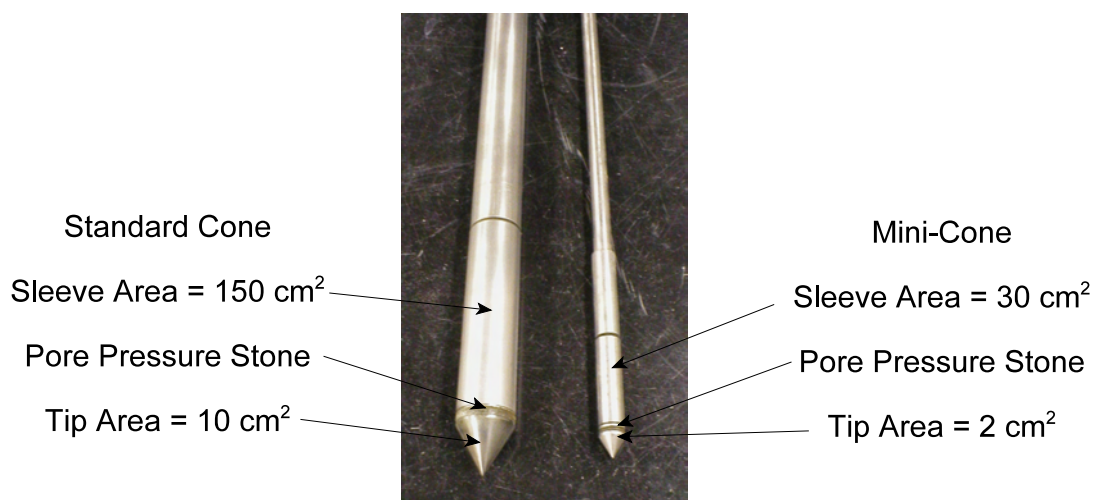
**Figure 14** Two cone tip and sleeve assemblies of different sizes.

The tip area (diameter) can influence the magnitude of the resulting  $q_c$  value similar to the effects of foundation diameter on capacity. This is due to the increased zone of influence beneath the tip as the cone diameter increases for various devices. Therefore, in relative uniform soils, the tip diameter has little effect. In layered or more heterogeneous strata, a smaller tip diameter will better register the minute changes in soil type and strength. Larger diameter cones physically average the effects of thin layers. Figure 14 shows two different-sized cone tip and sleeve assemblies.

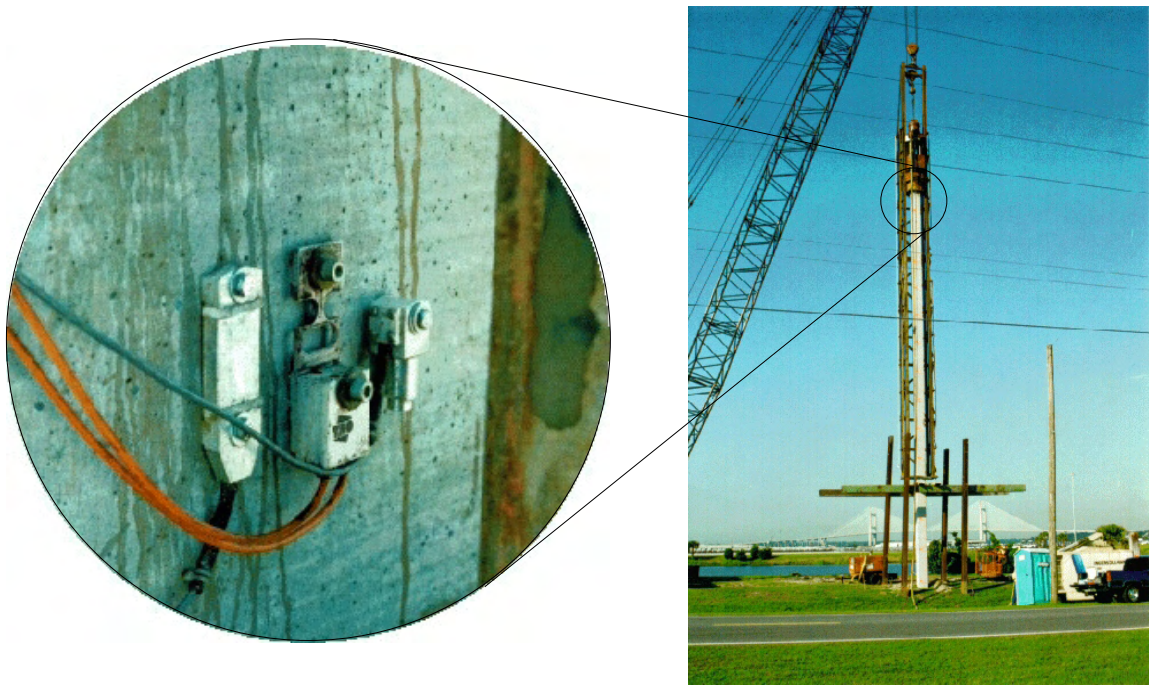
**Figure 22** Strain gages and accelerometers attached to pile during pile driving.  
(Courtesy of Applied Foundation Testing, Inc.)

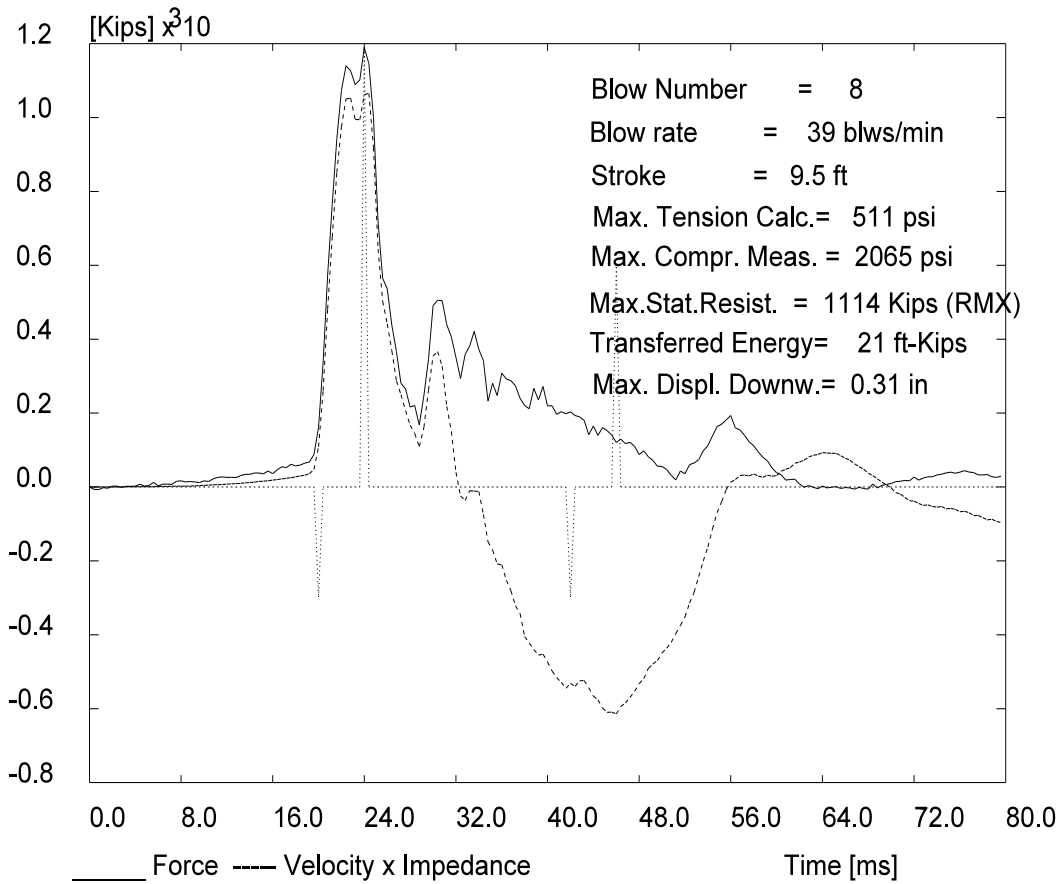
**Figure 23** Field data showing pile driving performance (Courtesy of Applied Foundation Testing, Inc.).

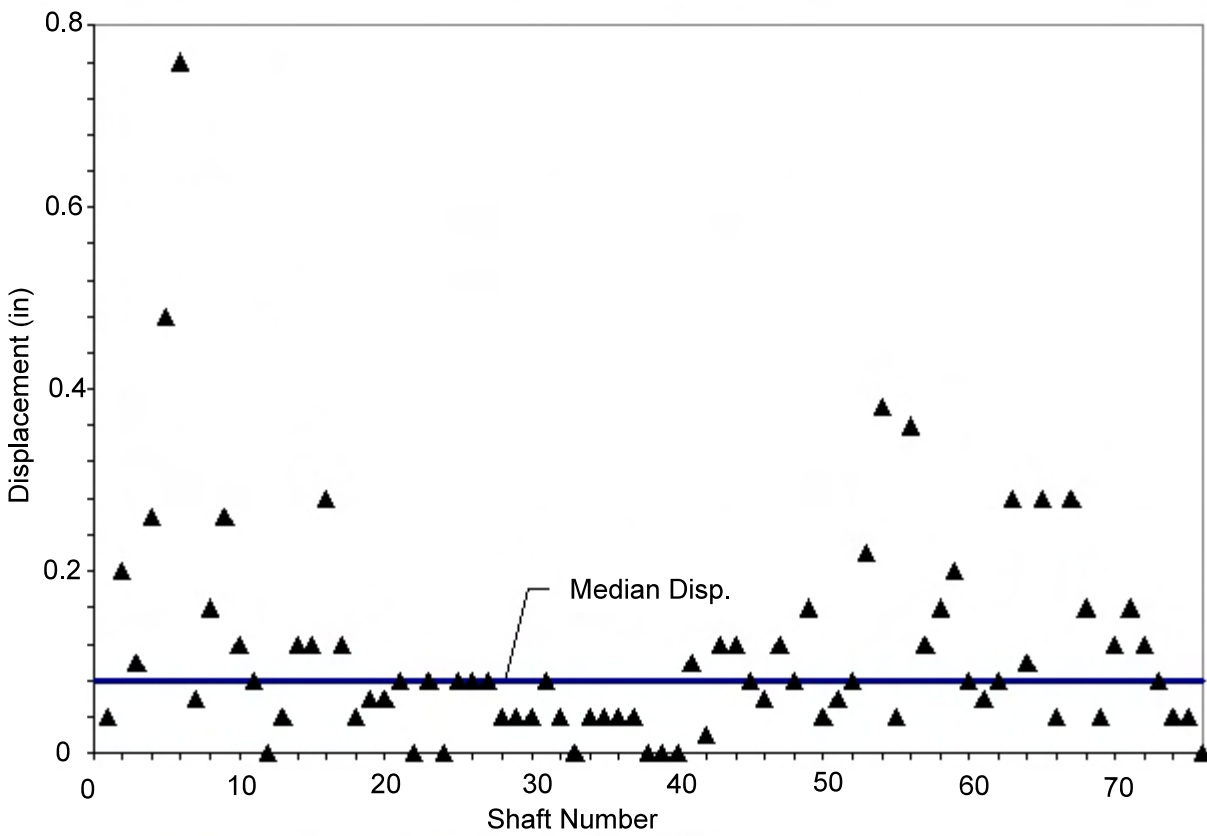
**Figure 25** The displacement observed for every shaft on a project at design pressure.

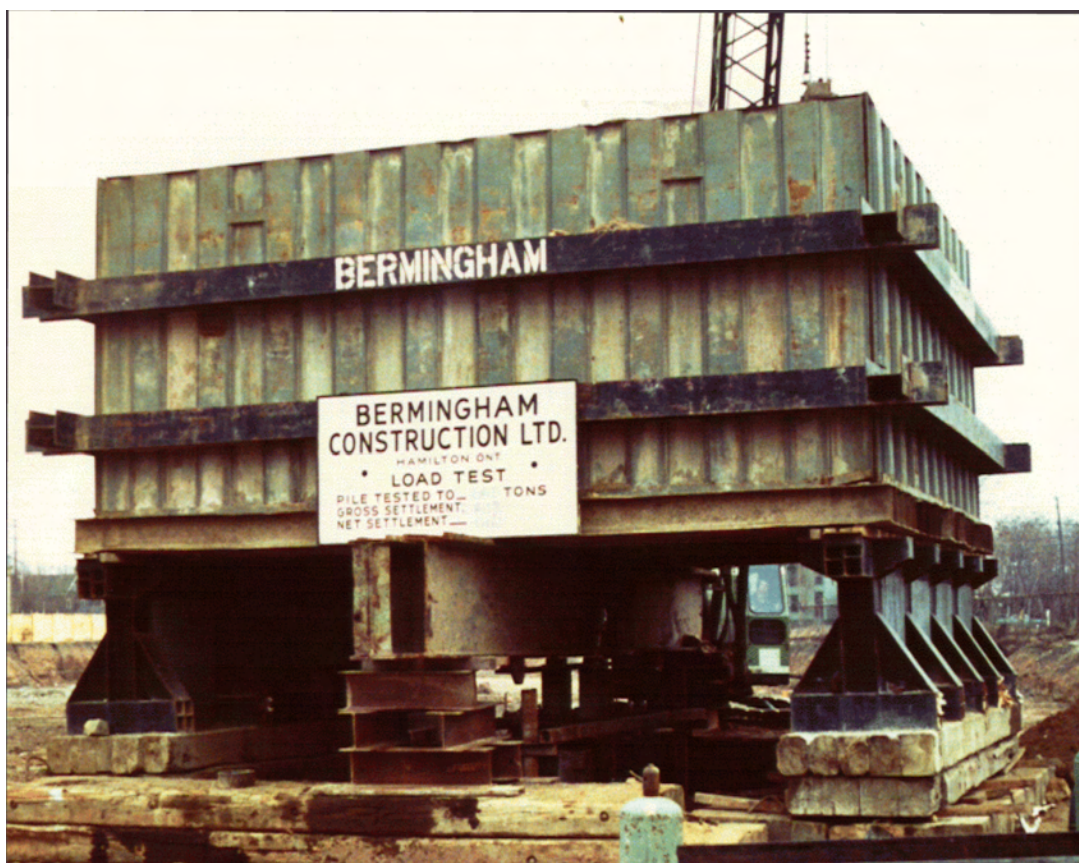
**Figure 26** Kentledge load test setup; 400 ton (Courtesy of Bermingham Construction, Ltd).
