## Acknowledgments

## Table of Contents

## Case Study 2: St. Anthony Falls Bridge Foundation Monitoring

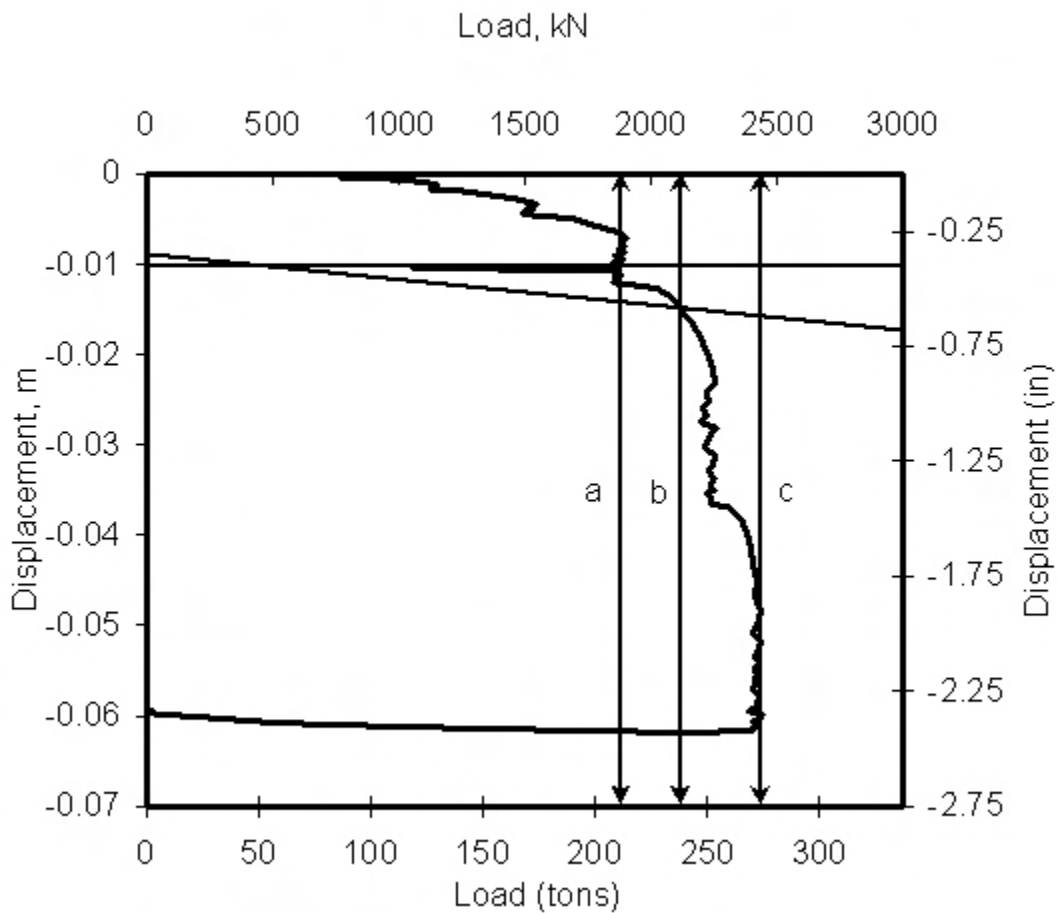
**Figure 28** Static load test results showing 3 different failure criteria capacities (a) a 10mm permissible disp, (b) offset method, and (c) ultimate capacity.

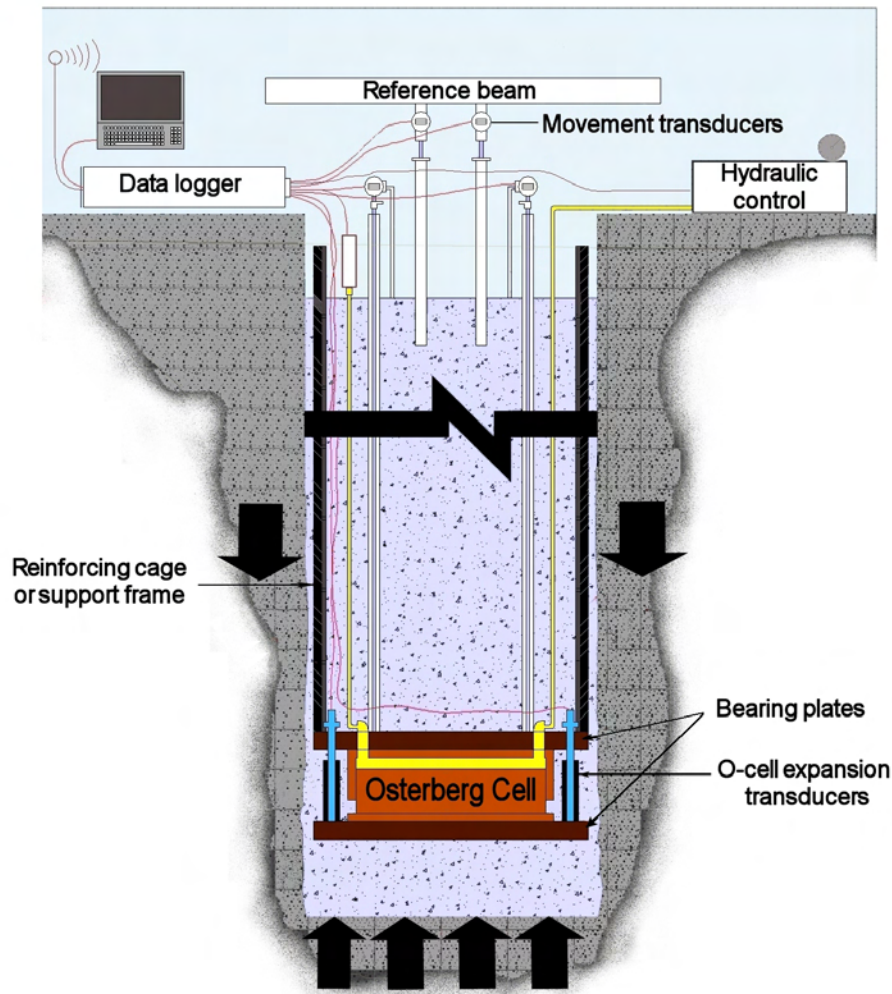
**Figure 29** Section view of the bidirectional loading scheme of an O Cell  
(Courtesy of LoadTest, Inc).

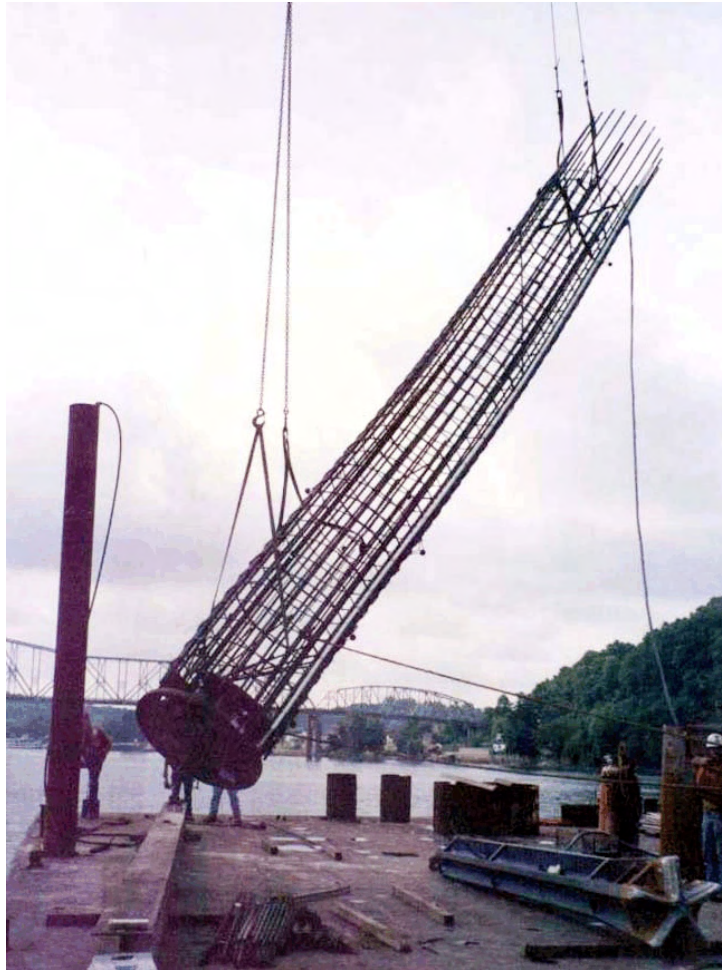
**Figure 30** O Cell and cage lifted for installation  
(Courtesy of LoadTest, Inc.).

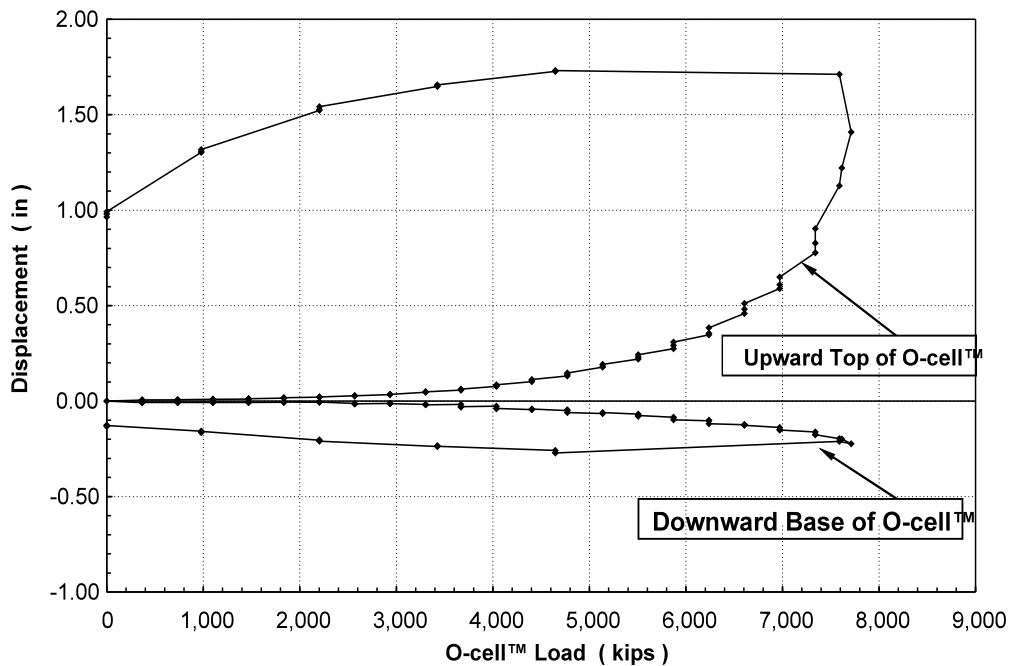
**Figure 31** Typical output showing upward and downward foundation response.  
(Courtesy of Load Test, Inc.)

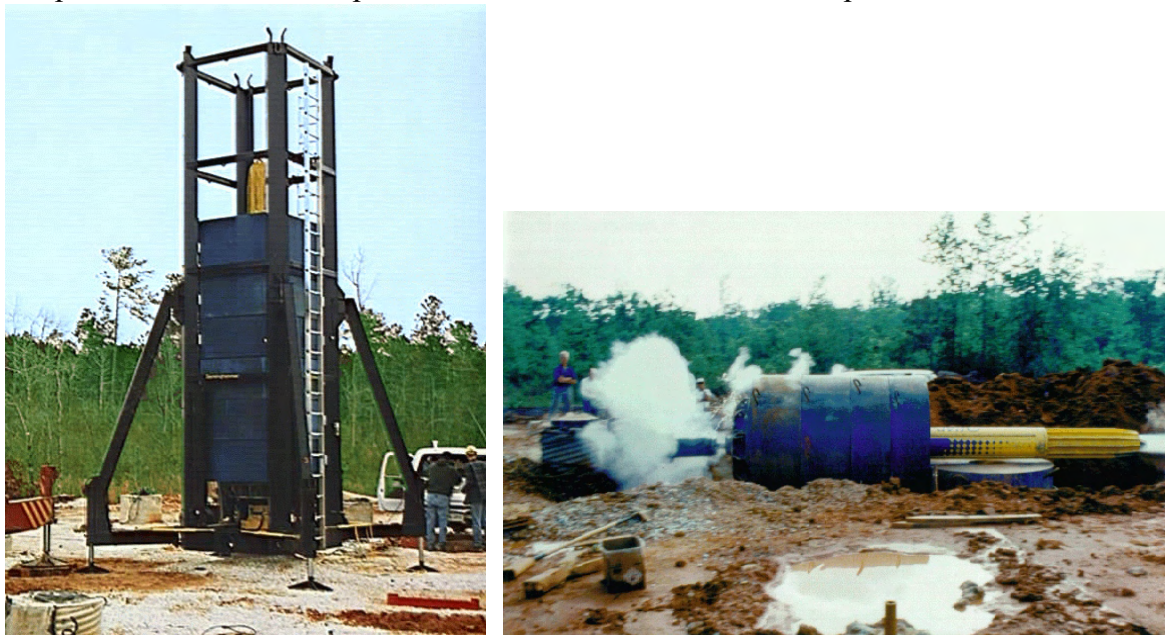
**Figure 32** Axial statnamic test setup (left), lateral statnamic test in progress (right).

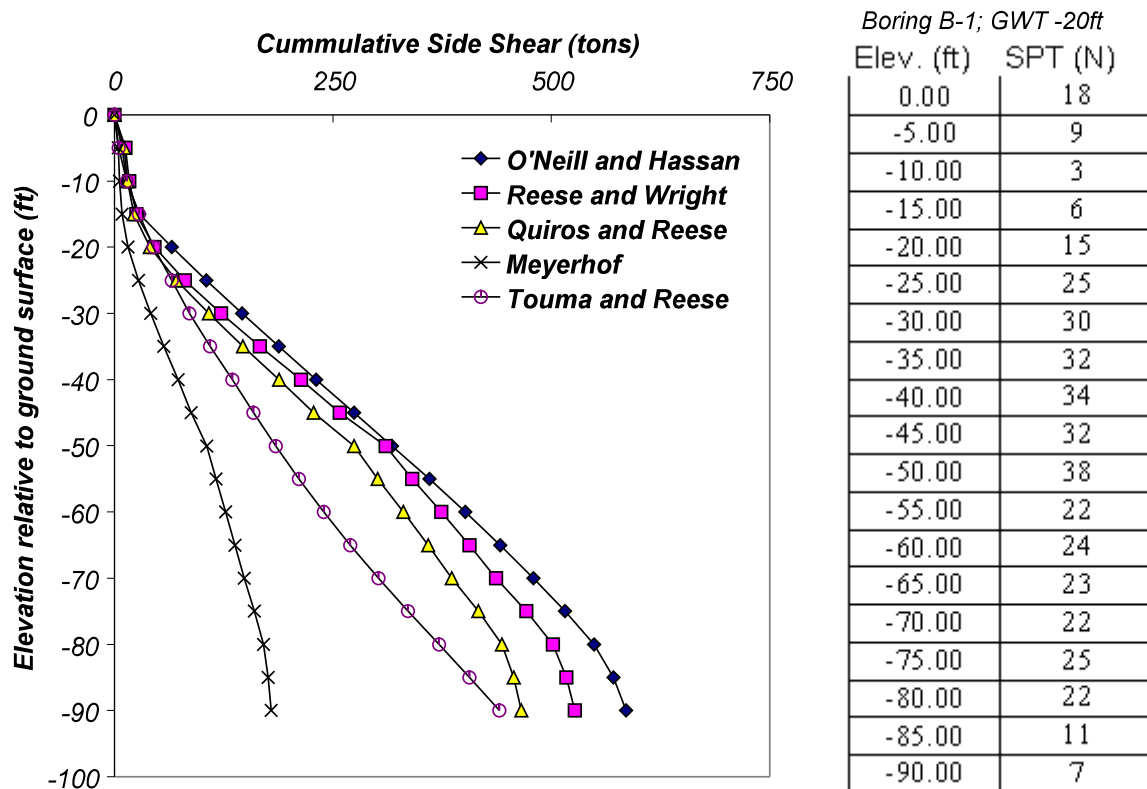
**Figure 2** Comparison of estimated side shear capacities in sandy soil (3 ft diam).

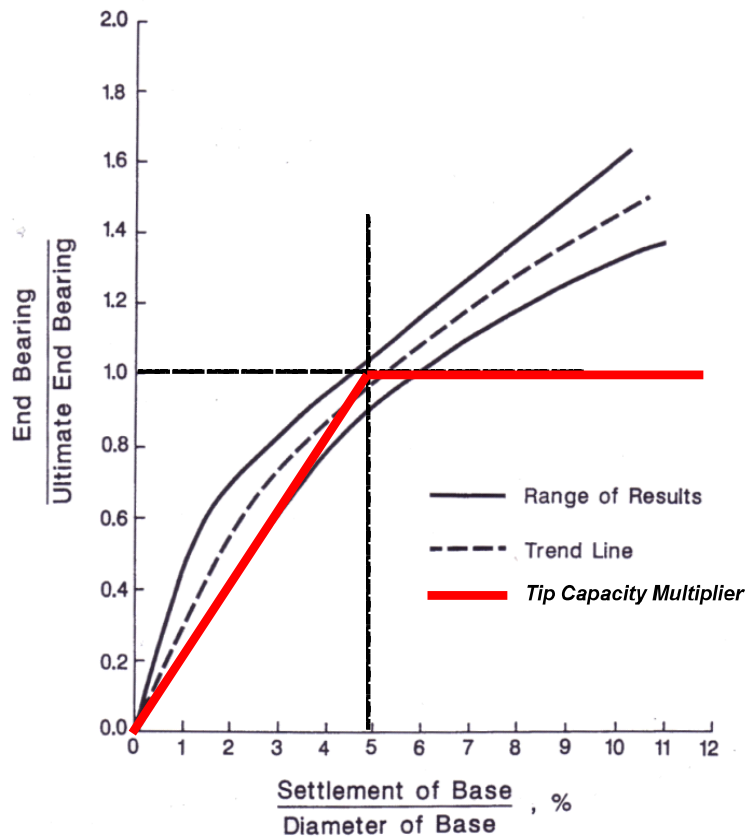
**Figure 3** End bearing response of sands as a function of displacement (based on Reese and O'Neill, 1988).

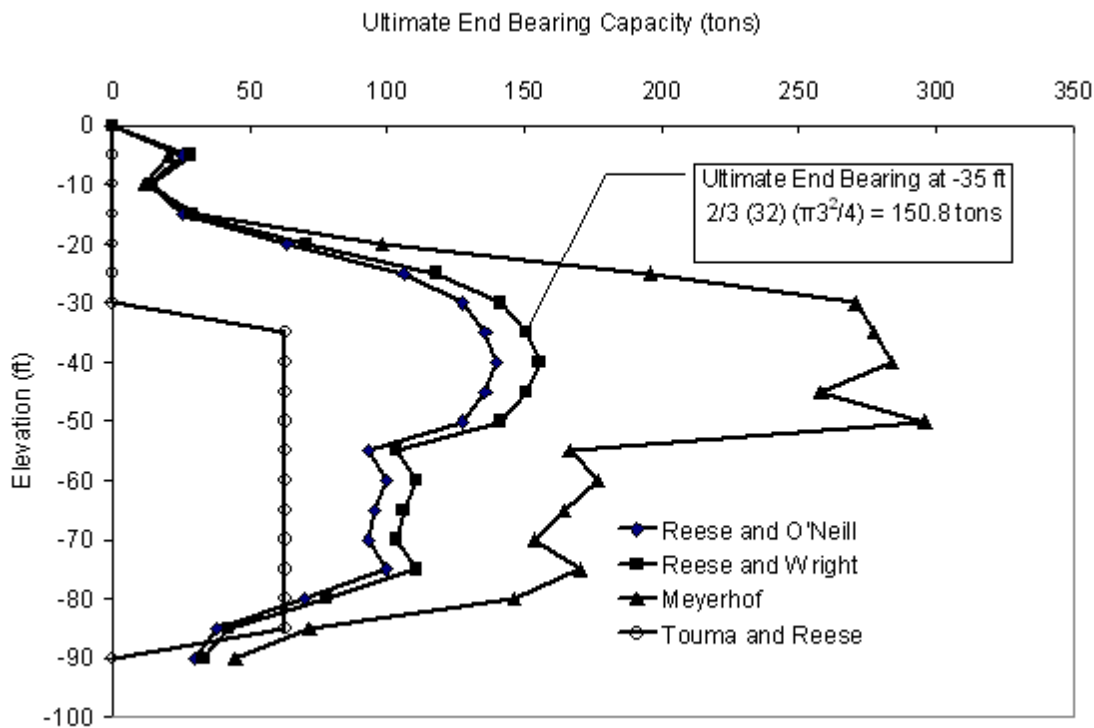
Figure 4 Comparison of end bearing methods in sand (3 ft diam, Boring B-1).

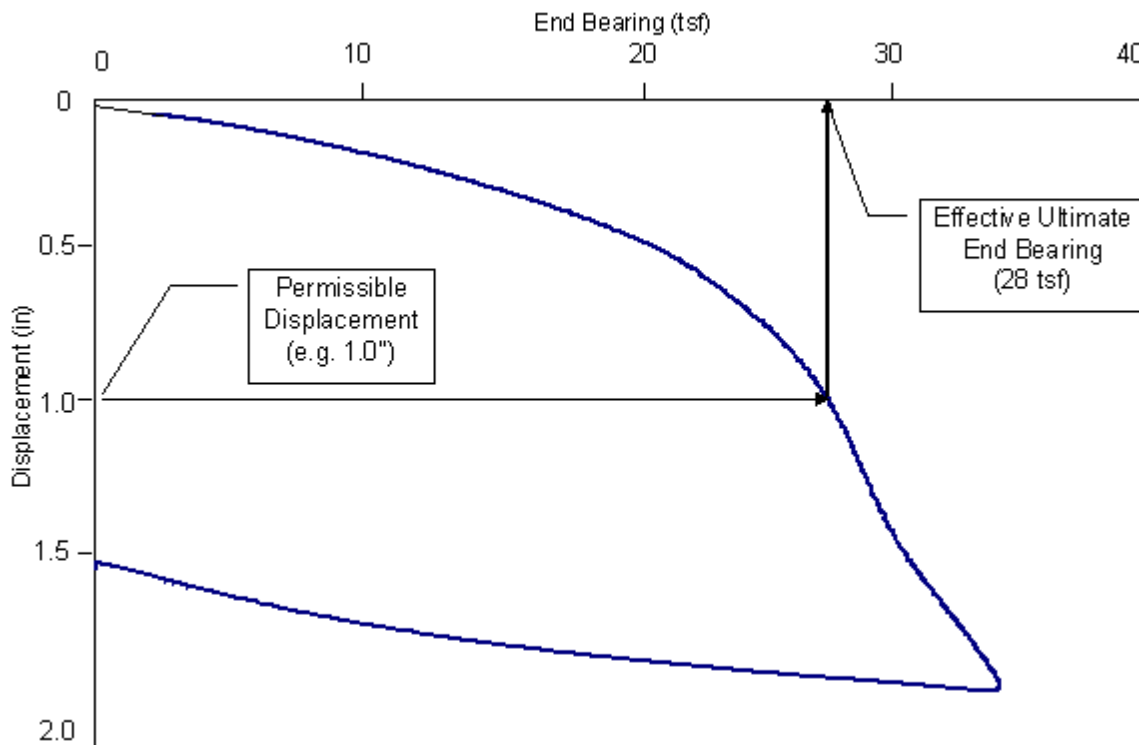
**Figure 7** End Bearing Load Test Results.

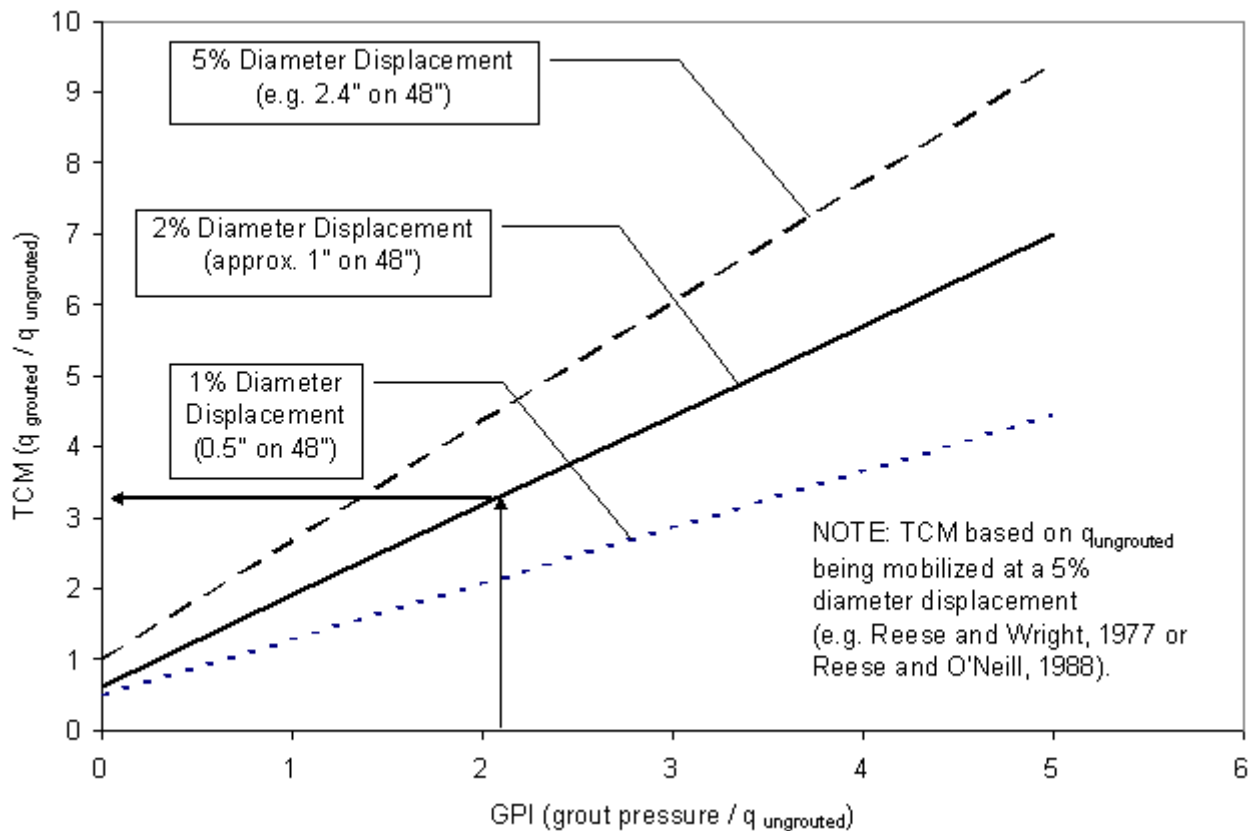
**Figure 8** Correlations used in *Step 6* to establish TCM (Mullins, et al., 2001).

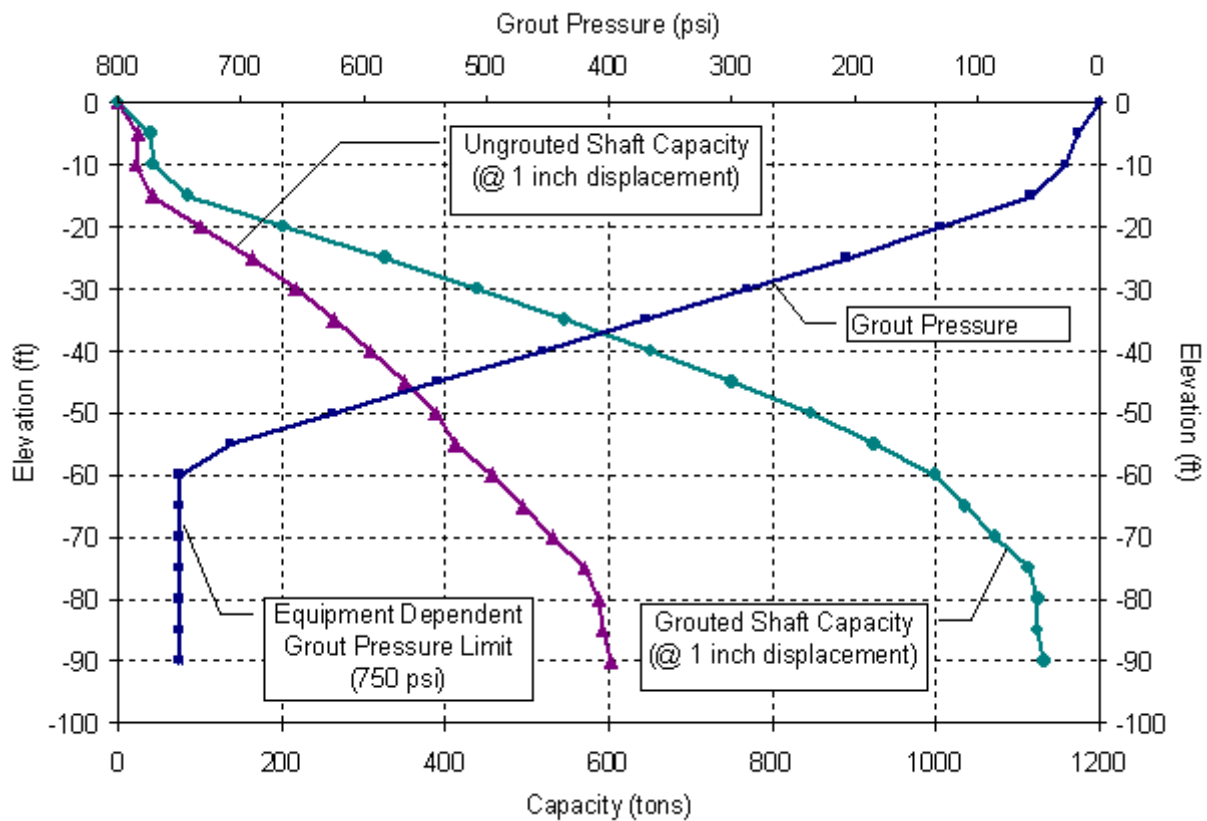
Figure 9 Post grouted shaft capacity extended from Example 1.

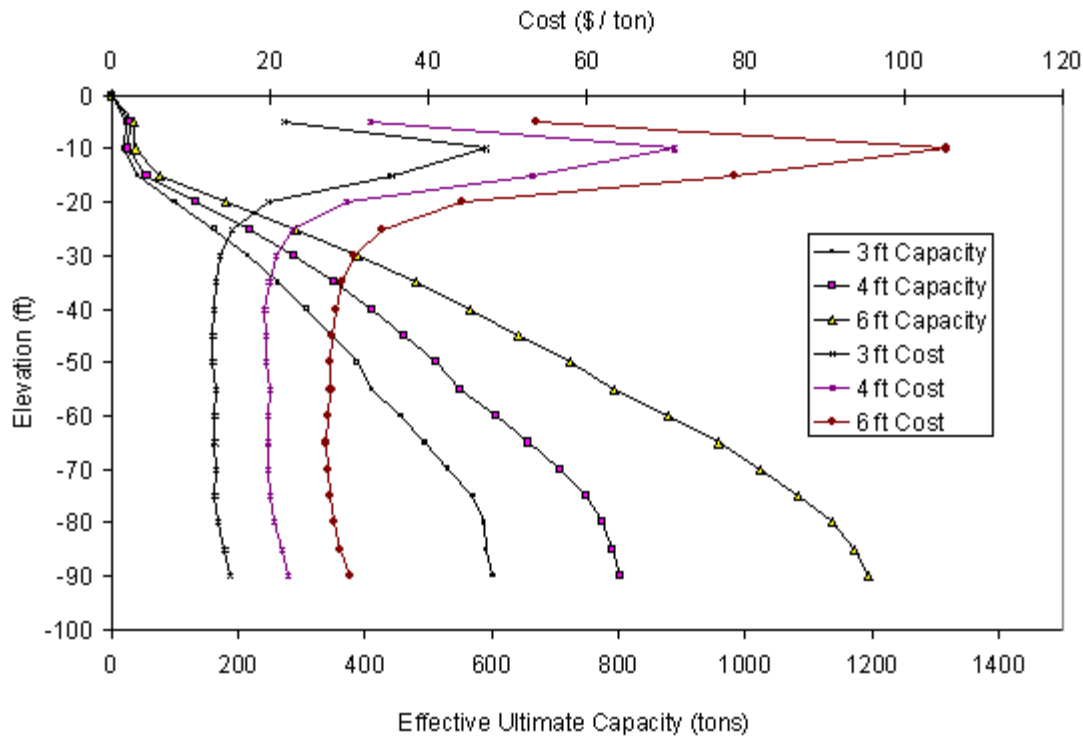
**Figure 10** The effect of shaft size selection on cost.

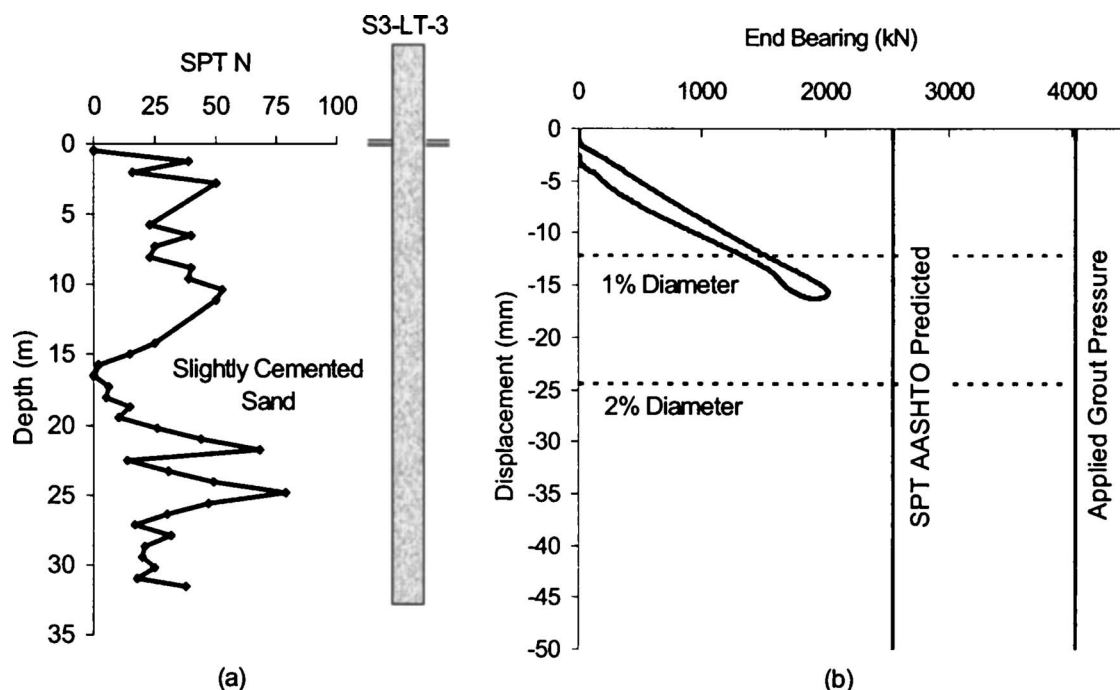
**Fig. 12.** Site III (a) soil boring log and (b) end bearing load test results for test shaft LT-3

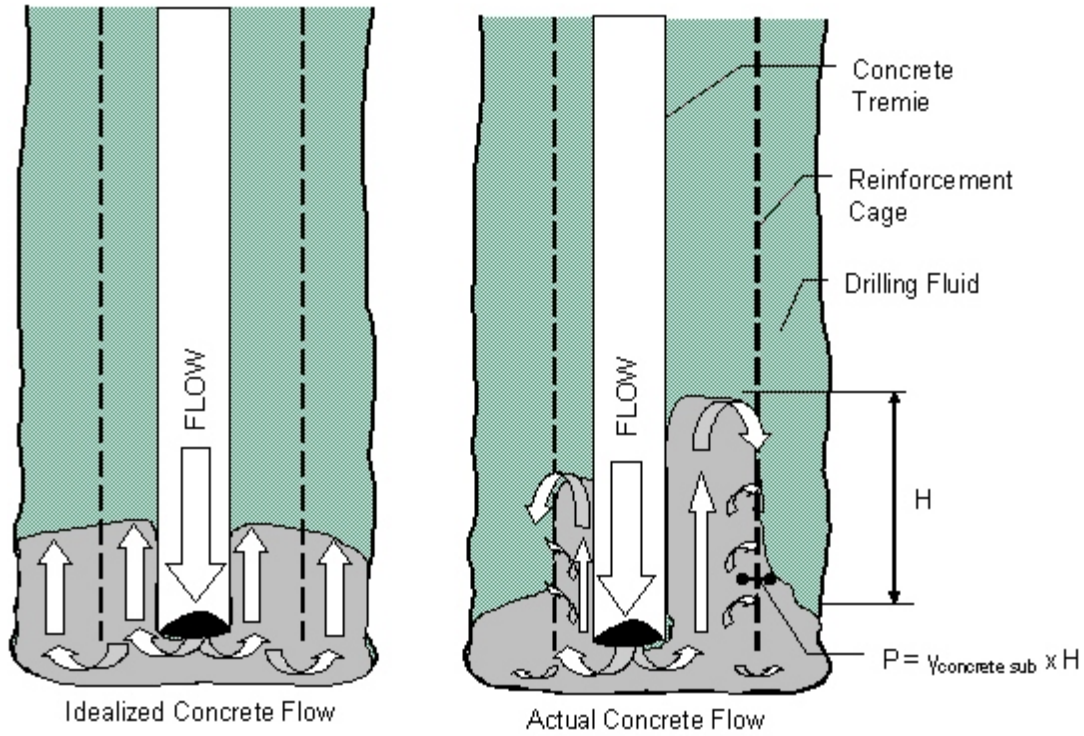
Figure 1 Behavior of Rising Concrete in Tremie Poured Drilled Shaft

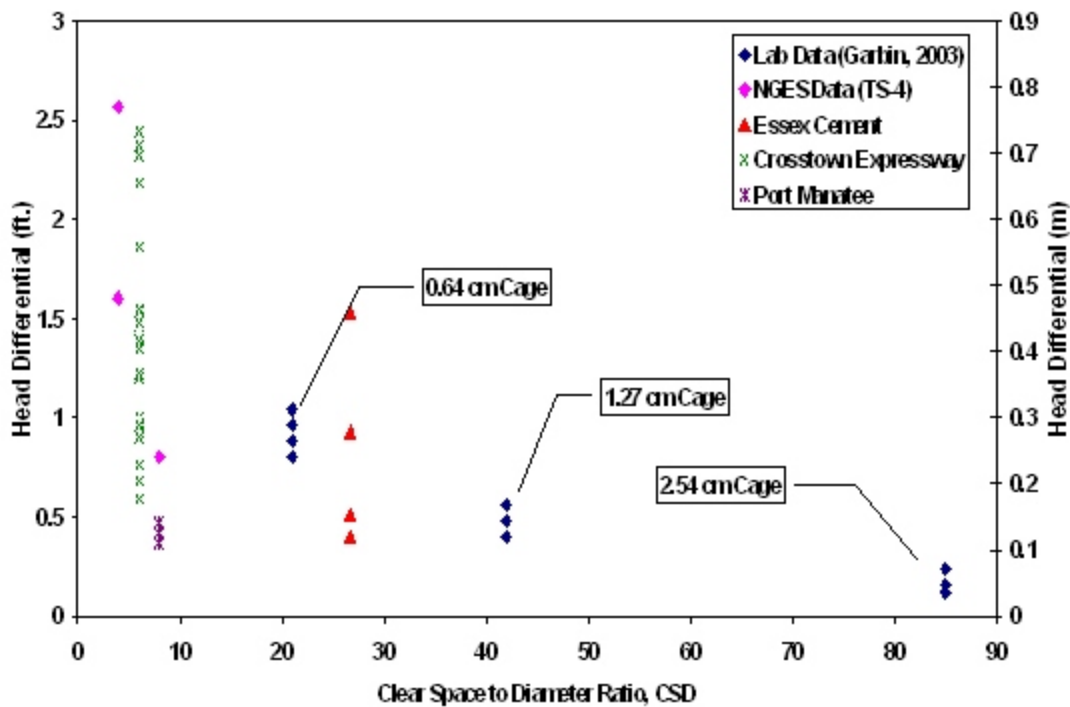
Figure 6 Summary of CSD Ratio Versus Head Differential

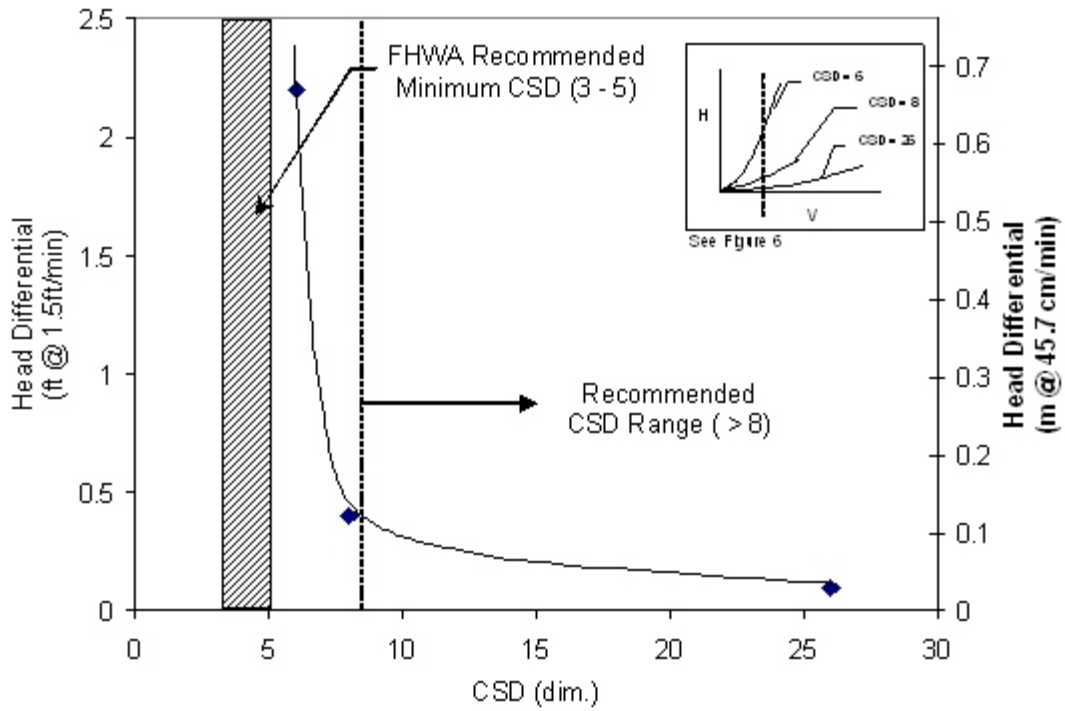
Figure 8 Recommended CSD Range for Drilled Shaft Construction

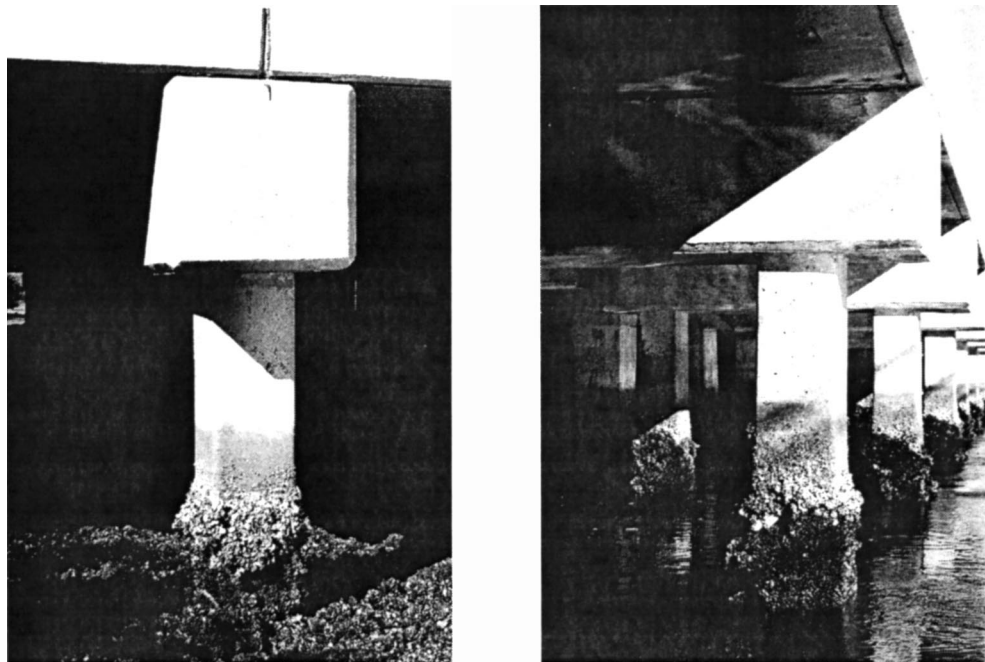
Fig. 7. Marine growth on pile surface

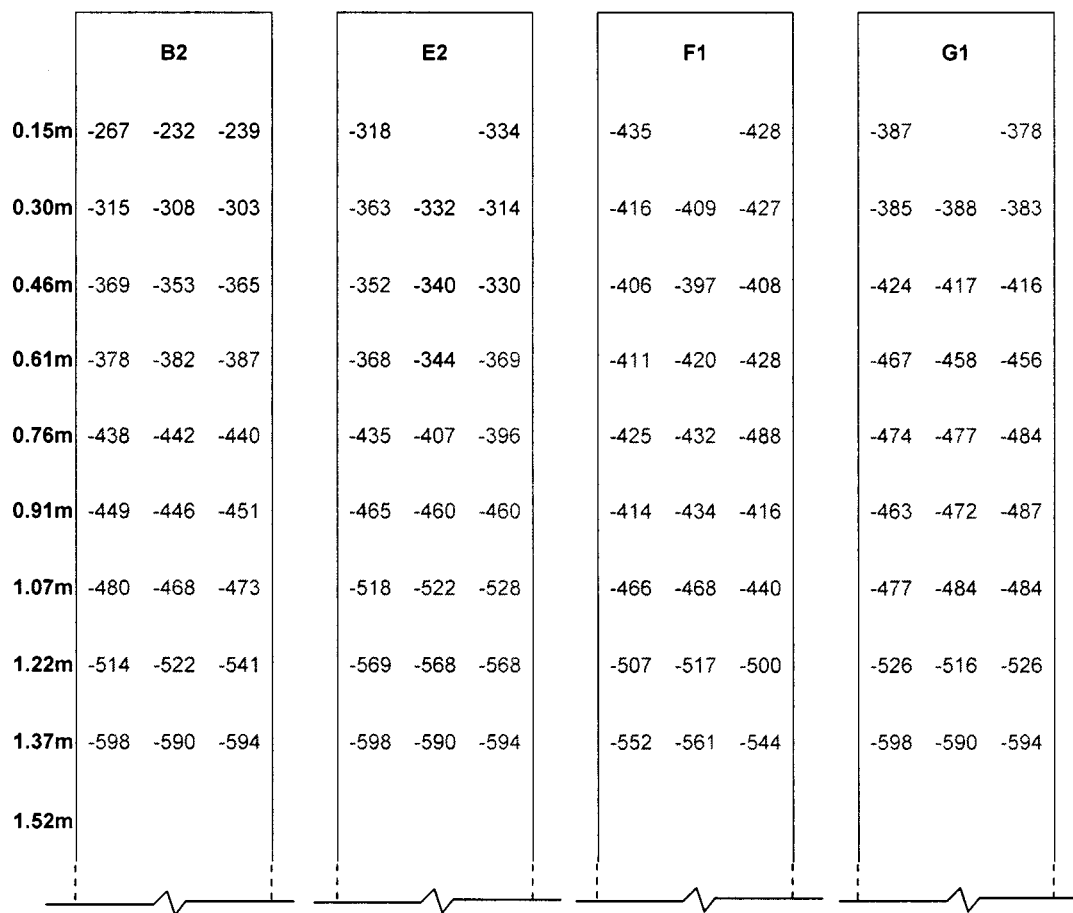
Fig. 13. Initial half-cell potential map for south face (units: mV)

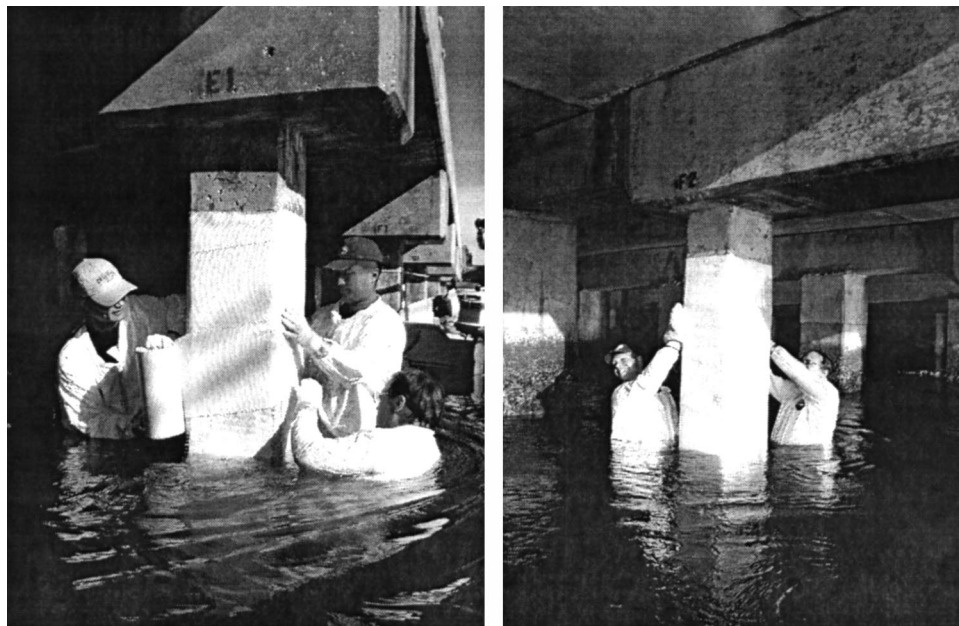
**Fig. 17.** Applying wrap

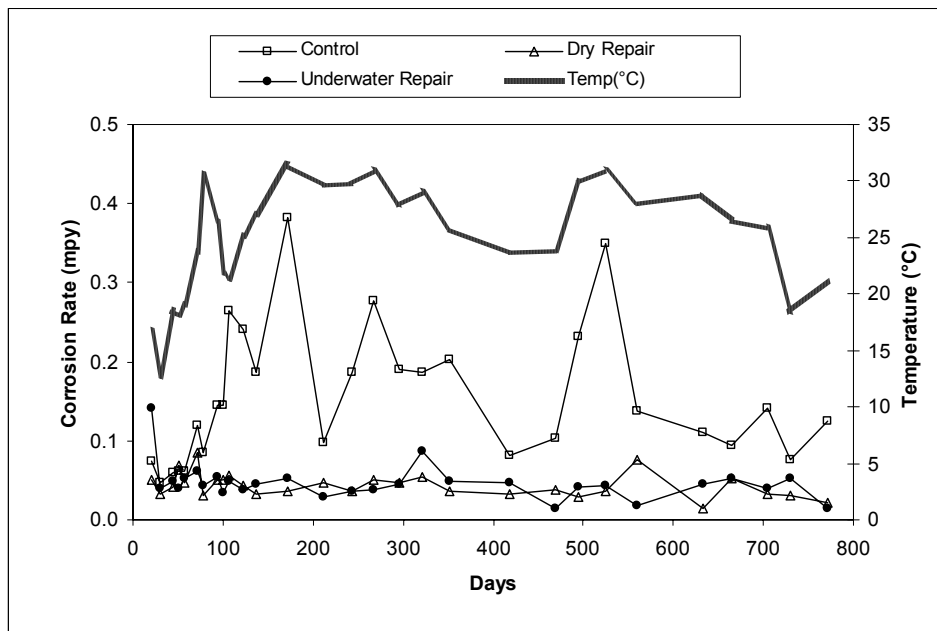
Figure 13 -- Results of Corrosion Rate Measurement at Allen Creek Bridge, Clearwater

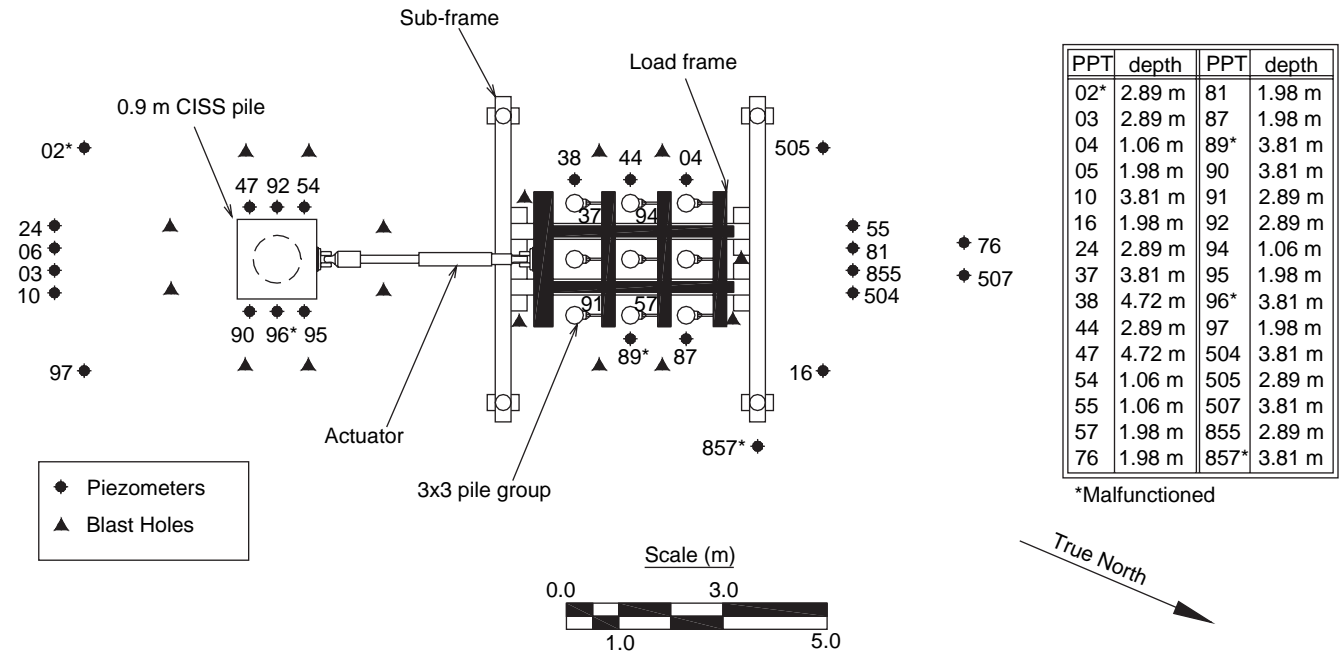
FIGURE 6 Layout of nine pile group and 0.9-m cast-in-steel-shell (CISS) pile along with locations of blast holes and piezoresistive piezometers for Treasure Island testing (PPT = pore pressure transducer).

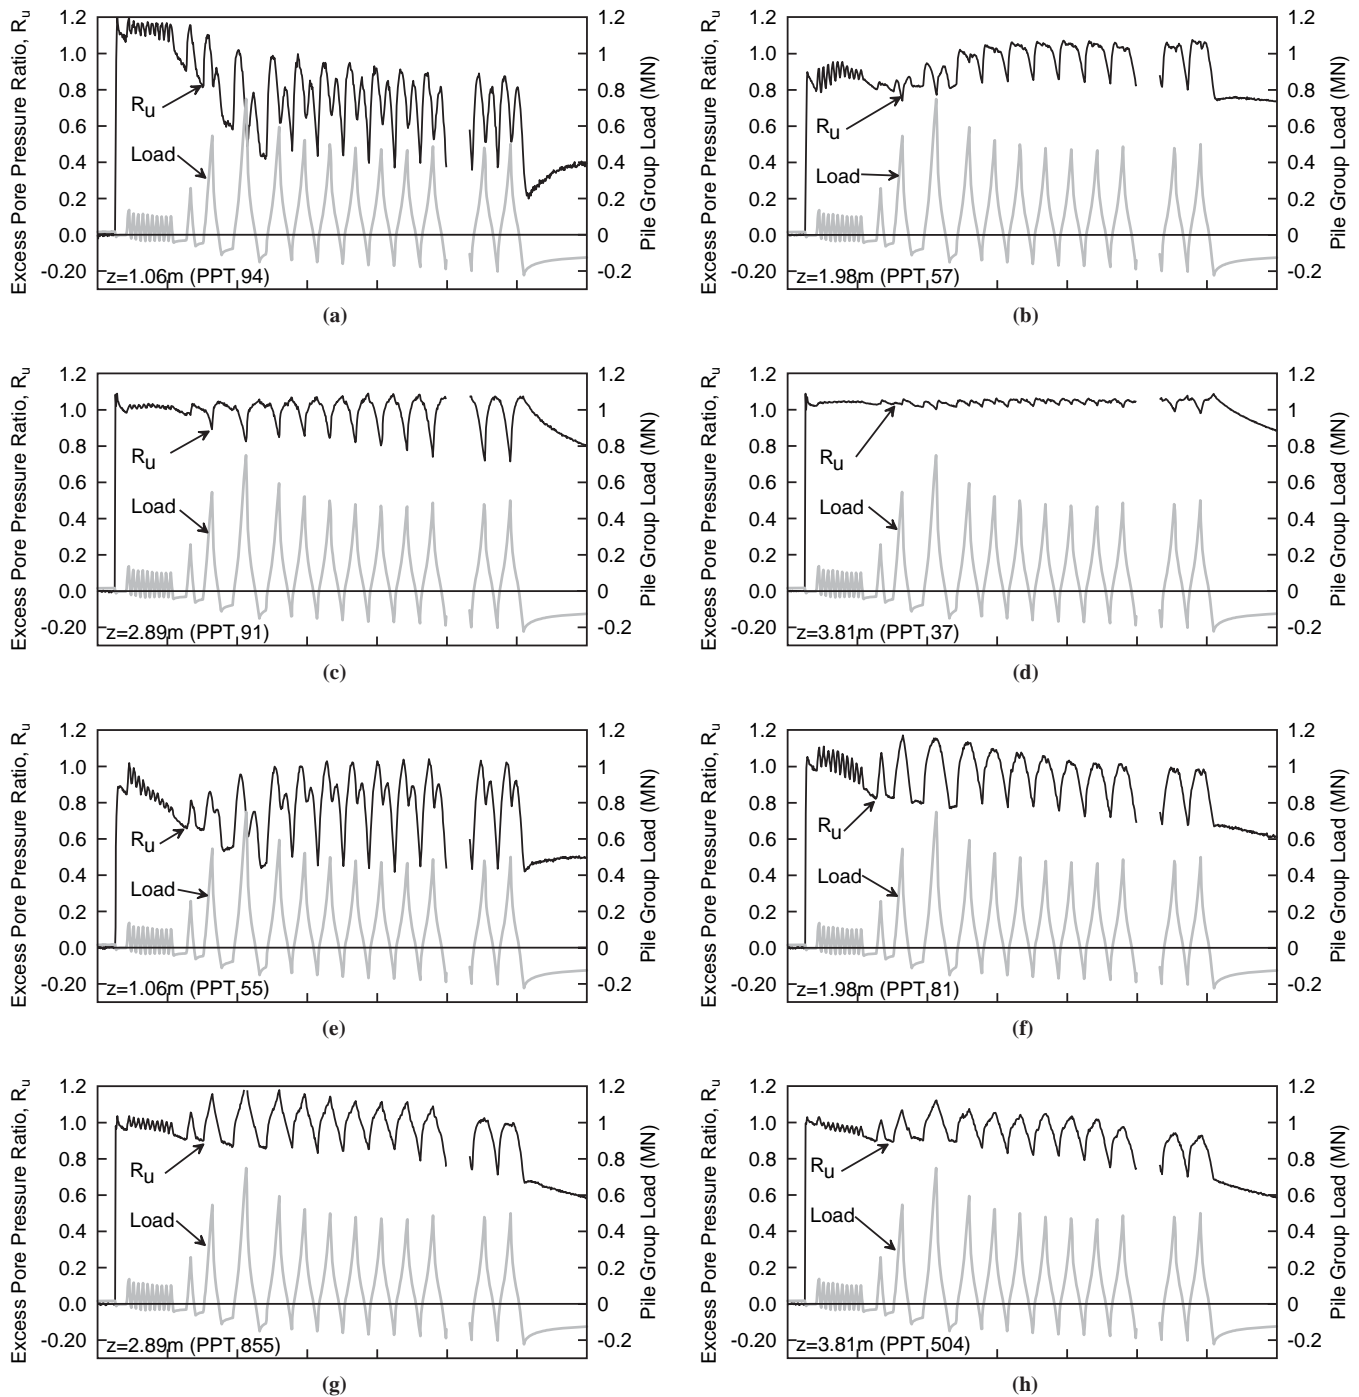
FIGURE 7 Time histories of total load and excess pore pressure ratios at four depths adjacent to nine-pile group, (a) to (d), and four depths 3.2 m in front of group, (e) to (h).

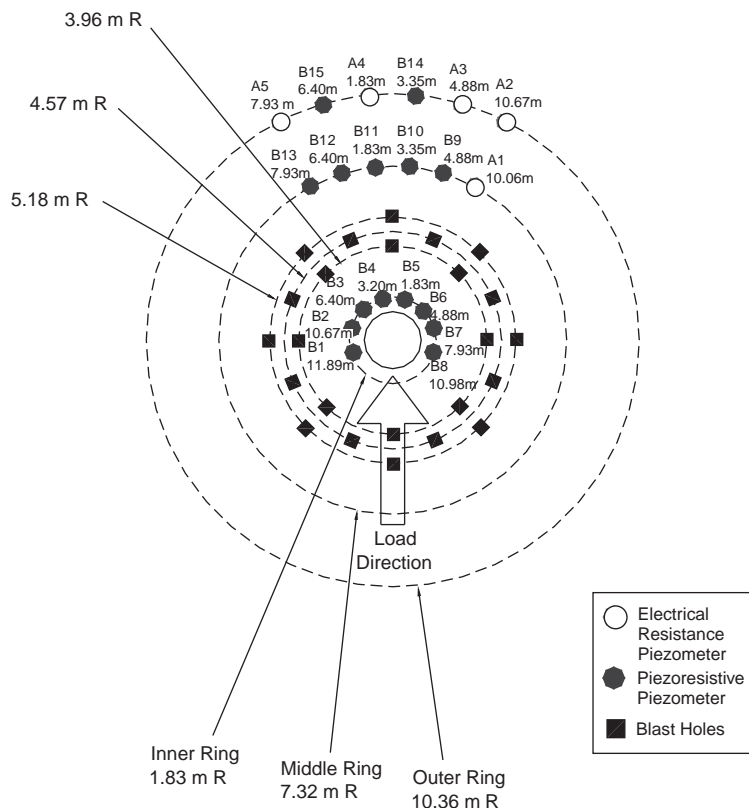
FIGURE 9 Layout of test shaft in relation to blast holes and piezometers at Cooper River Bridge testing.

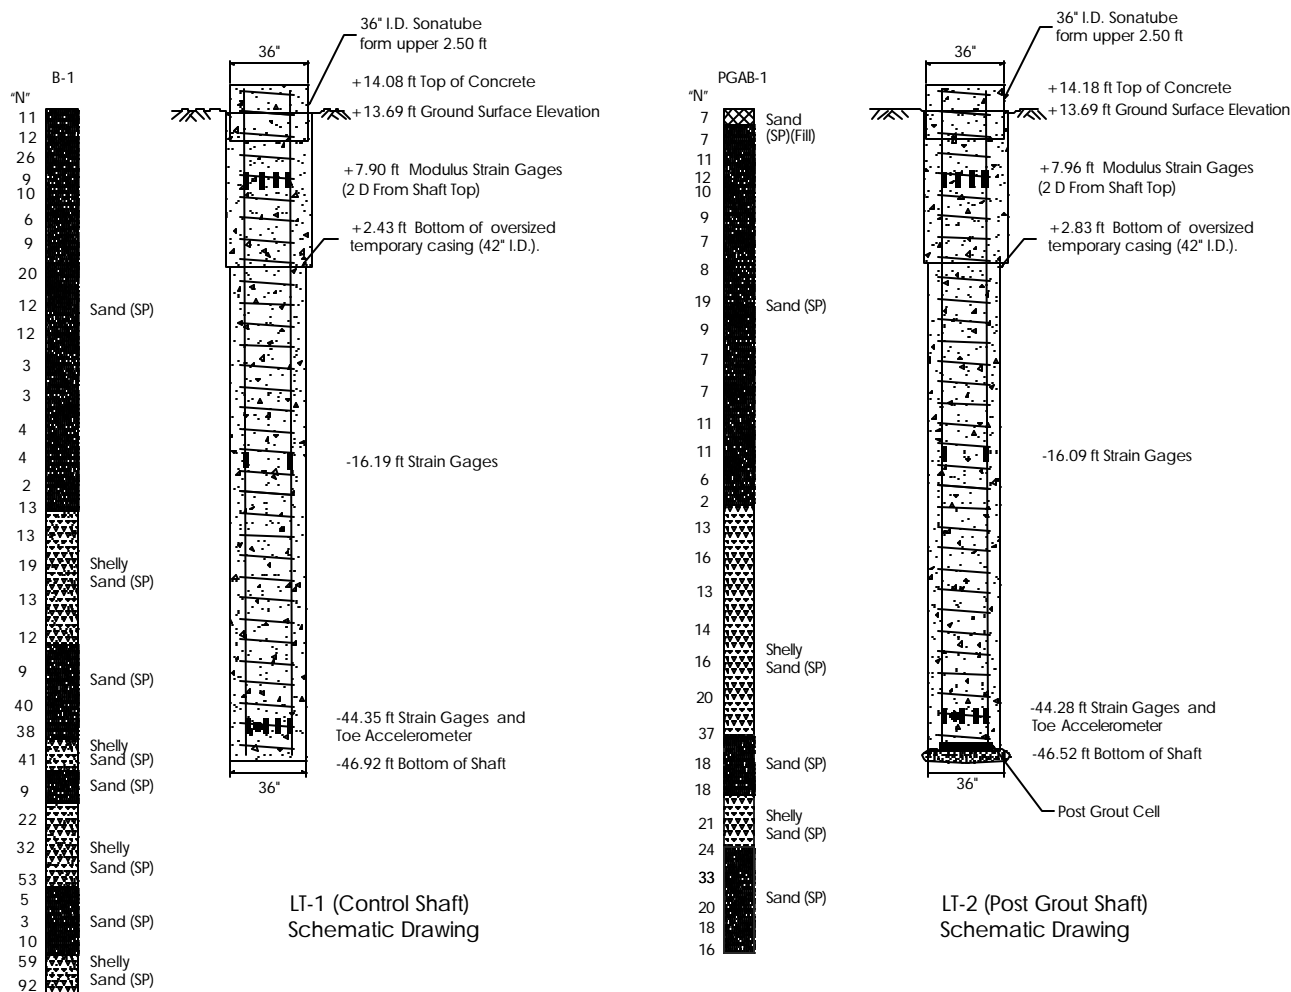
Figures 1 and 2. Schematic drawing of test shafts and soil profile.

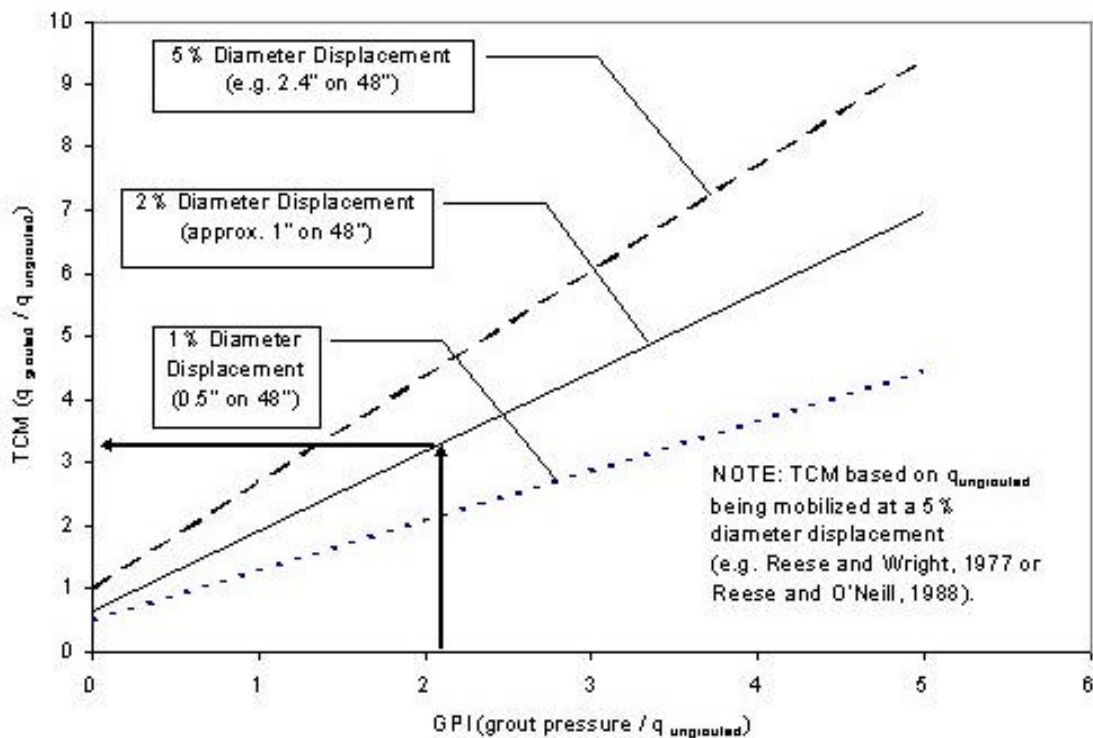
Figure 3. Design curve for shaft tips in sand (Mullins et al., 2001).

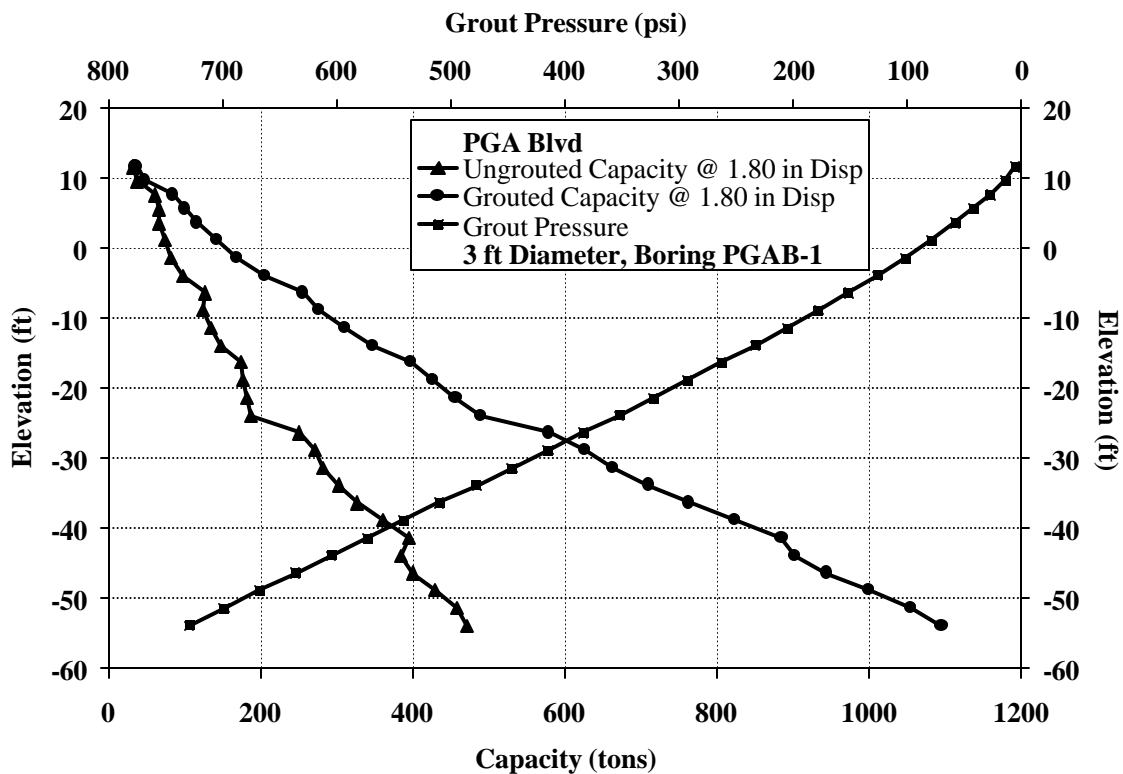
Figure 4. Site-specific design curve
