## Acknowledgments

## Table of Contents

## Case Study 2: St. Anthony Falls Bridge Foundation Monitoring

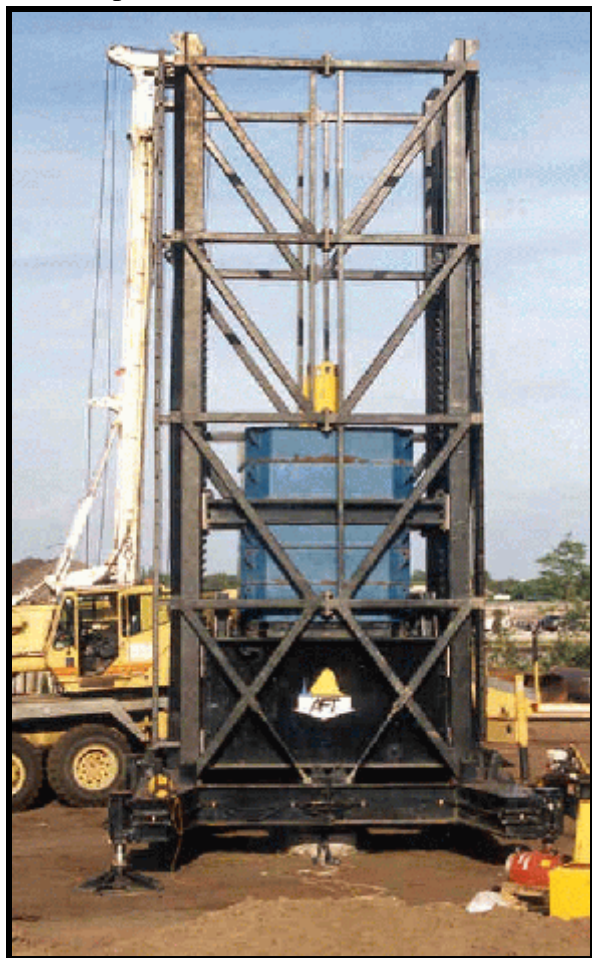
Figure 10. 2000 ton Statnamic load test.

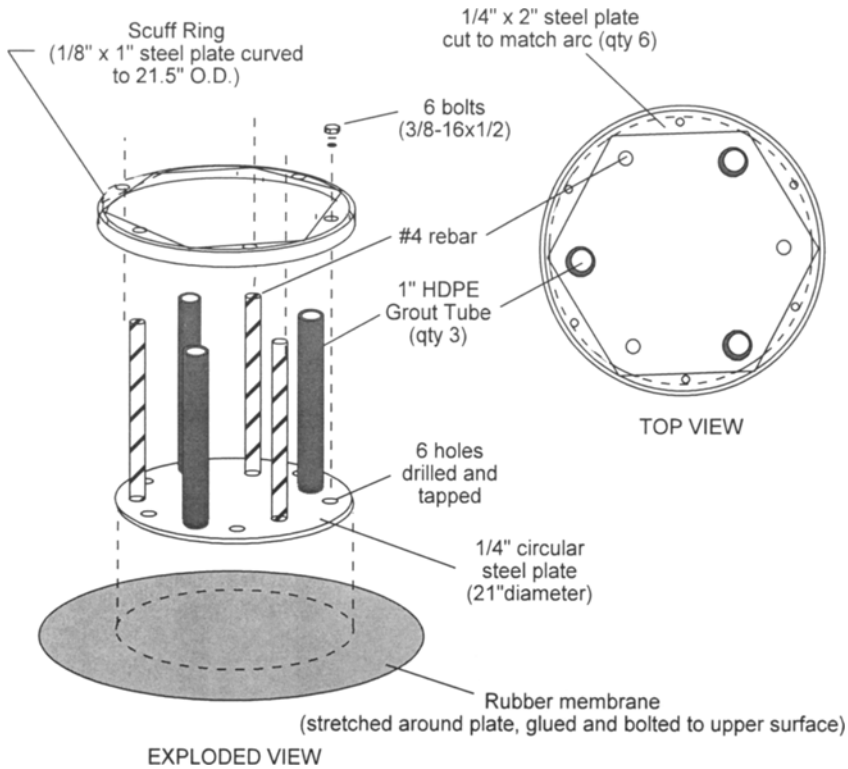
Figure 5. Flat-Jack Grouting Apparatus.

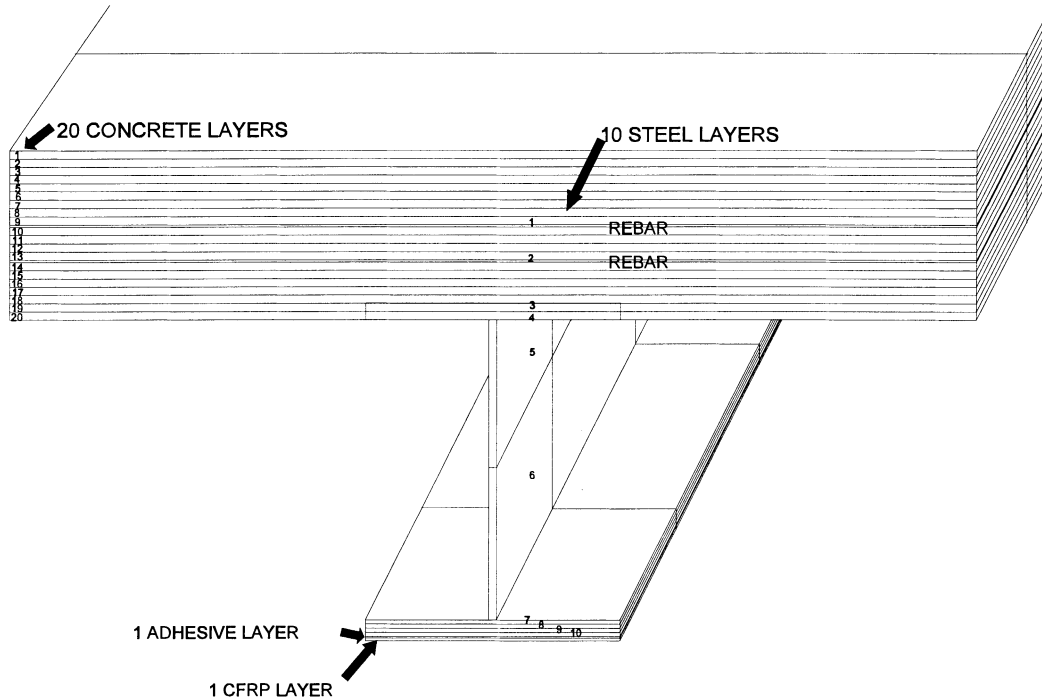
Fig. 17. Discretization of cross-section for finite element analysis.

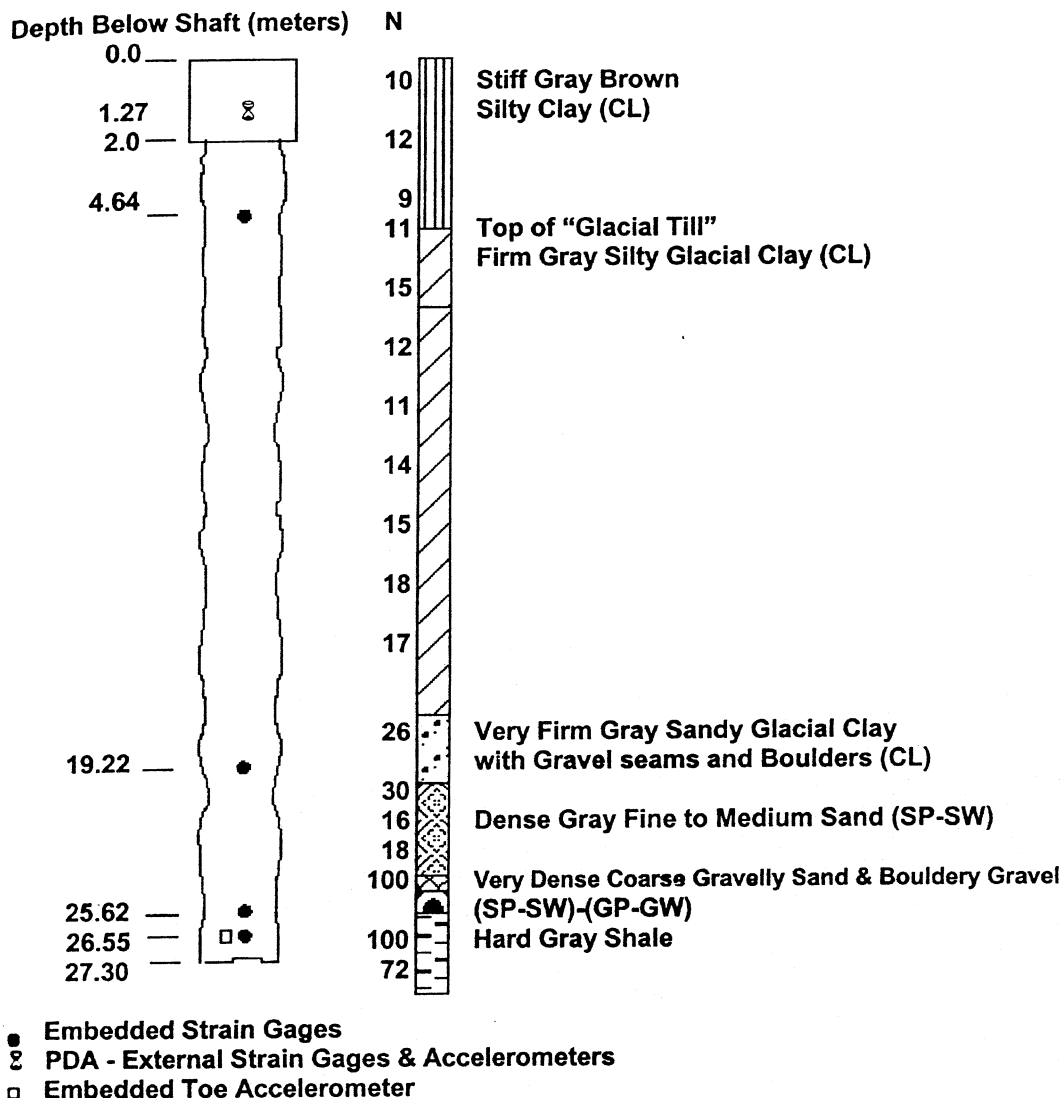
Figure 2. Soil Test Boring.

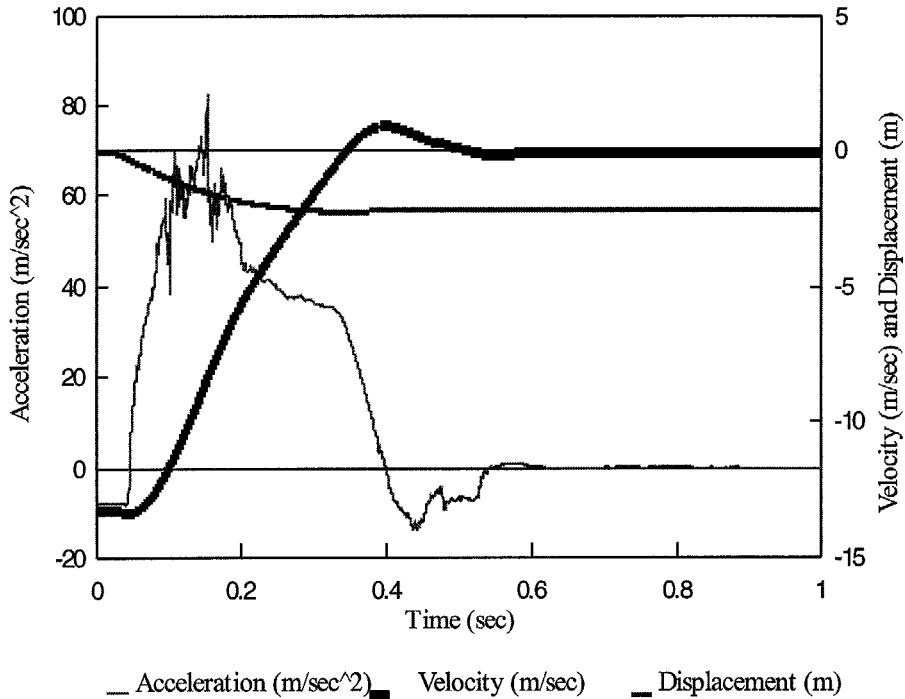
Fig. 6. Acceleration, velocity and displacement graphs for a typical high-energy impact (12.1 m drop height).

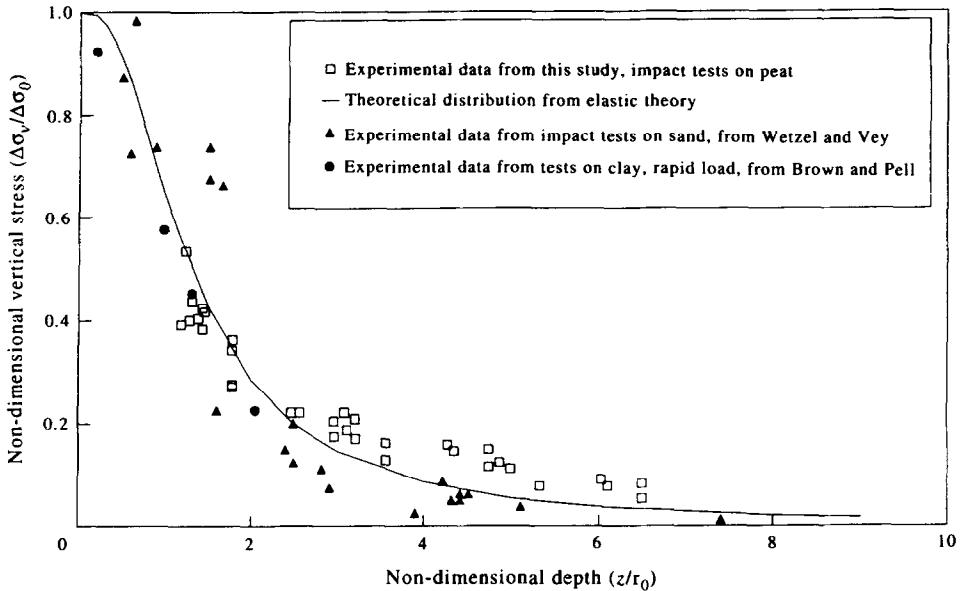
Fig. 2. Comparison of dynamic vertical stress distribution with elastic predictions.

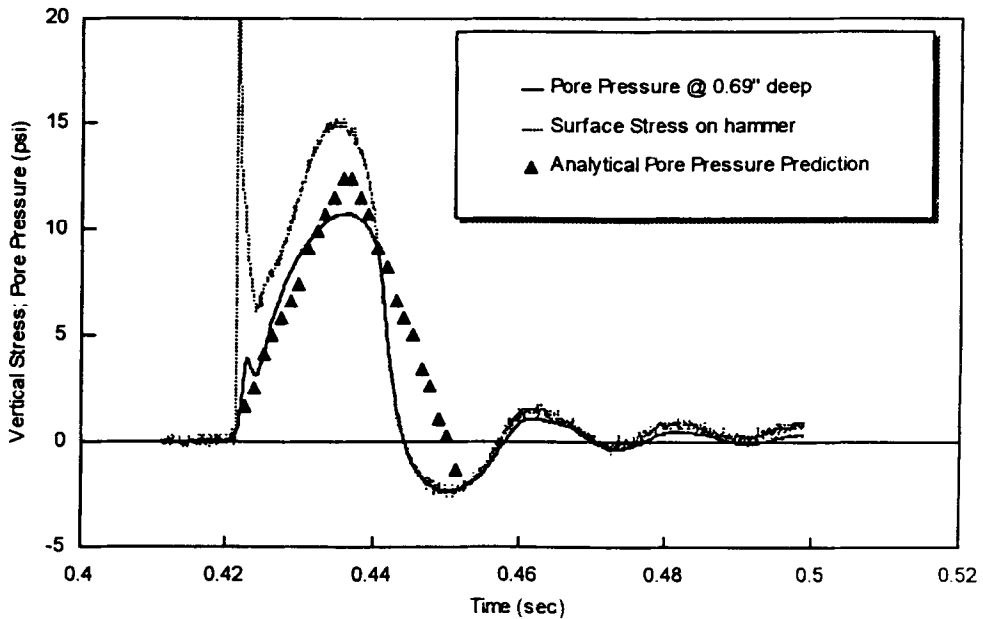
Fig. 8. Comparison of predicted and measured pore pressure variation.
