NON-COMPLIANCE WITH PLUMBING CODES IN CHINA: THE CRISIS OF SEWER GAS LEAKAGE

Alex A. Volinsky

Cite this Article: Alex A. Volinsky. Non-Compliance with Plumbing Codes in China: The Crisis of Sewer Gas Leakage. *International Journal of Construction Engineering (IJCE)*, 6(2), 2024, 1-9.

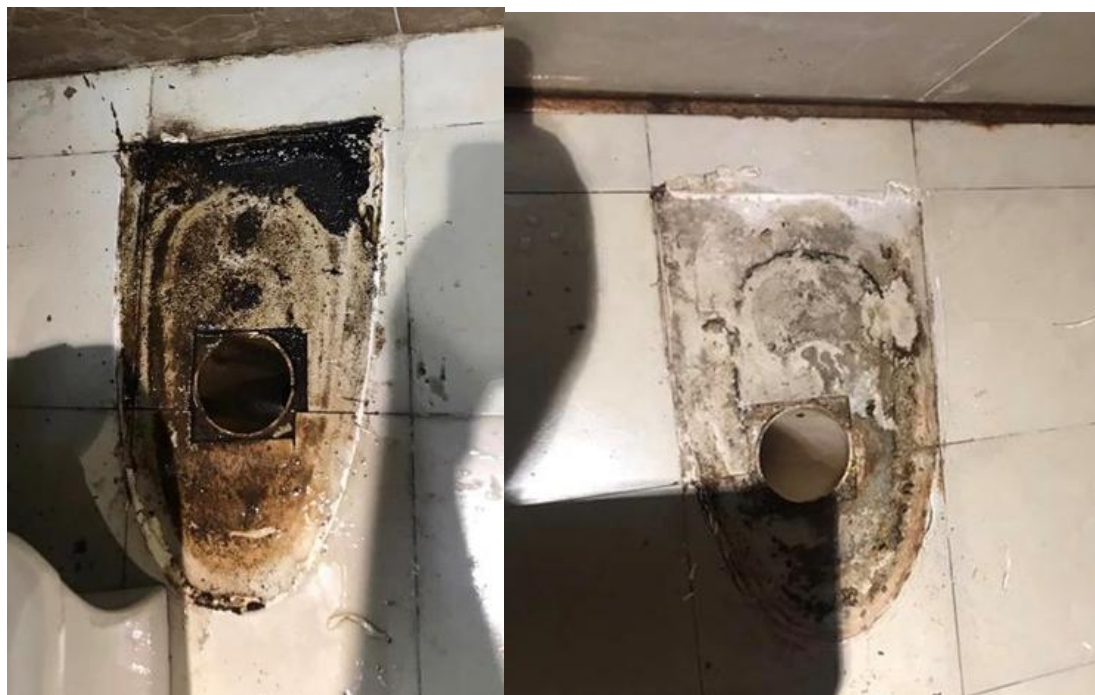
A previous publication highlighted the shortcomings of sewer and ventilation systems in China, as well as methods for temporarily stopping sewer gas leaks using plastic bags filled with water [1]. However, these measures did not yield the desired results, which were documented on video [5]. The other remaining source of sewer gas leakage in the room was the toilet. The hotel management was cooperative, and the building maintenance staff removed the toilet in the newly remodeled room 8326. It became clear that the seal between the toilet and the sewer pipe was missing in Figure 1(a). The plumber installed the gasket under the toilet, but this did not resolve the issue. The standard gasket was not thick enough to create a proper seal between the toilet and the drainpipe.

To the author's knowledge, there is no requirement in China to use a flange on a sewer pipe when installing a vertical outlet toilet, as specified in the building code [6]. Figure 1(b) illustrates that, during installation in room 8623, the toilet was positioned more than 5 cm to the right of the pipe center. While it is possible to install a vertical outlet toilet without a flange, this requires extra effort and the expertise of a qualified plumber to ensure the toilet is properly centered over the sewer pipe and that a tight seal is formed between the toilet and the flange. Like other construction professionals, plumbers in China must obtain a license, which requires

Figure 1. (a) Floor drainpipe under a vertical outlet toilet in remodeled room 8326 showing signs of leakage and poor seal; (b) Improperly installed toilet off the drainpipe center in room 8623 at Dinis Hotel.

1. **Enforce Existing Building Codes:** Government agencies must monitor compliance with national standards such as GB 50015-2019 and CJ/T 186-2018.
2. **Mandate Flange Usage:** Update standards to explicitly require the use of flanges for vertical outlet toilets.
3. **Enhance Public Awareness:** Educate the public about the health risks associated with sewer gas leakage.
4. **Train Construction Professionals:** Establish mandatory training and certification programs for plumbers and construction workers.
5. **Adopt International Best Practices:** Collaborate with international organizations to benchmark and implement proven solutions.

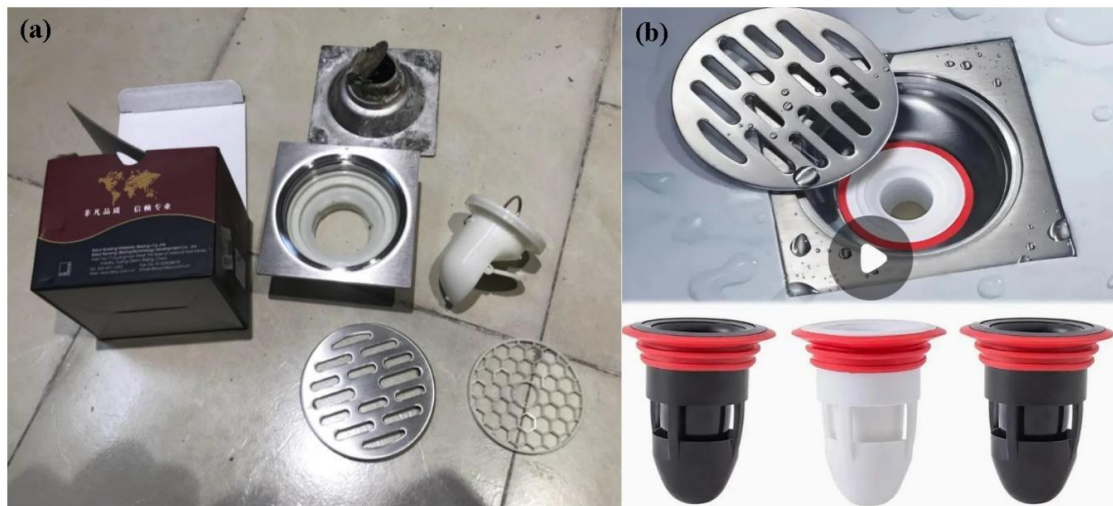
The Anhui Tower Hotel in Beijing, located at No. 1 West Huixin Street, Chaoyang District, Beijing 100029, China, underwent a major renovation in 2023. The author stayed at this hotel in the summer of 2024. Unlike the Dinis Hotel, where only one floor was renovated, the Anhui Tower Hotel underwent a complete remodel, including a full replacement of its plumbing. The bathroom shower and floor drains had air valves installed, as shown in Figure 2(a). However, these devices allow sewer gases to escape, particularly when there are pressure fluctuations in the sewer pipes, such as when a toilet or sink is flushed. A video shows gas bubbles escaping from beneath a plastic bag filled with water placed over a floor drain while the sink is being drained [7].

The top of Figure 2(a) shows an old drain insert with an air valve that is stuck in the open position due to metal corrosion. Unlike a water trap, an air valve cannot provide full protection against sewer gas leakage [8]. If there is no water trap built into the drainpipe, an insert with a water seal can be used, as shown in Figure 2(b). The dimensions of the water trap insert must comply with the relevant building codes to ensure proper water drainage, prevent clogging, and prevent the water in the trap from drying out.

Figure 2. (a) New drain insert with an air valve and magnetic flap. Above is the old drain insert with the air valve stuck in the open position due to metal corrosion; (b) Inserts with water trap for floor or shower drains.

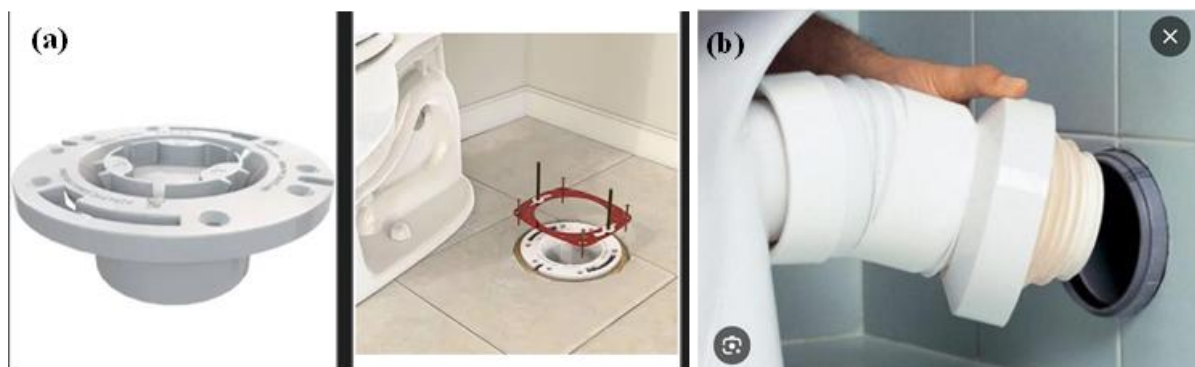
In the US, toilets are installed on top of the waste pipe using a flange and a wax ring. Two brass bolts are used to center the toilet over the waste pipe and secure it in place, as shown in Figure 3(a). The wax ring creates a tight seal between the toilet and the flange. Experienced plumbers know that, in many cases, two wax rings may be required to ensure a proper seal.

Figure 3. (a) Flange with gasket and bolts for installing toilet onto a sewer pipe in the USA; (b) Flexible collar for connecting a sewer pipe outside the horizontal outlet toilet in Europe.

In Europe, toilets typically have horizontal outlets that discharge from the back of the toilet, connected to the sewer pipe via a sealed collar, as shown in Figure 3(b). Since the connection is external, any damage or installation flaws are visible without the need to remove the toilet.

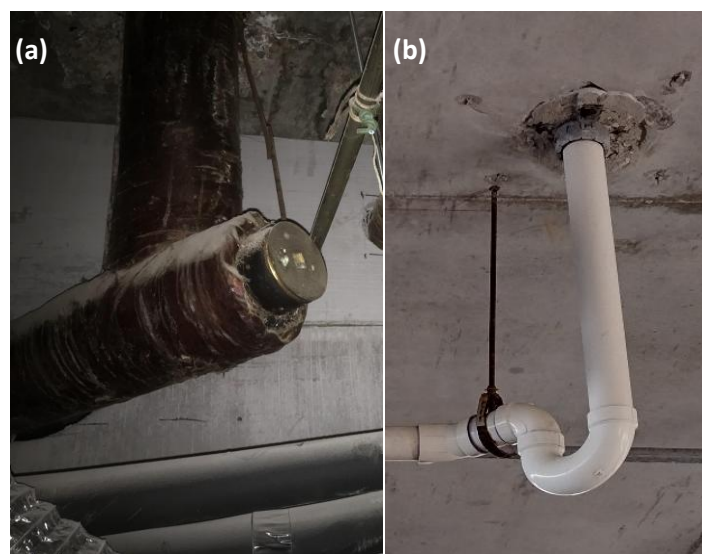
As shown in Figure 4(a), the shower drainpipe lacks a water trap. A typical bathroom includes a bathtub or shower, a sink, and a toilet. According to China's national standards, a floor drain must be installed in the bathroom. The siphon is integrated into the toilet and sink drains, so additional water traps in the sewer pipes are not required. However, the bathtub or shower drain, and the bathroom floor drain do not have a trap, so it is built as a part of the sewer pipe in Figure 4(b). The absence of a water trap in the shower drain, as seen in Figure 4(a), violates China's national standard GB 50015-2019. As a result, sewer gases enter the bathroom through the shower and floor drains, even though air valves are installed in both drains.

Figure 4. (a) Shower drain sewer pipe in Anhui Tower Hotel without a water trap; (b) Sewer pipe with a built-in p-trap.
