# Foundation & Geotechnical Engineering, LLC

FGE Project No.: G08-L-293

Subject: **Shaft Integrity Testing Results**  
XXXXXXXXXXXXXXXXXXXXXXXXXXXX

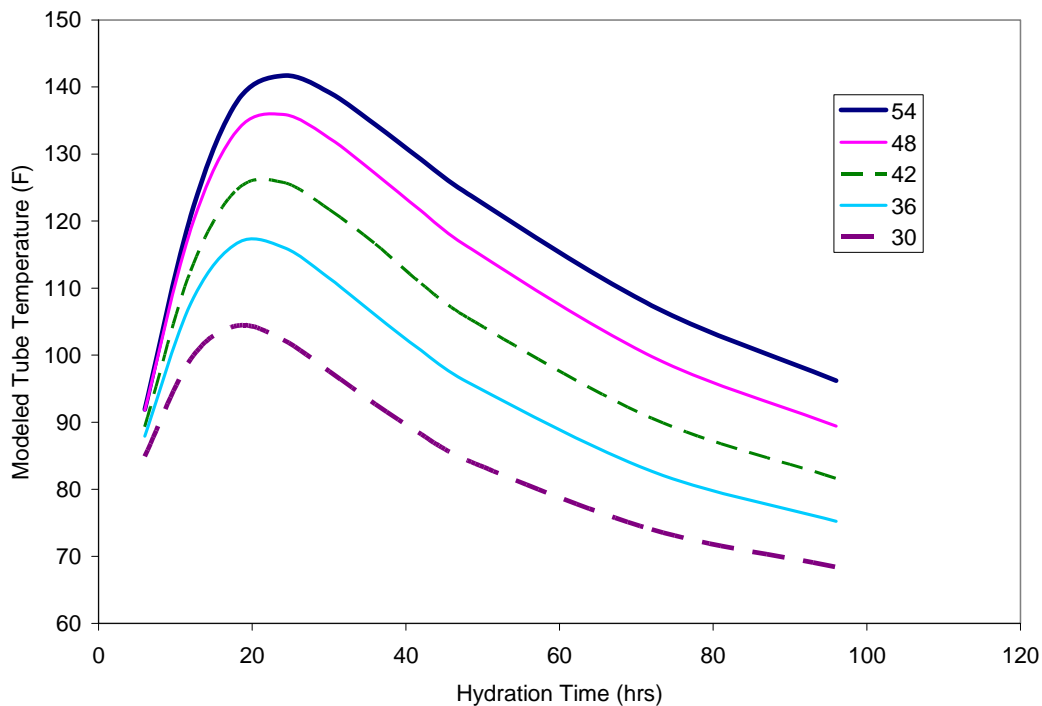
Prior to analysis of the field measurements a model was created based on the heat generation properties of the above concrete mix, insulation properties of the soil around the shaft and the time of the test relative to shaft construction. The expected normal temperature varies with time as the shaft either heats or cools depending on its stage in the hydration process. The following graph shows the anticipated temperatures for 30, 36, 42, 48, and 54 inch diameter shafts under the ambient and soil conditions at the XXXXXXXXXXXXXXXXXXXXXXXXXXXXXXX.

**Figure 1** Normal access tube temperatures for shaft sizes tested.
