International Journal of Civil Engineering and Technology (IJCIET)

CAUSES OF ODOR IN KITCHENS, BATHROOMS, AND TOILETS OF MULTI-STORY RESIDENTIAL APARTMENTS WITH NATURAL VENTILATION

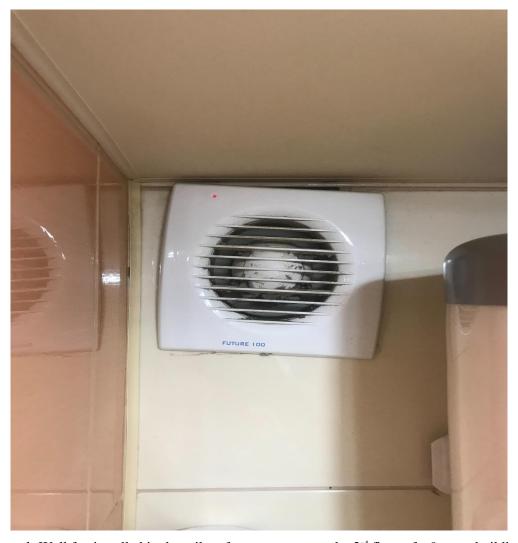
Figure 1. Wall fan installed in the toilet of an apartment on the 3rd floor of a 9-story building in Tomsk.

Electric fans designed to be inserted into the ventilation grills in bathrooms and toilets are available on the market. Figure 1 shows a wall-mounted fan installed in the toilet vent of an apartment on the 3rd floor of a 9-story residential building in Tomsk Russia. There was a strong tobacco smoke smell in the toilet in the mornings, and periodically sewage smell. Figure 2 shows a wall fan installed in the bathroom of an apartment on the 9th floor of a 10-story residential building. Covered by the smell of shampoos in the bathroom, there was a sewer smell. The author noticed an extraneous odor in several bathrooms and toilets of apartments in the city of Tomsk in the summer of 2021 and 2022. The problem of nuisance smell in kitchens, bathrooms, and toilets is present in other Russian cities, including Moscow. There are similar problems in other countries, especially in China and Thailand, but perhaps due to other reasons.

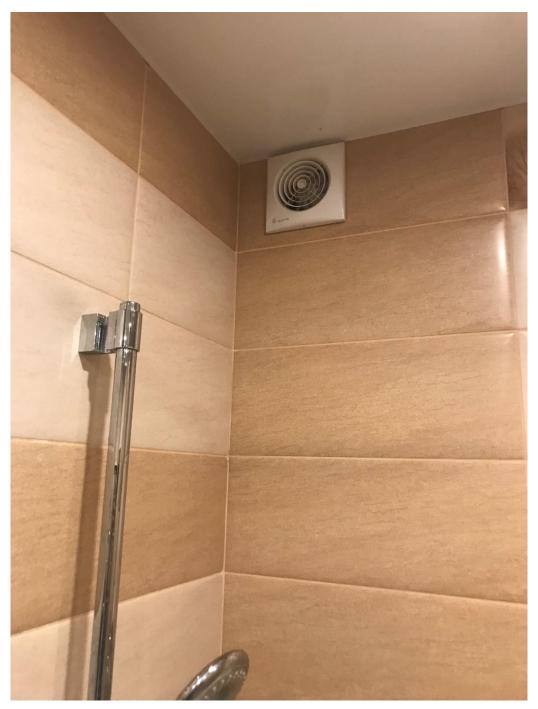
Figure 2. Wall fan installed in the bathroom of an apartment on the 9th floor of a 10-story building in Tomsk.

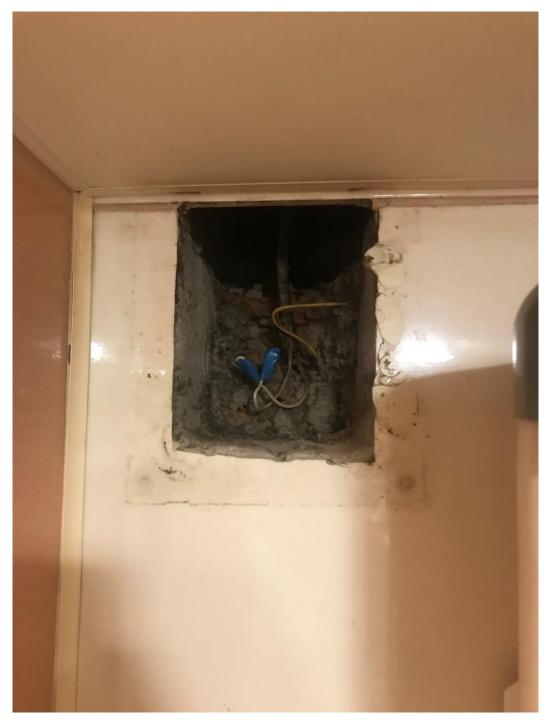
Figure 3. The air vent in the bathroom of a residential apartment in Tomsk without a fan.

In the summer of 2022, the problem of a nuisance smell in the apartment of a residential building in Tomsk was solved by temporarily sealing the ventilation grill. Figure 3 shows the vent after the wall fan has been removed and the electrical wires insulated. In Figure 4, the vent is temporarily sealed with a thick plastic film and adhesive tape. After this modification, the occasional smell of tobacco smoke and other unpleasant odors disappeared.

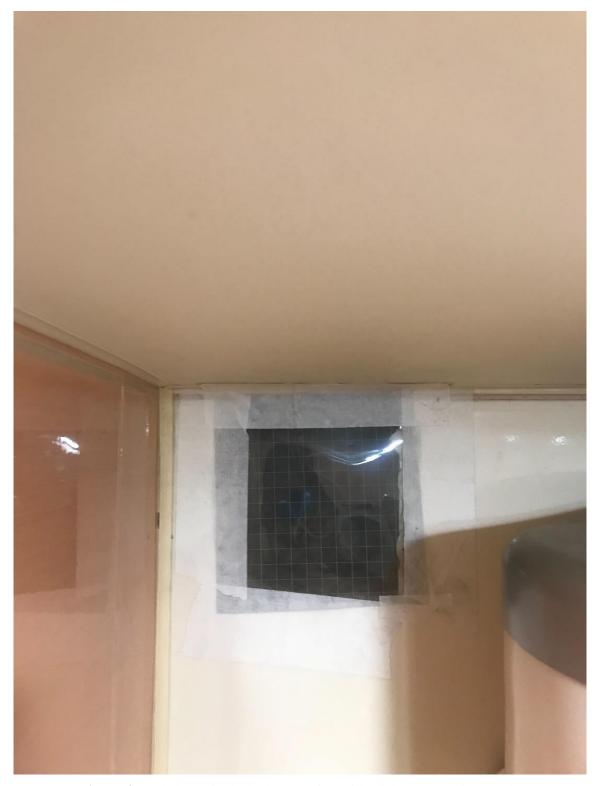
Figure 4. Sealed vent in the bathroom of a residential apartment in Tomsk.

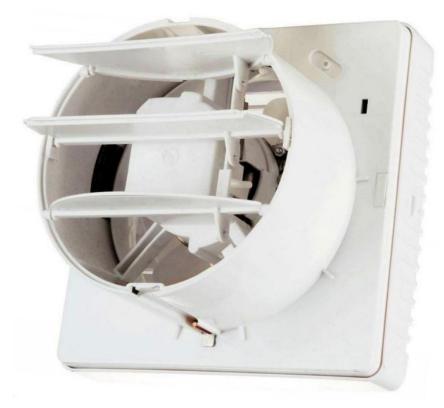
Figure 5. Fan with a damper.

Figure 5 shows a fan with a damper that prevents air from flowing out of the vent. While such a damper fan will prevent odor from other apartments, the fan itself interferes with the entire natural ventilation system of an apartment building. Forced airflow from a fan in one apartment disrupts the natural flow of air in the ventilation system of the entire residential building, causing an unpleasant smell in neighboring apartments. Therefore, instead of a fan, a check valve needs to be installed in the vent, as shown in Figure 6.

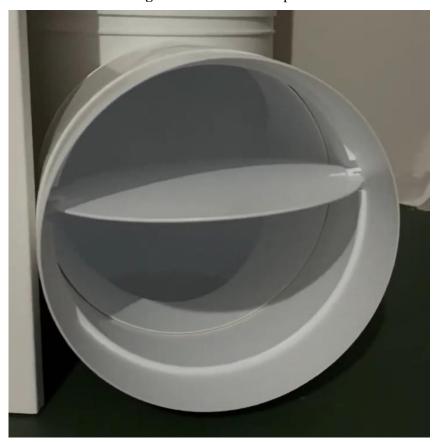
Figure 6. Air check valve.
